Report Title: Geotechnical Report 44 Wandeen Road, Clareville
Report Date: 9/4/25

GEOTECHNICAL INVESTIGATION:

Alterations and Additions at **44 Wandeen Road, Clareville**

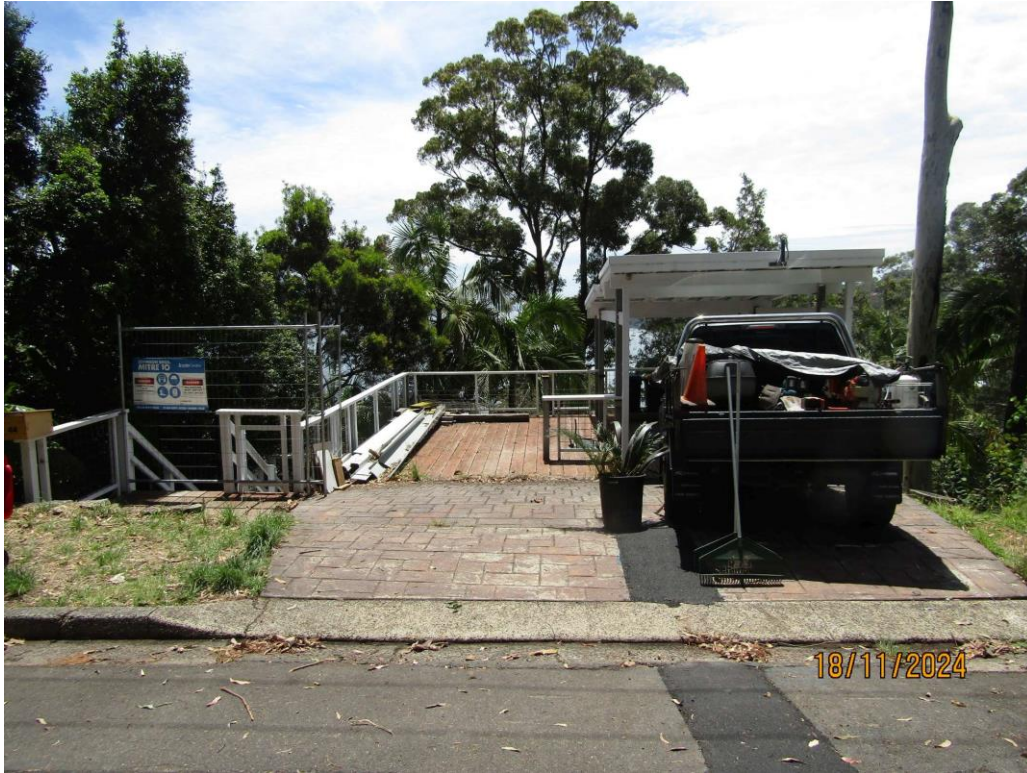
Photo 1

- 2.3** At the road frontage, a partially suspended concrete driveway runs to a suspended timber carport (Photo 1). The concrete piers and steel posts that support the driveway and carport stand vertical (Photos 2 & 3). The fill batter for the road merges into the natural steep slope (Photo 4). The existing house is partially demolished (Photos 5 & 6). One of the supporting brick walls of the house displays a stepped crack through the mortar (Photo 7). It is expected that this wall will be

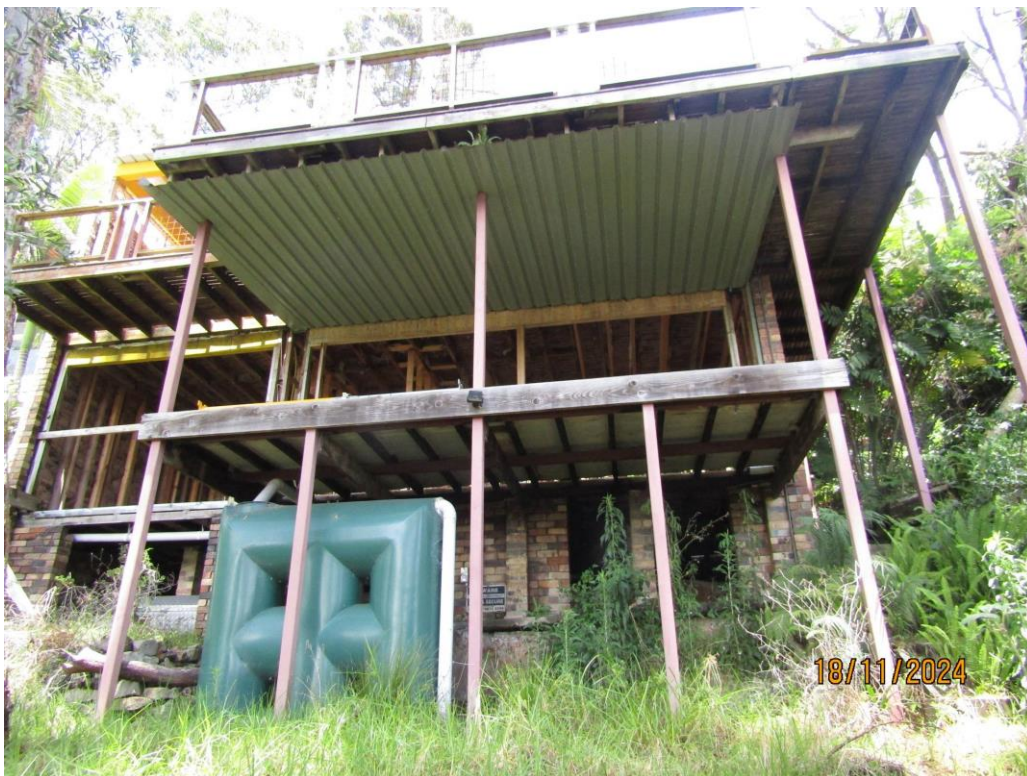
Photo 6

Stable sandstone flagging up to ~1.5m high and a stable concrete retaining wall ~1.5m high support cuts for the house and fills for garden and paved areas above (Photos 9 & 10). Suspended timber balconies extend off the downhill side of the house (Photo 6). The steel posts that support the balconies stand vertical. Low timber, timber crib, and brick retaining walls support fills for level garden and lawn areas beside and downslope of the house. The timber retaining wall at the downhill side of the house is tilting downslope slightly (Photo 11), but due to its low height and location, it is not considered a significant threat to life or property. A moderate to steeply graded garden and lawn area extends off the downhill side of the retaining walls to the downhill property boundary (Photo 12).

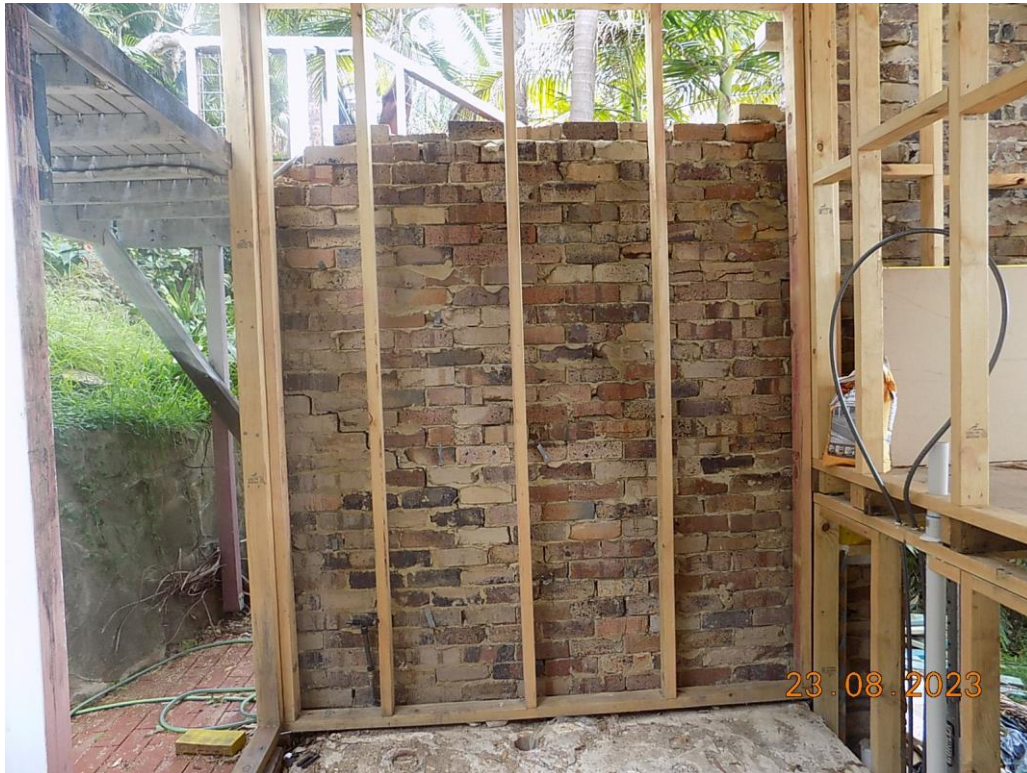
Photo 7

demolished or remediated as part of the proposed works. The brick piers supporting the house stand vertical (Photo 8).

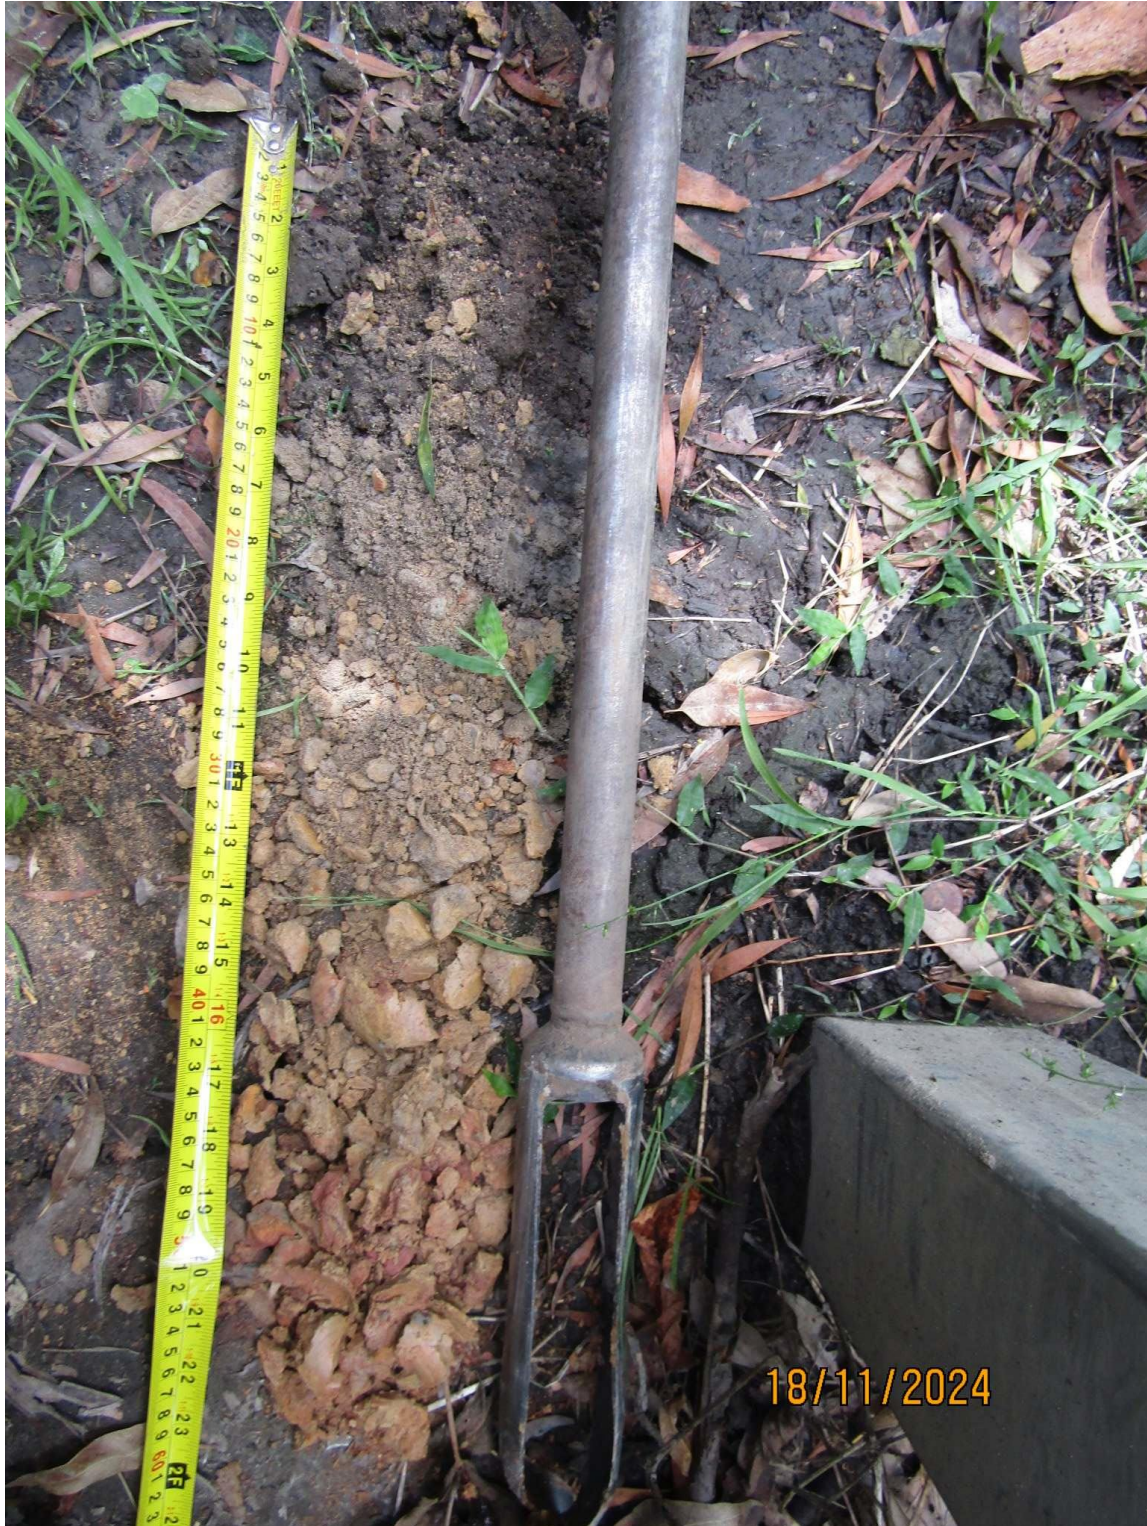
AUGER HOLE 1 (~RL59.3) – AH1 (Photo 13)

Depth (m)	Material Encountered
0.0 to 0.3	FILL , sandy soil and clayey soil, with some rock fragments, dark brown, grey, orange, damp, fine to coarse grained.
0.3 to 0.6	CLAY , yellow/orange brown, stiff, dry.

End of hole @ 0.6m in stiff clay. No water table encountered.

Photo 13: AH1 – Downhole is from top to bottom.

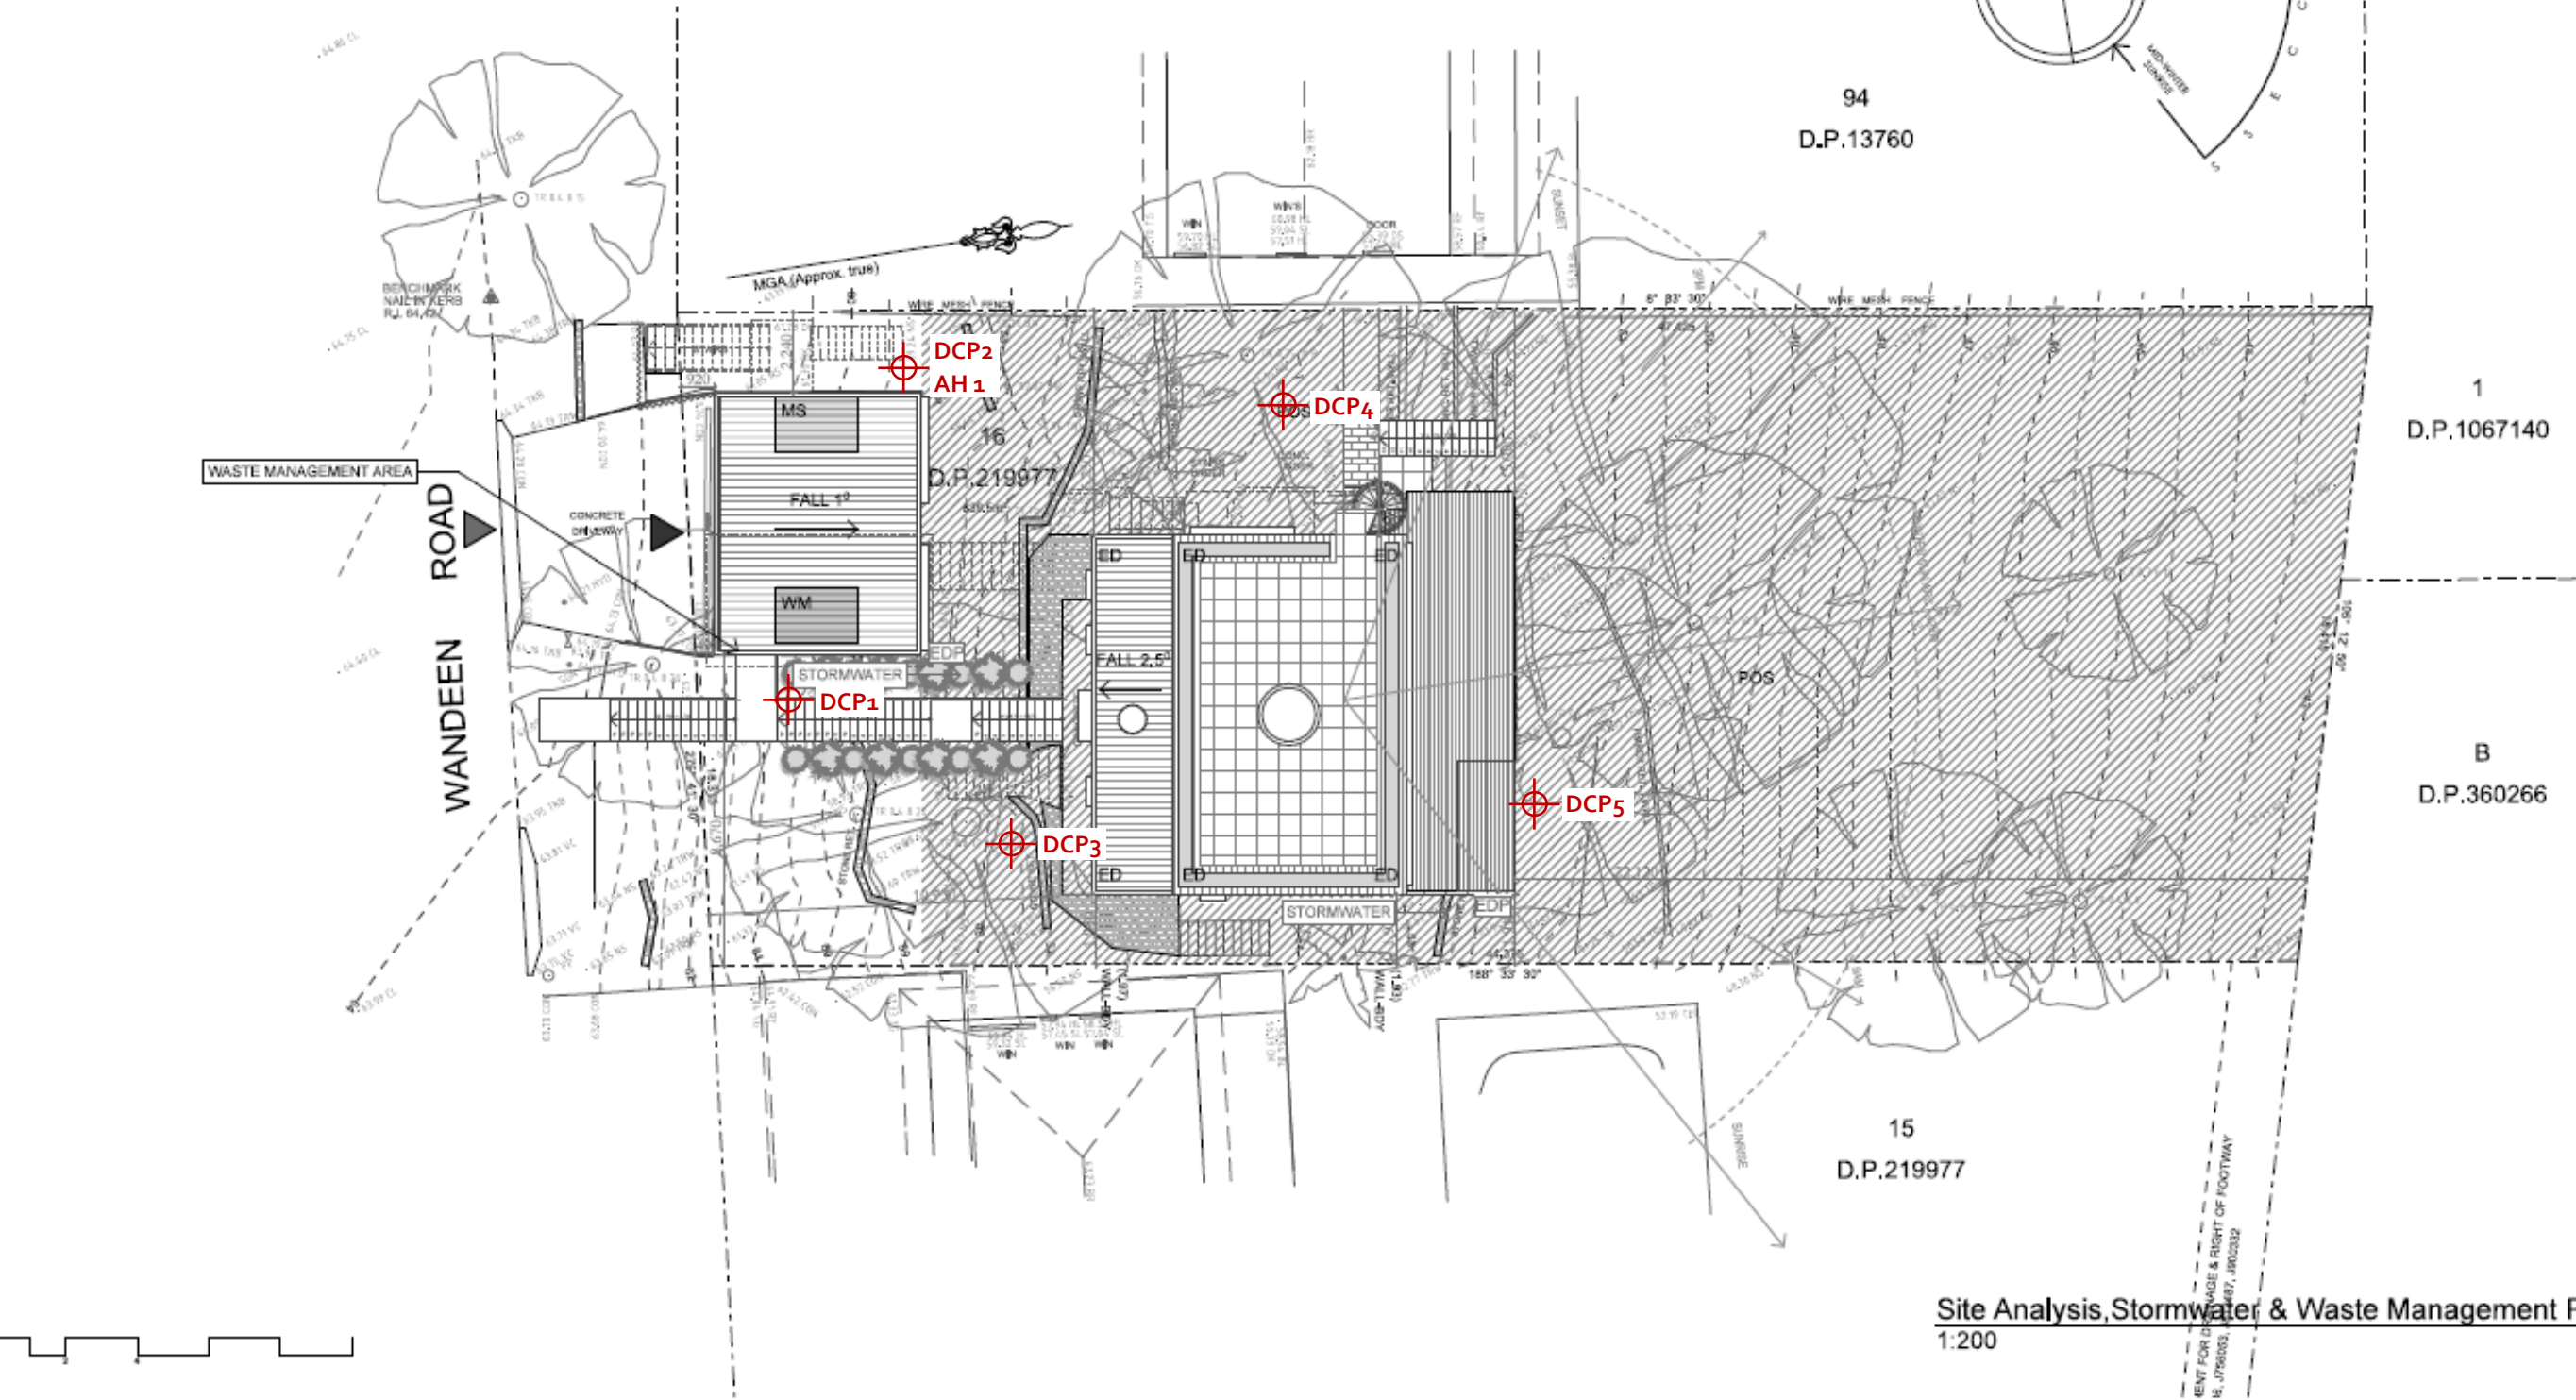
SITE PLAN – showing test locations

One hand Auger Hole (AH) was put down to identify the soil materials. Five Dynamic Cone Penetrometer (DCP) tests were put down to determine the relative density of the overlying soil and the depth to weathered rock. The locations of the tests are shown on the site plan attached. It should be noted that a level of caution should be applied when interpreting DCP test results. The test will not pass through hard buried objects so in some instances it can be difficult to determine whether refusal has occurred on an obstruction in the profile or on the natural rock surface. This may have occurred for DCP1. Due to the possibility that the actual ground conditions vary from our interpretation there should be allowances in the excavation

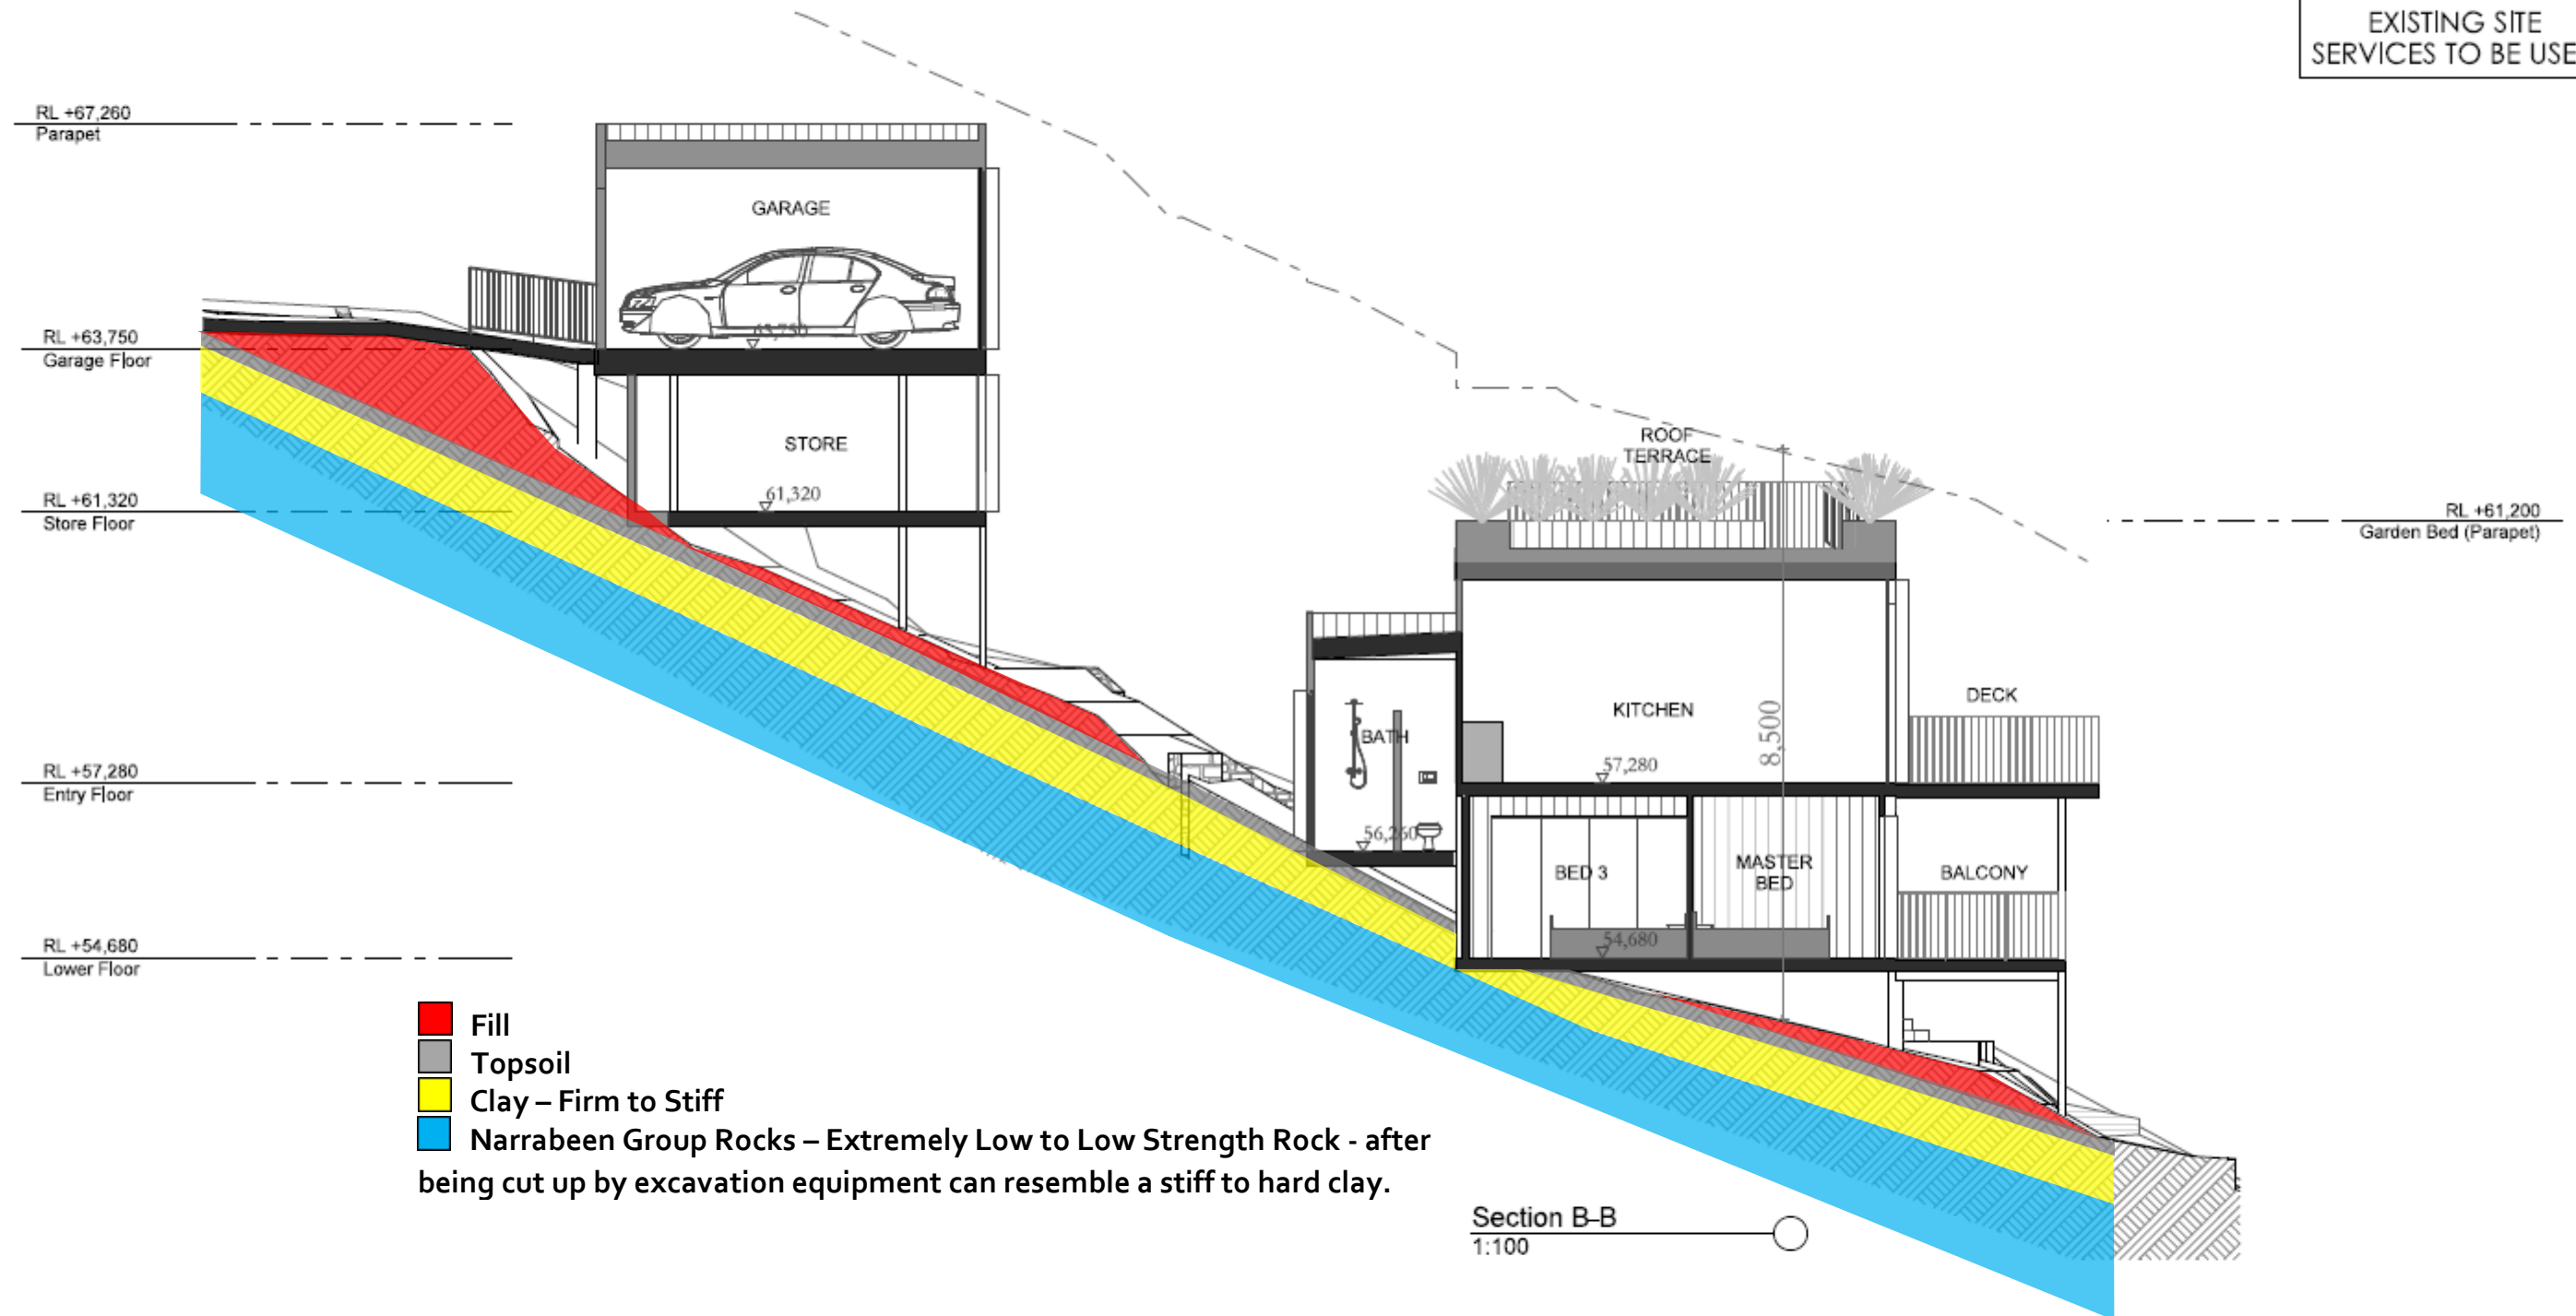
TYPE SECTION – Diagrammatical Interpretation of expected Ground Materials

The slope materials are colluvial at the near surface and residual at depth. In the test locations, the ground materials consist of fill and a thin topsoil over firm to stiff clays. Fill to an estimated maximum depth of ~1.0m provides level platforms for lawn, garden, and paved areas across the property. In the test locations, the clays merge into the weathered zone of the underlying rock at depths of between ~0.9m to ~1.5m below the current surface. The weathered zone of the underlying rock is interpreted as Extremely Low to Low Strength Rock. It is to be noted that this material is a soft rock and can appear as a mottled stiff clay when it is cut up by excavation equipment. See Type Section attached for a diagrammatical representation of the expected ground materials.
