**GEOTECHNICAL RISK MANAGEMENT POLICY FOR PITTWATER**  
**FORM NO. 1 – To be submitted with Development Application**

Development Application for Grexx Holdings Pty Ltd, Jonathan Odisho

This report provides geotechnical recommendations regarding the existing ground conditions in order to have a clear guidance for design and construction of ground structures.

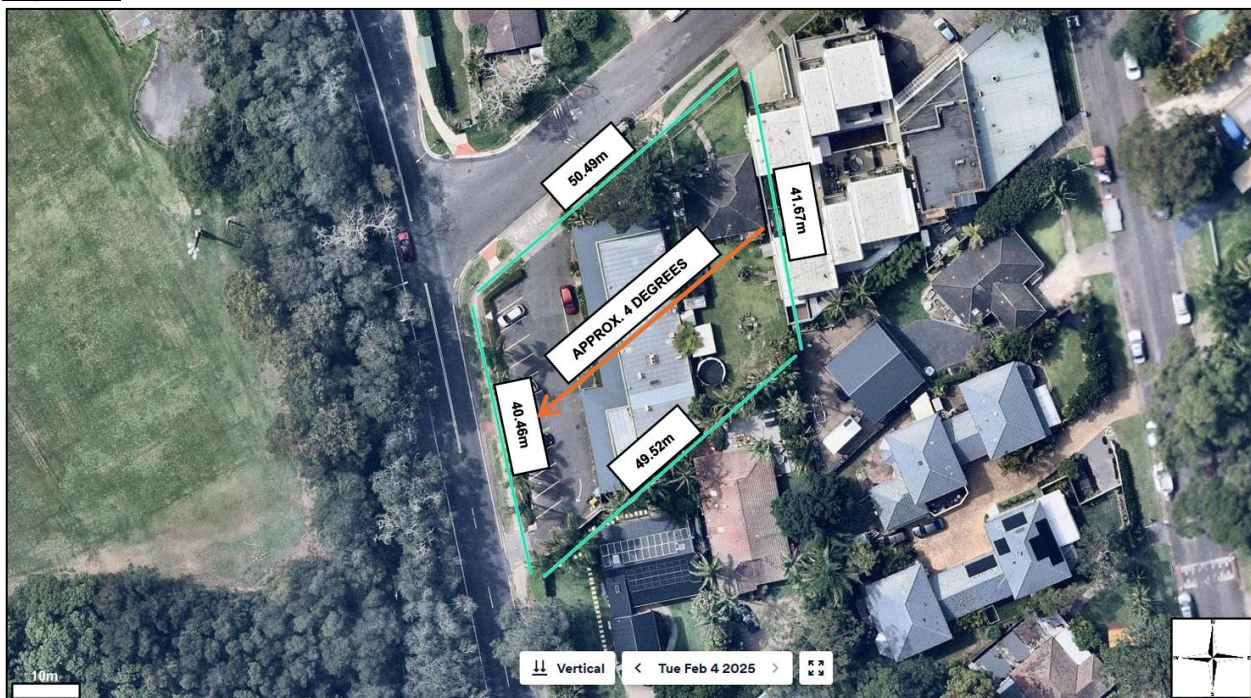
**Figure 2:** Site Dimensions

The longitudinal slopes from the highest point of the site (RL 4.52) to the lowest point (RL 2.15) is approximately 4° as shown in Figure 2.

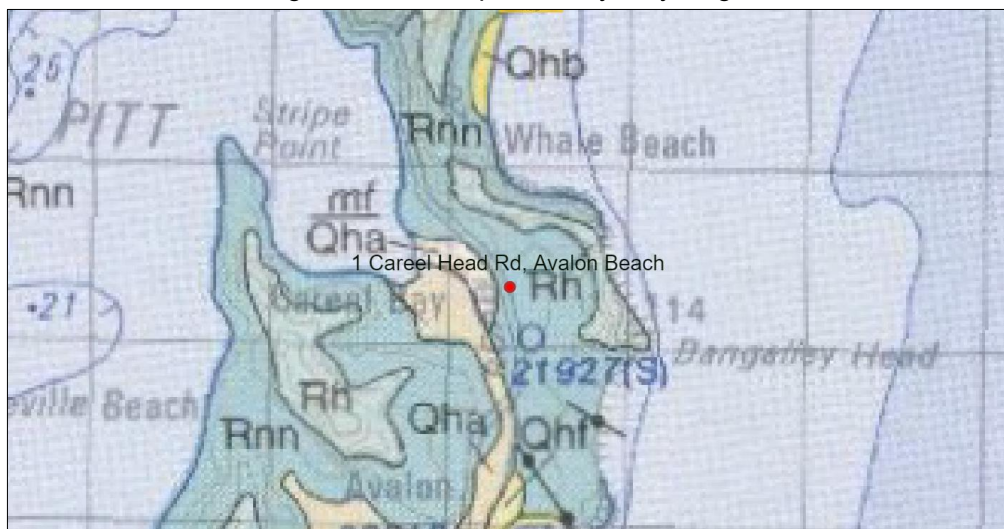
**Figure 3:** 1:100,000 scale Geological Series Map of the Sydney Region

The 1:100,000 scale Geological Series Sheet 9130 (Edition 1) 1983 of the Sydney region (Figure 3) indicates that the subject site is underlain by Narrabeen group Terrigal Formation (**Rnn**) consists of interbedded laminite, shale, and quartz, to lithic-quartz sandstone. Minor red claystone north of Hawkesbury River. Clay pellet sandstone (Garnie Fm) south of Hawkesbury River.

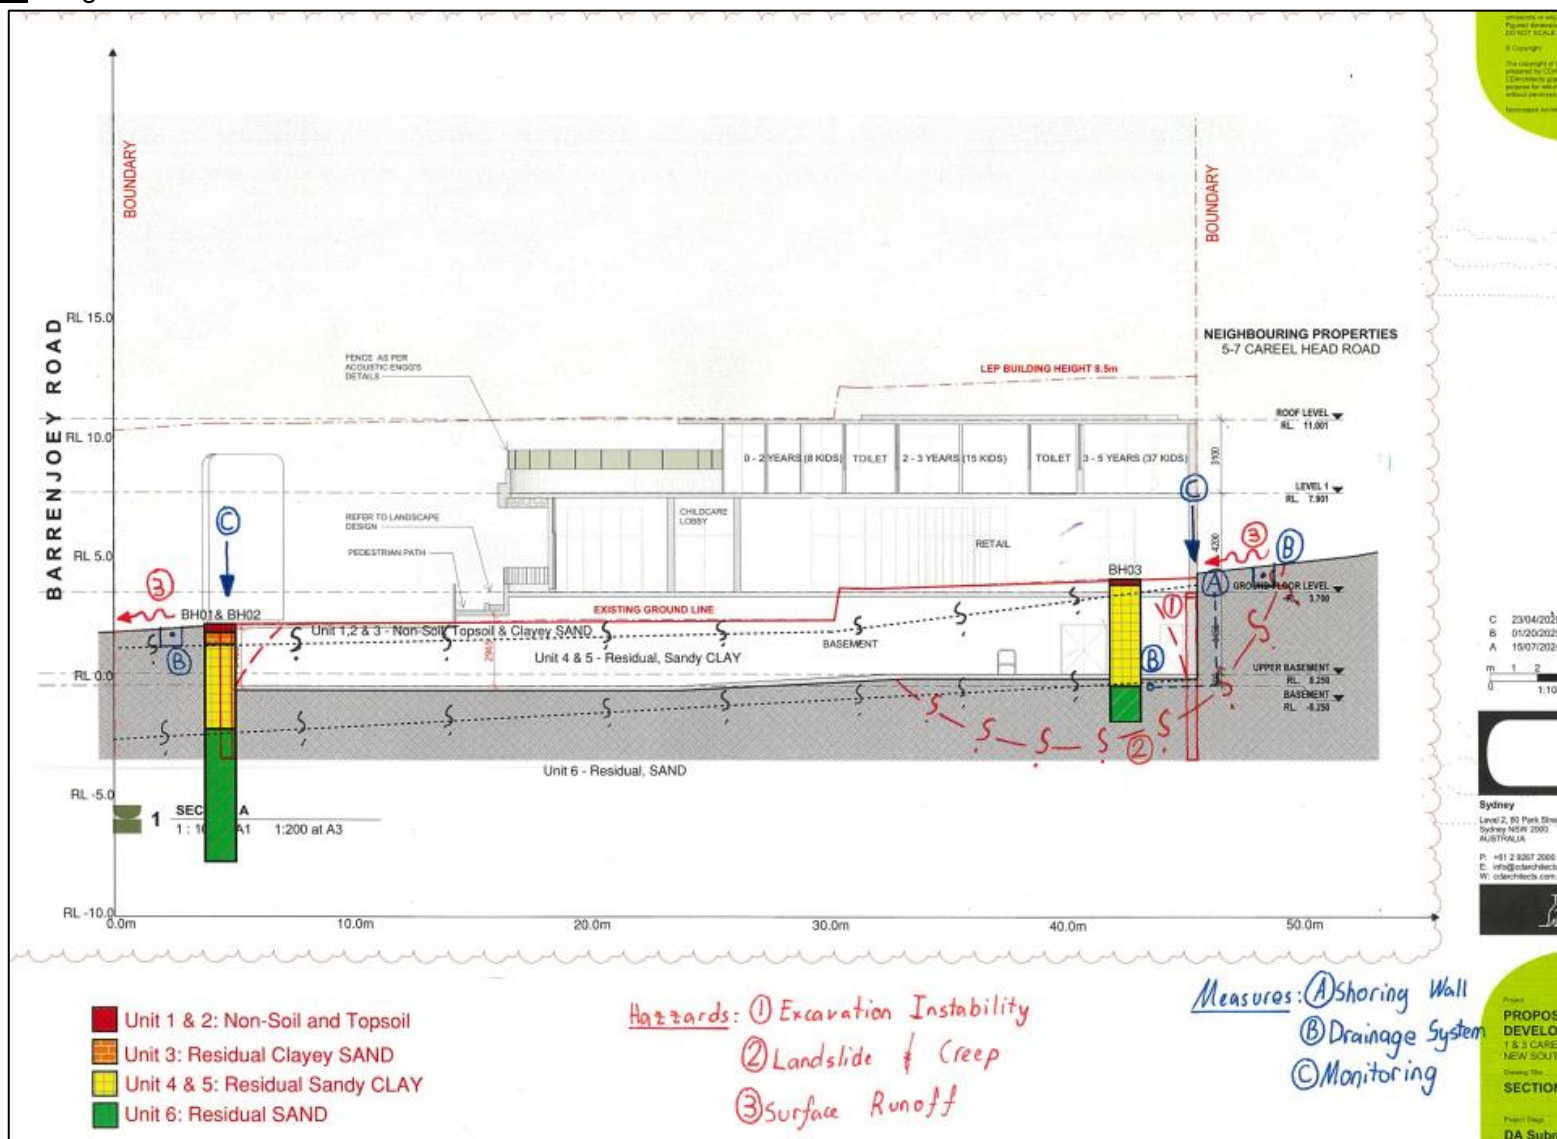
**Figure 4:** Longitudinal Section

According to the risk calculation the risk for the person most at risk will be less than the tolerable limits ( $1 \times 10^{-6}$  per annum – as mentioned in Pittwater Council, Council Policy No. 178).

According to the risk assessment, the following measures have been recommended in order to make sure that the stability of the slope is suitable for the future development. A longitudinal section has been developed in order to show the natural ground levels, subsurface conditions, proposed development, possible hazards and proposed measures to mitigate the risks of these hazards (refer to Figure 4)
