Geotechnical Assessment

Project: Alterations & Additions
25 Marlborough Avenue, Freshwater NSW

Prepared for:
Y2 Design Vista

Ref: AG 25184
6 May 2025

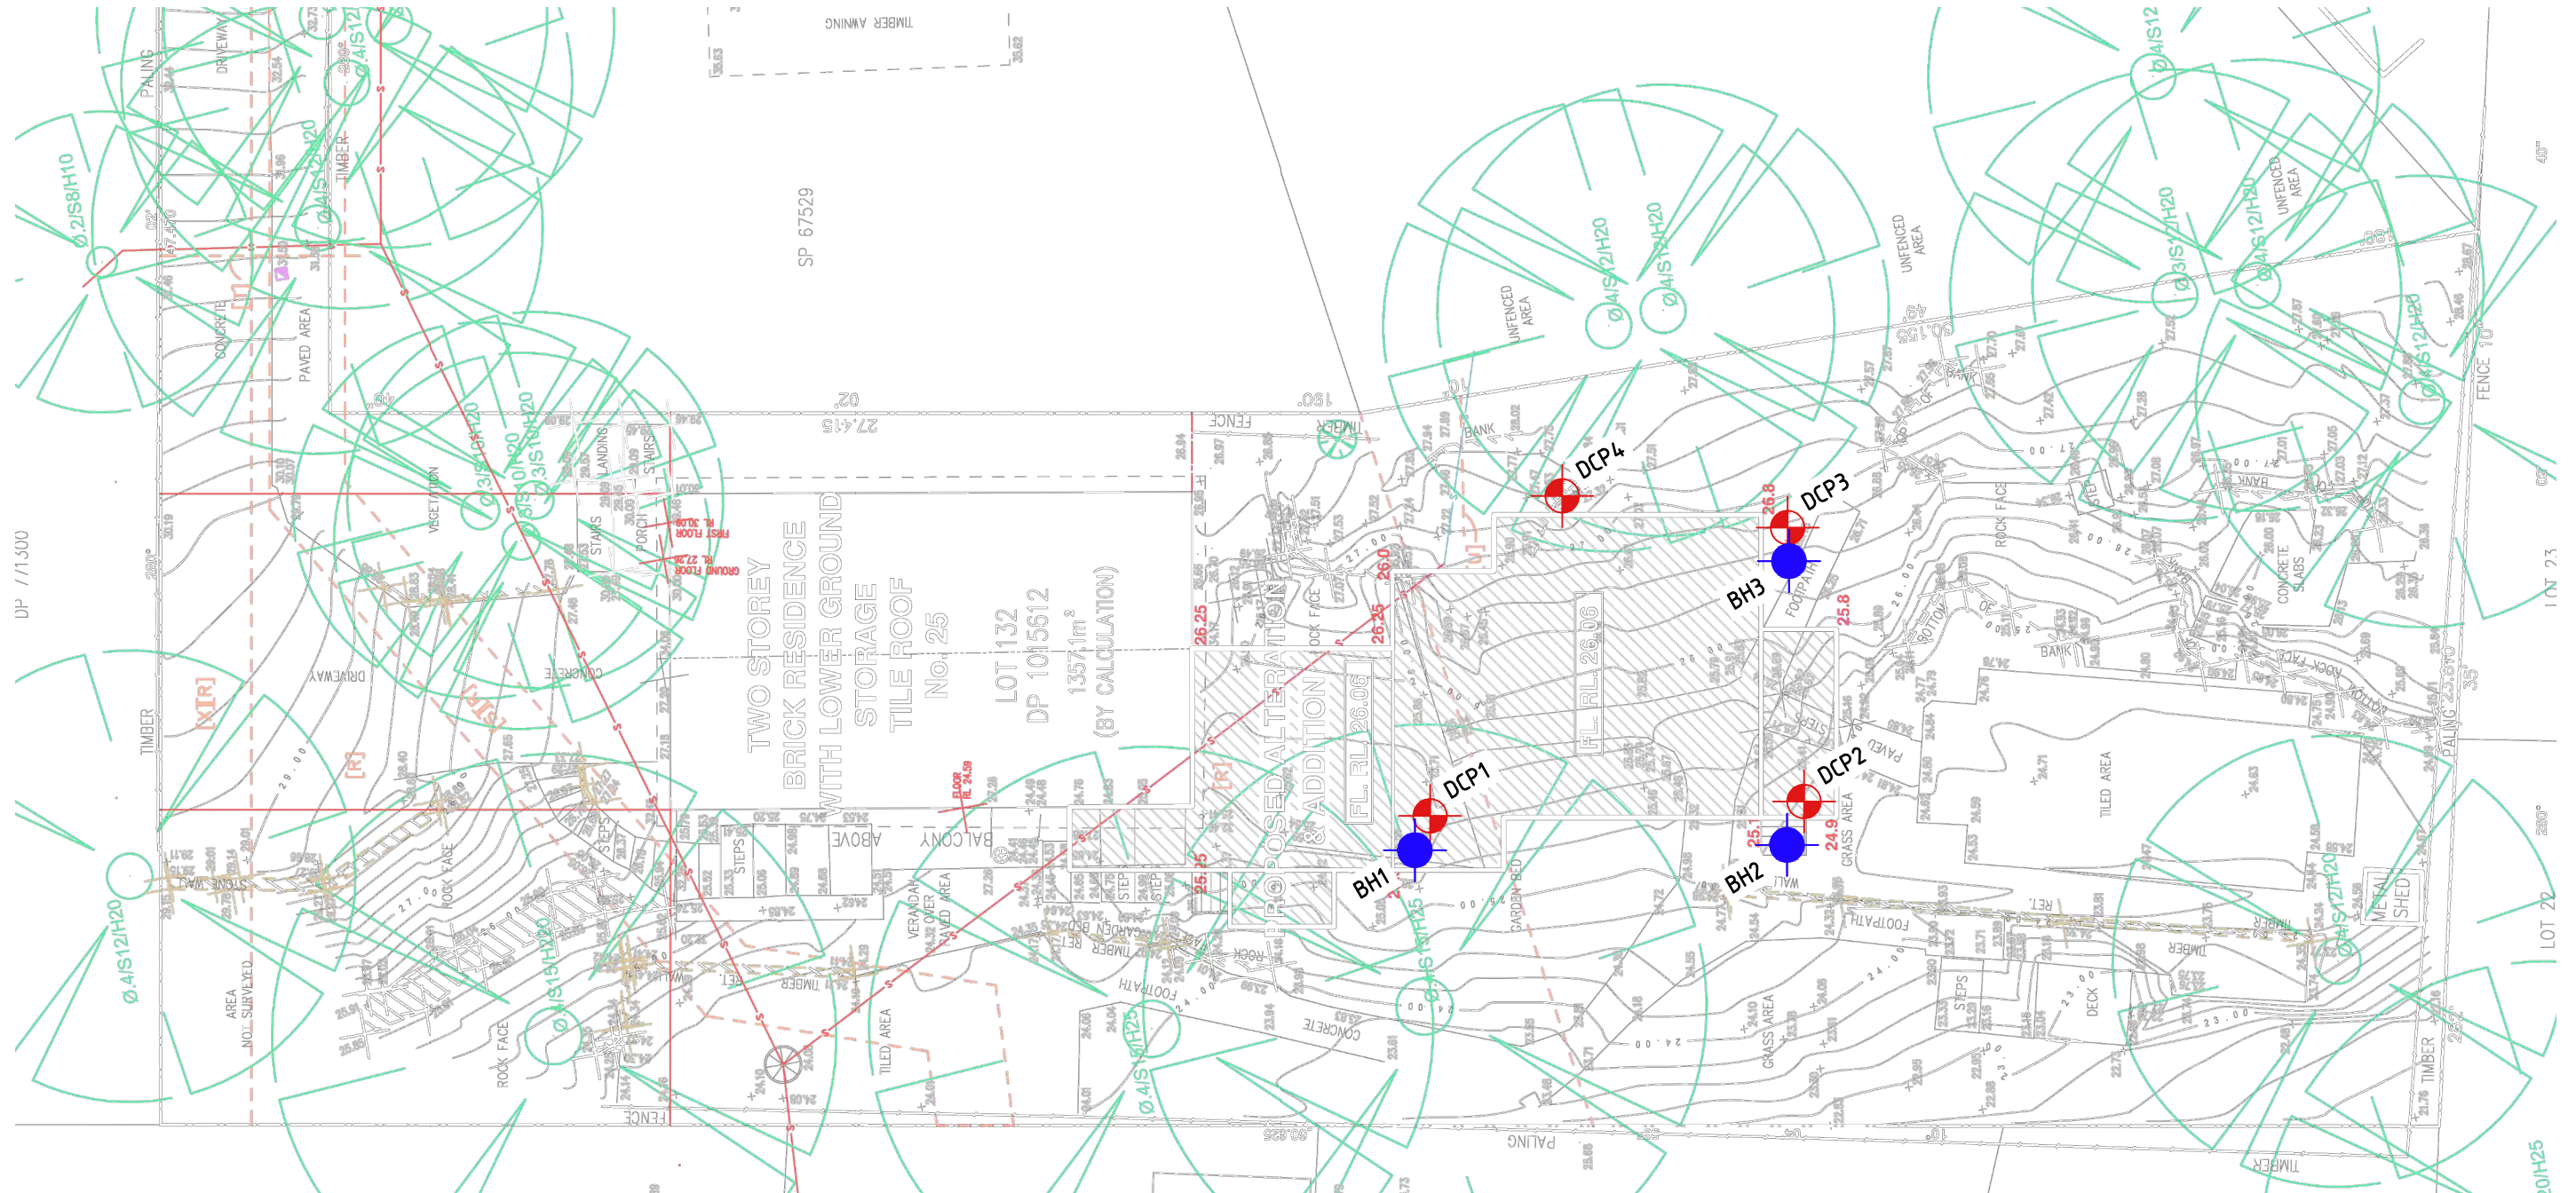
DATE: 04/05/2025
SCALE: AS SHOWN @ A3
DRAWING TITLE:
SITE PLAN
DRAWING NO:
AG 25184- S1

SITE PLAN/GROUND TEST LOCATIONS
SCALE NTS

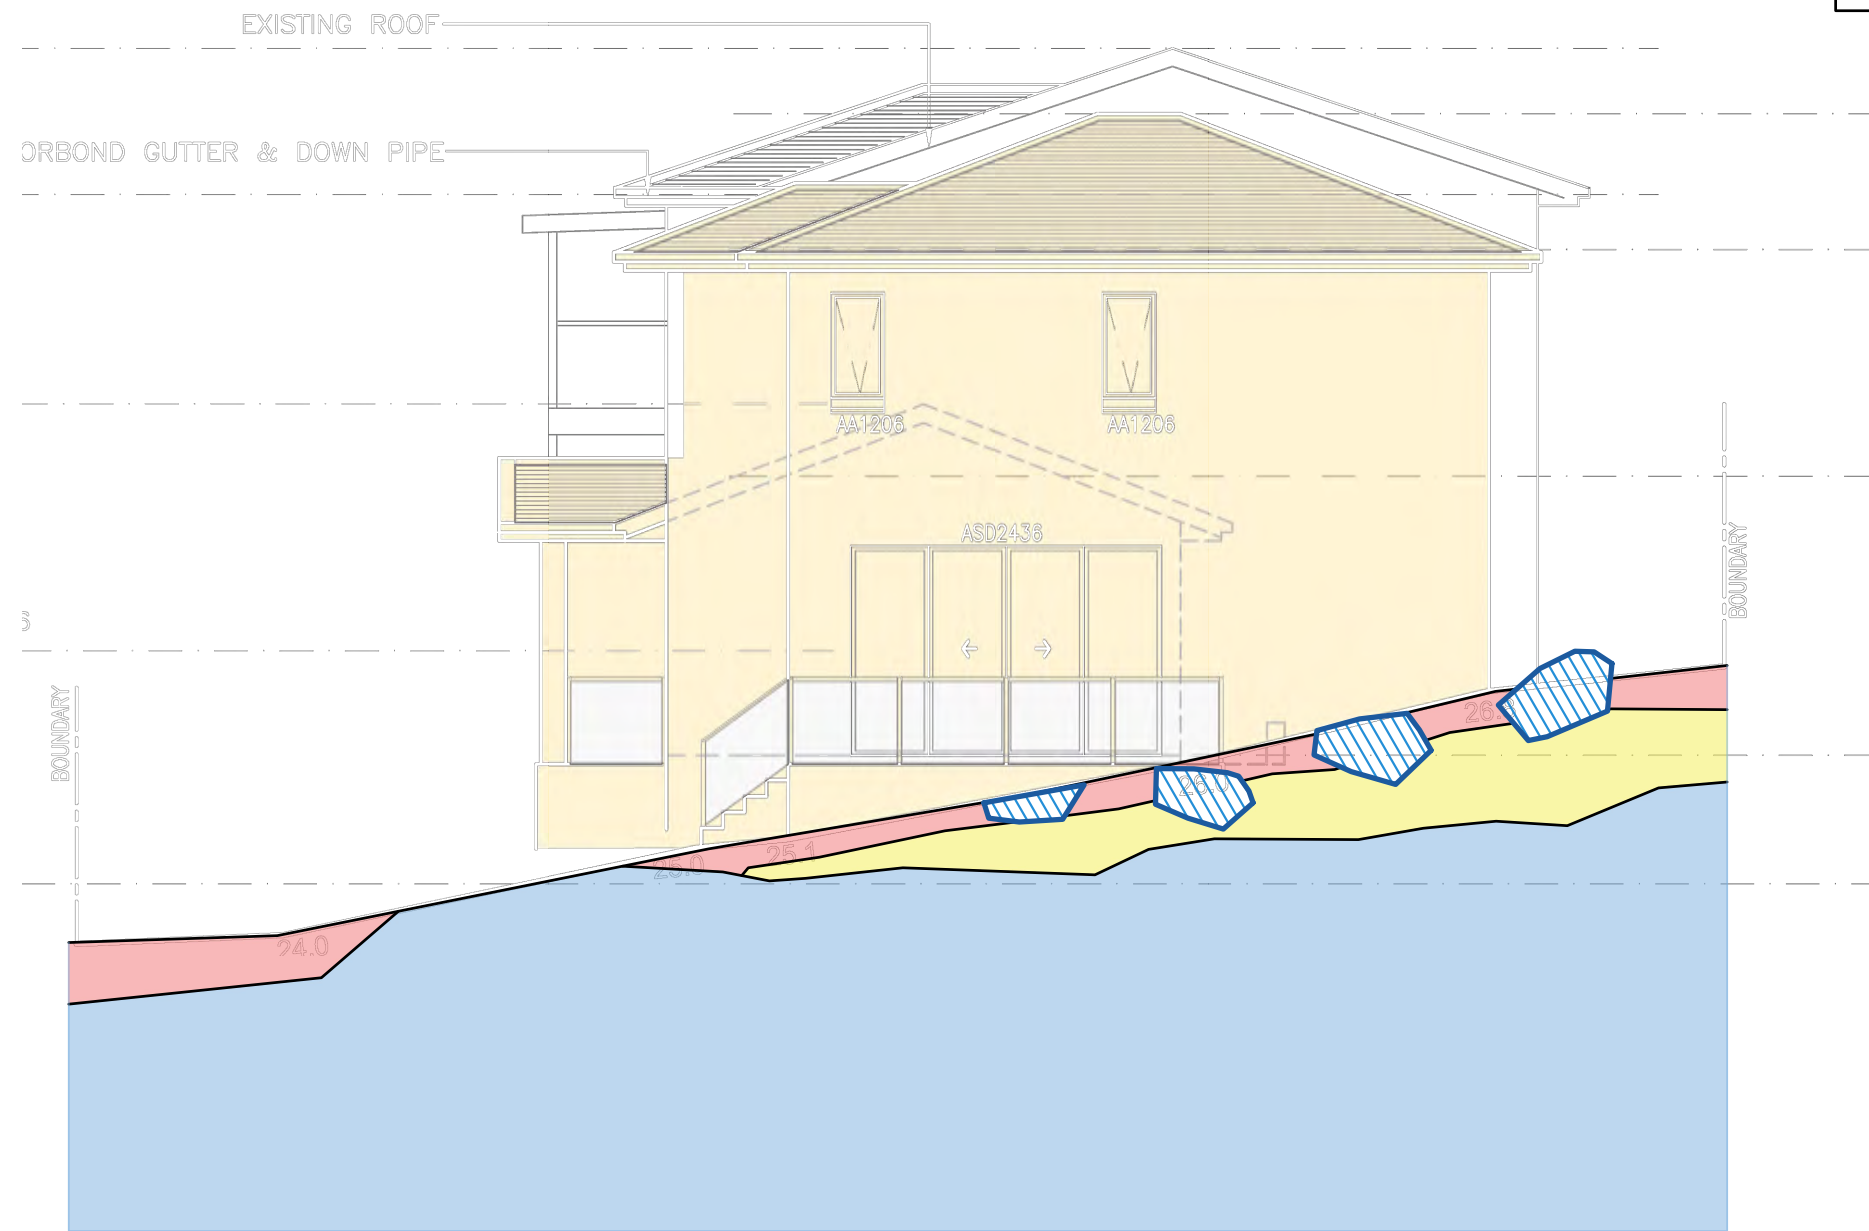
INFERRED GEOLOGICAL SECTION
SCALE NTS

INTERPRETED SUBSURFACE SECTION ONLY.
ACTUAL GROUND CONDITIONS MAY VARY.

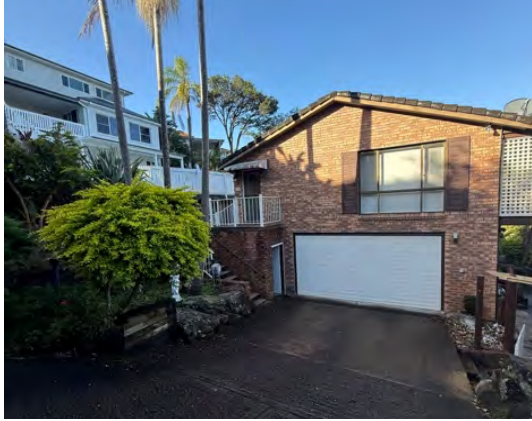
Photo 1: Front of residence.

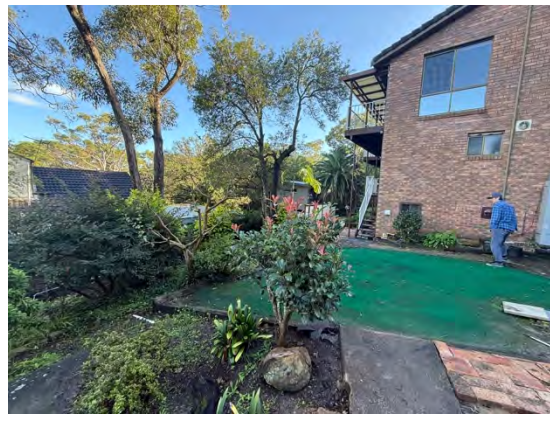
Photo 2: Location of the proposed extension.

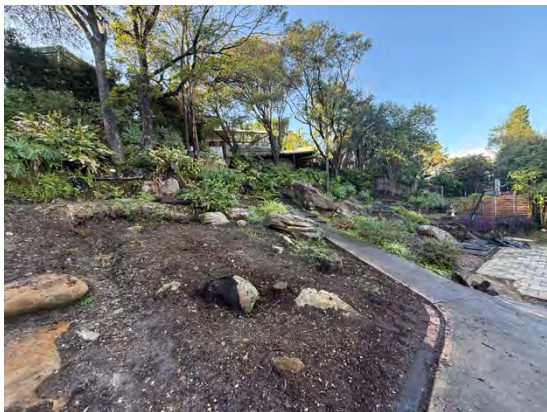
Photo 3: Area to the southeast of the proposed extension, highlighting sandstone floaters.

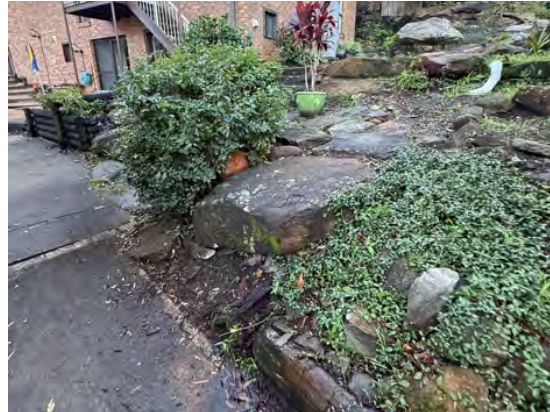
Photo 4: Exposed bedrock in the location of the proposed sandstone bedrock.
