Geotechnical Assessment

Project: Proposed Dual Occupancy
81 Beacon Hill Road, Beacon Hill NSW

Prepared for:
Alex Jackson

Ref: AG 25214
29 May 2025

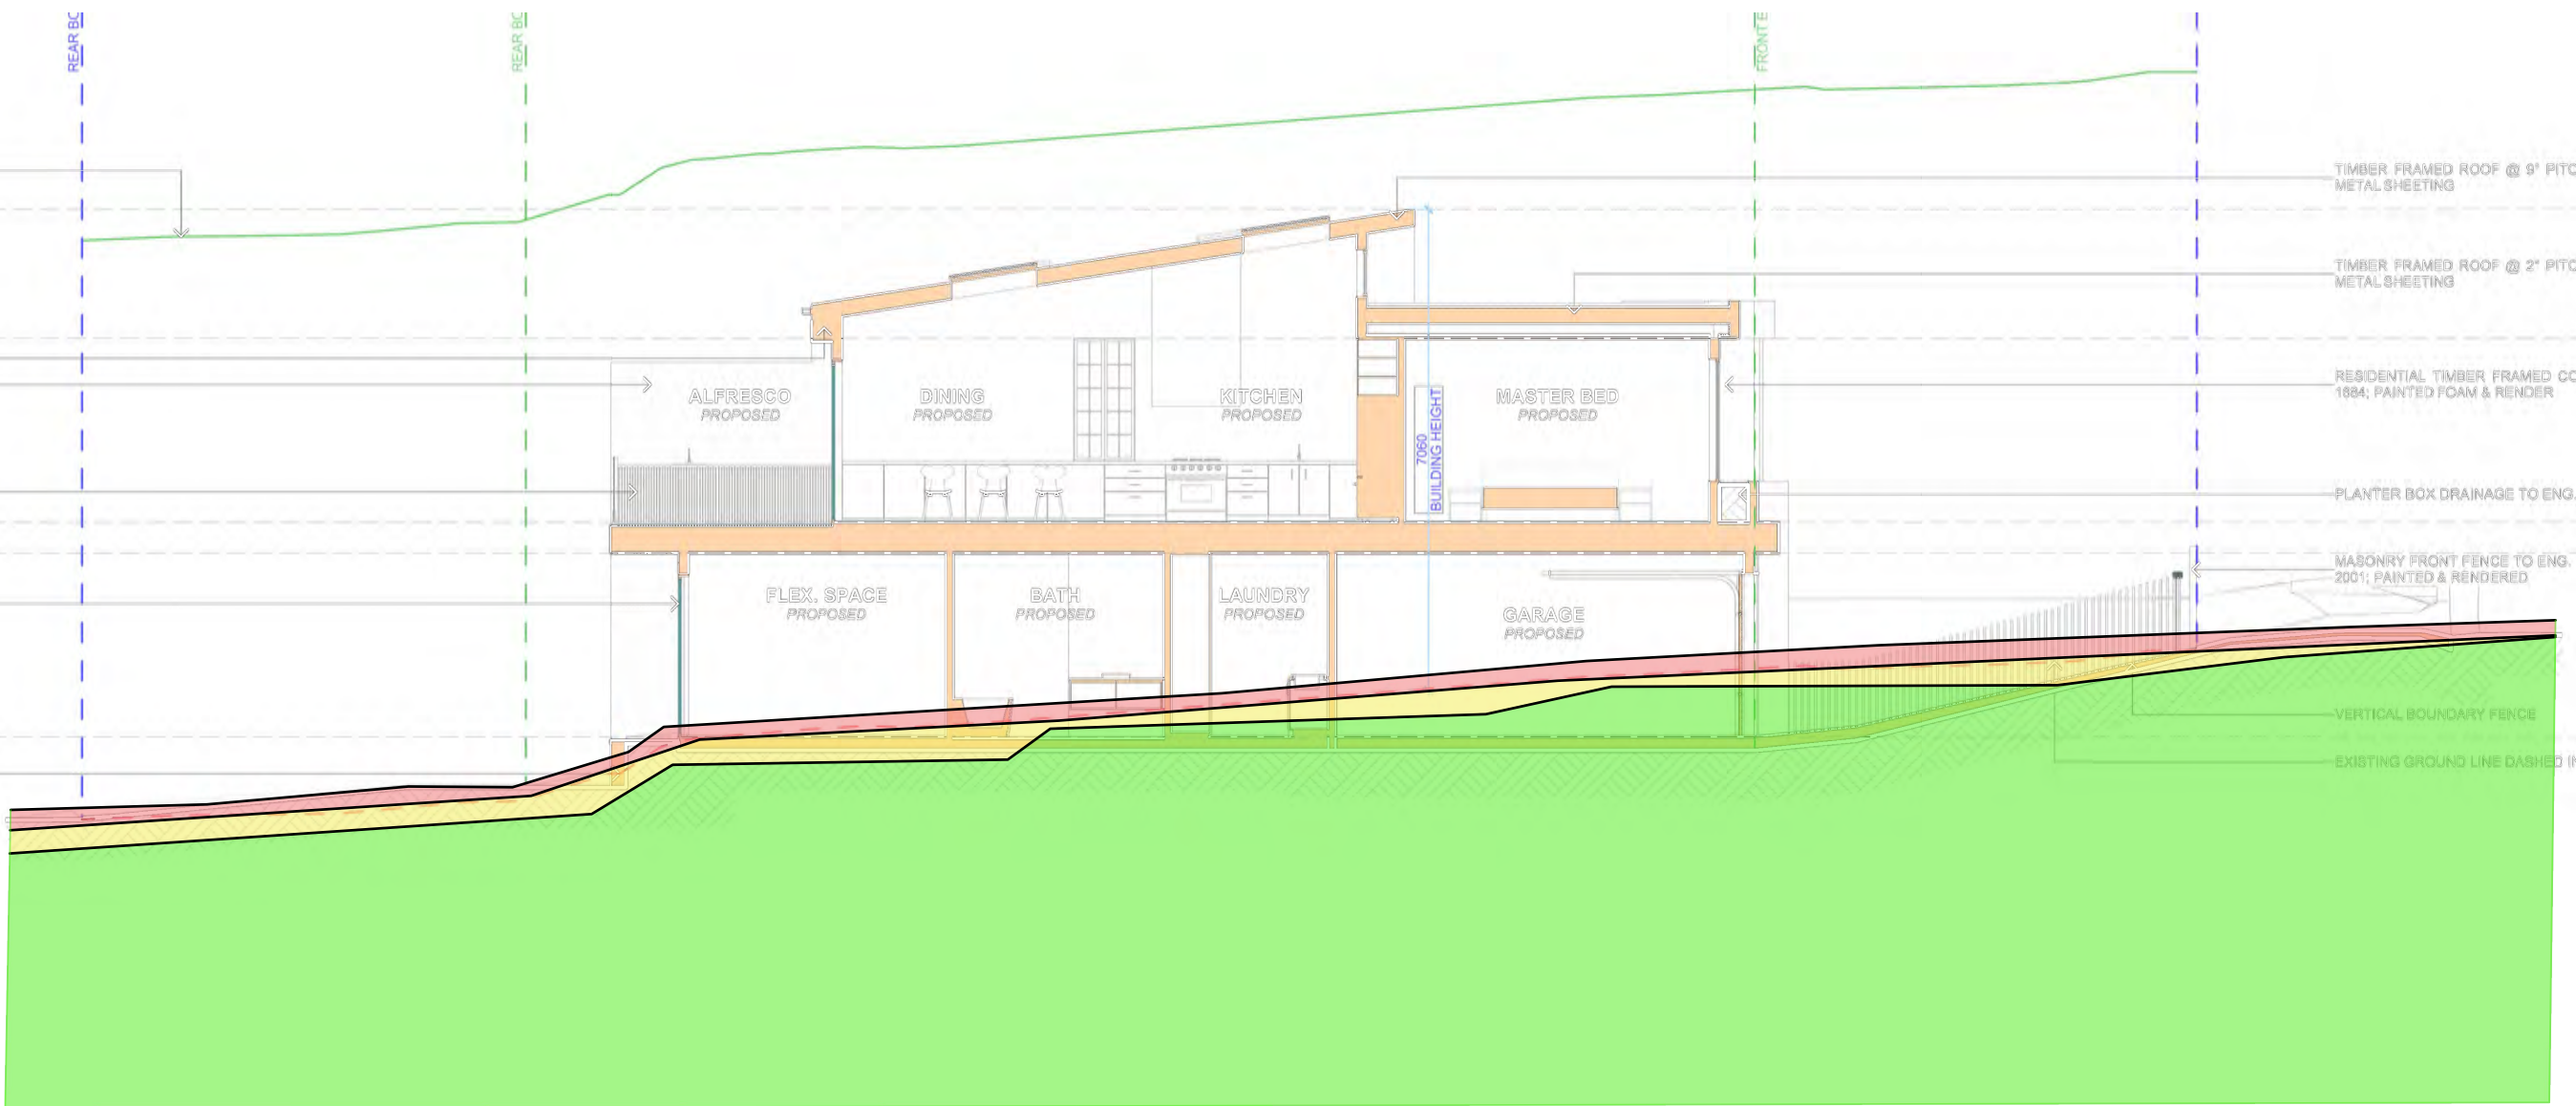
INFERRED GEOLOGICAL SECTION
SCALE NTS

INTERPRETED SUBSURFACE SECTION ONLY.
ACTUAL GROUND CONDITIONS MAY VARY.

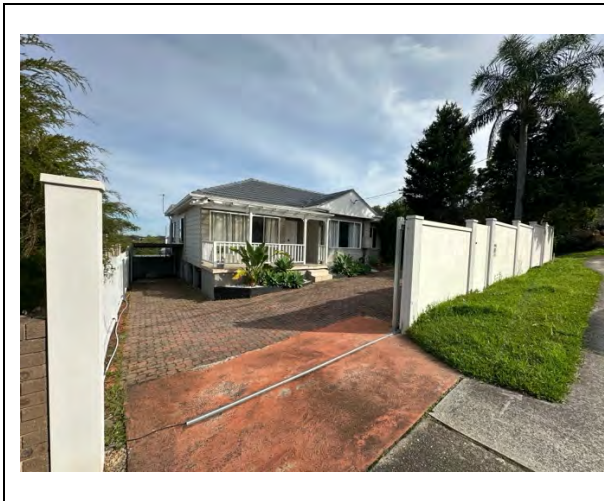
Photo 1: Site frontage, looking south.

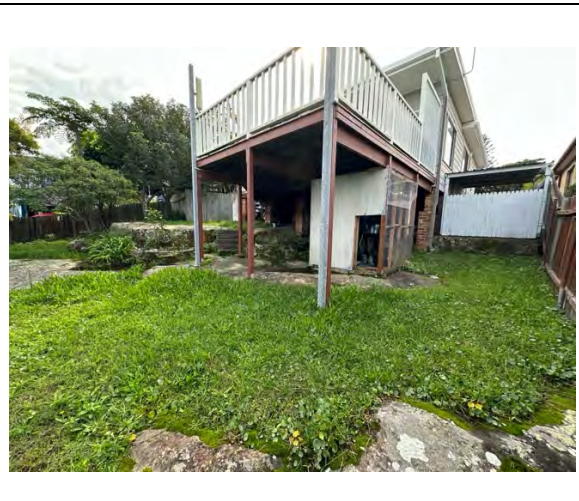
Photo 2: Photo taken from southern boundary, looking north.

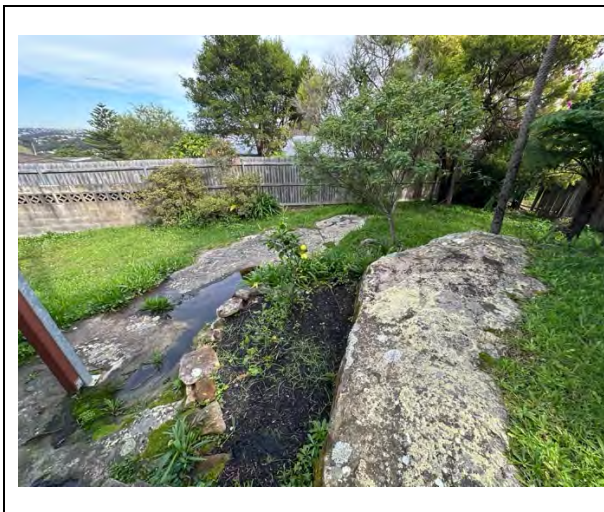
The existing building at the site is a single storey clad dwelling with a grassed front yard and larger grassed backyard areas. Neighbouring buildings are mostly single and double storey dwellings. Exposed sandstone formations were observed at multiple locations throughout the site.

Photo 3: Photo showing sandstone formations exposed at multiple location over the site.

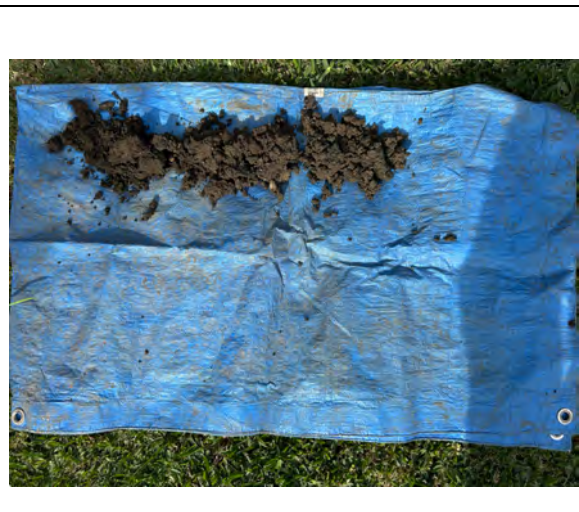
The soil profile consists of shallow uncontrolled fill and silty topsoil (O & A Horizons), silty sand (B Horizon) and weathered bedrock (C Horizon). Based on our observations and the results of testing on site, we would expect weathered sandstone bedrock to be found within 0.1 to 0.2 metres below current surface levels across the area of the proposed works and potentially deeper where filling has been carried out.

Photo 4: Subsurface soil profile of BH01.
