REPORT TO
**MANLY PROPERTY GROUP NO.2 PYT LTD ATF
MANLY UNIT TRUST NO.2**

ON
HAZARDOUS BUILDING MATERIALS SURVEY

FOR
PROPOSED DEMOLITION WORKS

AT
27 EAST ESPLANADE, MANLY, NSW

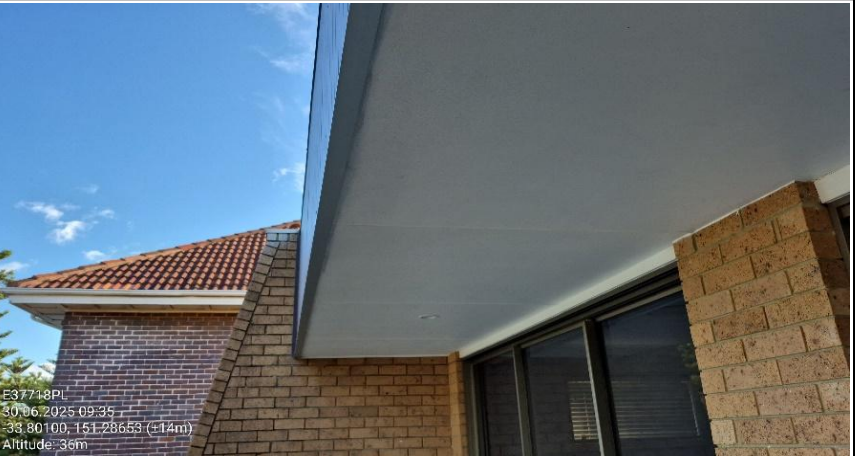
Building exterior, Unit 4, Eastern extent, Adjacent sunroom, Section of upper external wall	Fibre Cement Sheeting	ASB4	No asbestos detected: Organic fibres detected	-	-	-	-	-	-
Building interior, Garage, Southern extent, Electrical Distribution boards	Fibre Cement Sheeting	NA - Electrical Hazard	Assumed to contain asbestos	Generally Intact	Non-Friable	2m ²	Confirm presence of asbestos through laboratory testing OR assume to contain asbestos and remove prior to refurbishment / demolition by appropriately licensed asbestos removal contractor in accordance with the relevant standard/code of practice/guidelines.	Yes

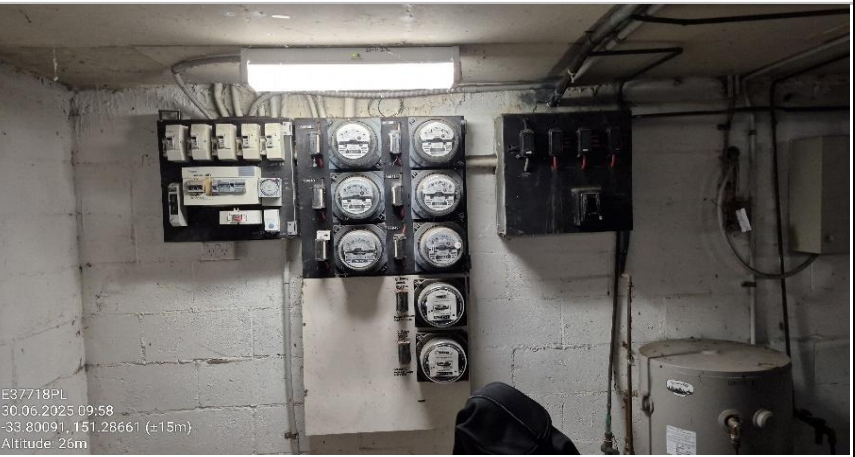
Building interior, Garage, Southern extent, Electrical Distribution boards, fuses	Internal Insulation	NA - Electrical Hazard	Assumed to contain asbestos	Generally Intact	Friable	<1m ²	Confirm presence of asbestos through laboratory testing OR assume to contain asbestos and remove prior to refurbishment / demolition by appropriately licensed asbestos removal contractor in accordance with the relevant standard/code of practice/guidelines.	Yes

The doors and electrical fuses were all in good condition at the time of the inspection and can remain in-situ in this condition. These items should not be tampered with or damaged prior to a time when sampling occurs. The potentially friable asbestos containing materials should either be treated and removed as containing asbestos; or should be sampled to confirm whether or not the material contains asbestos fibres.

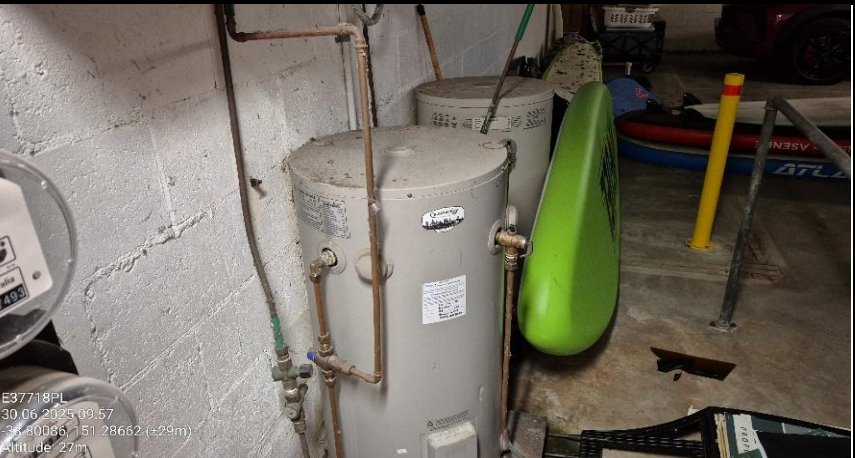
Building interior, Hallway, Cupboard under staircase, Hot water heaters	Internal Insulation	NA - Electrical Hazard	NA - Assumed to contain SMF	Generally Intact	-	2 Units	Remove prior to refurbishment / demolition by appropriately licensed hazardous materials contractor in accordance with the relevant standard/code of practice/guidelines.	Yes

All SMF containing materials must be removed in accordance with the national Standard and code outlined in Section 3 and by an experienced hazardous materials removal contractor.

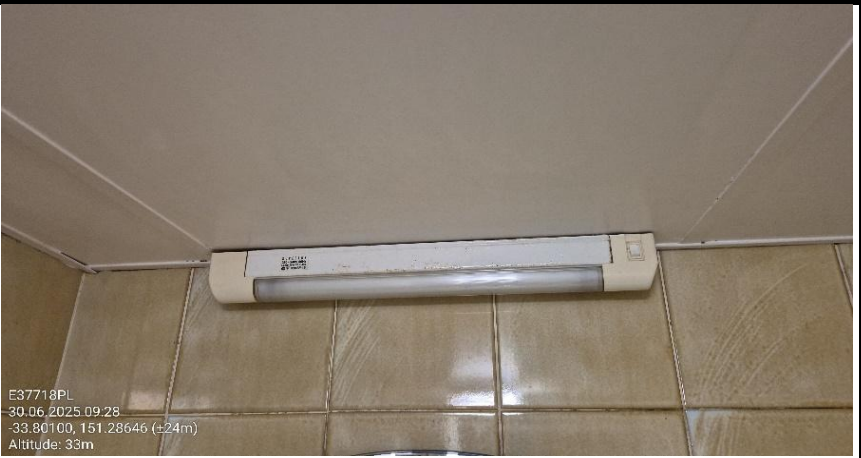
<div>E37718PL 30.06.2025 09:25 38.86100, 151.28546 (±24m) Altitude: 33m</div>
Building interior, Garage, Ceiling	Single tube Fluorescent Light fittings	NA - Electrical Hazard	Of an age indicative of housing PCB containing capacitors	Generally intact	NA	8 Units	Undertake detailed inspection following isolation of electricity supply, OR Handle in accordance with relevant standard/code of practice/guidelines.	No (access via ladder only)

- Prior to demolition when the power is disconnected, inspect the light fittings;
- Metal PCB containing capacitors are to be removed, placed in plastic lined 200 litre drums and disposed of as PCB Scheduled Waste. Any light fitting that shows signs of oil staining from capacitors is to be disposed of as PCB contaminated;
- Protective clothing including eye protection, PCB resistant gloves and overalls are to be worn;
- Contaminated gloves and disposable coveralls are to be disposed of as PCB contaminated waste; and
- Contractors licenced to transport and handle PCBs must be used for transport and disposal.
