# Geotechnical Assessment

**Project:** Alterations & Additions  
38 Judith Street, Seaforth NSW

**Ref:** AG 25211  
29 May 2025

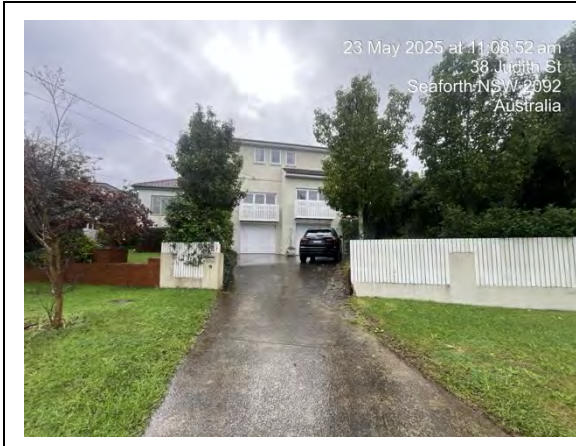
**Photo 1:** Site frontage

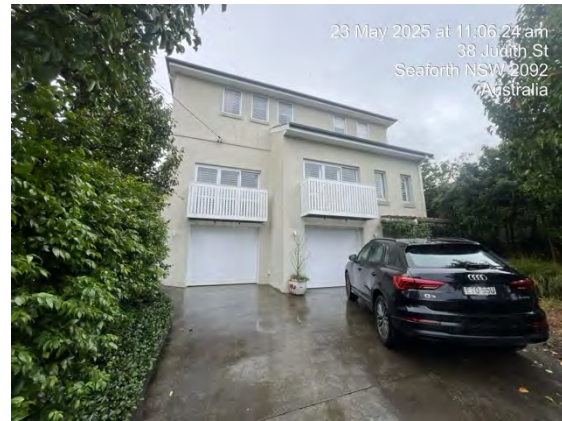
**Photo 2:** Residence frontage

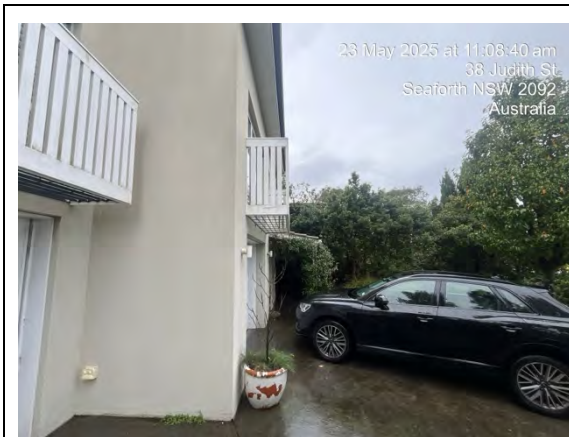
**Photo 3:** Residence frontage facing east

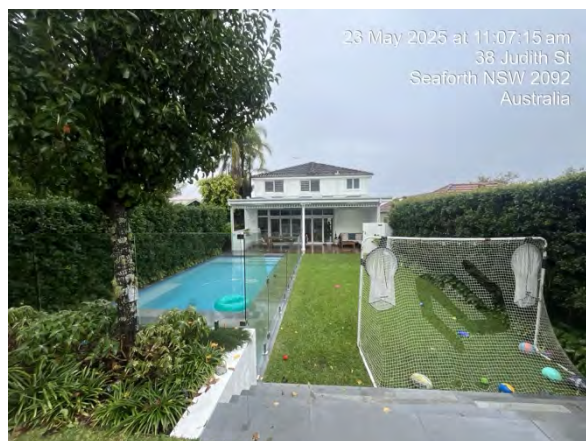
**Photo 4:** Residence rear
