Hazardous Building Materials (HBM) Assessment

Narrabeen Sports High School (8512)

Project 86973.02  
March 2020

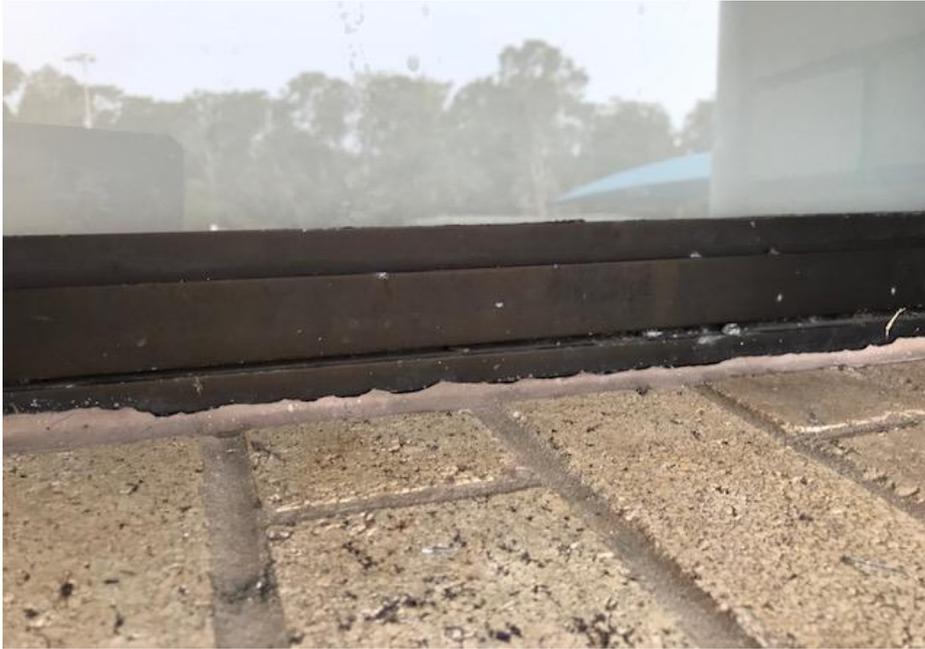
Photograph 1: B00A, throughout , windows, brown putty/mastic , asbestos detected by analysis.

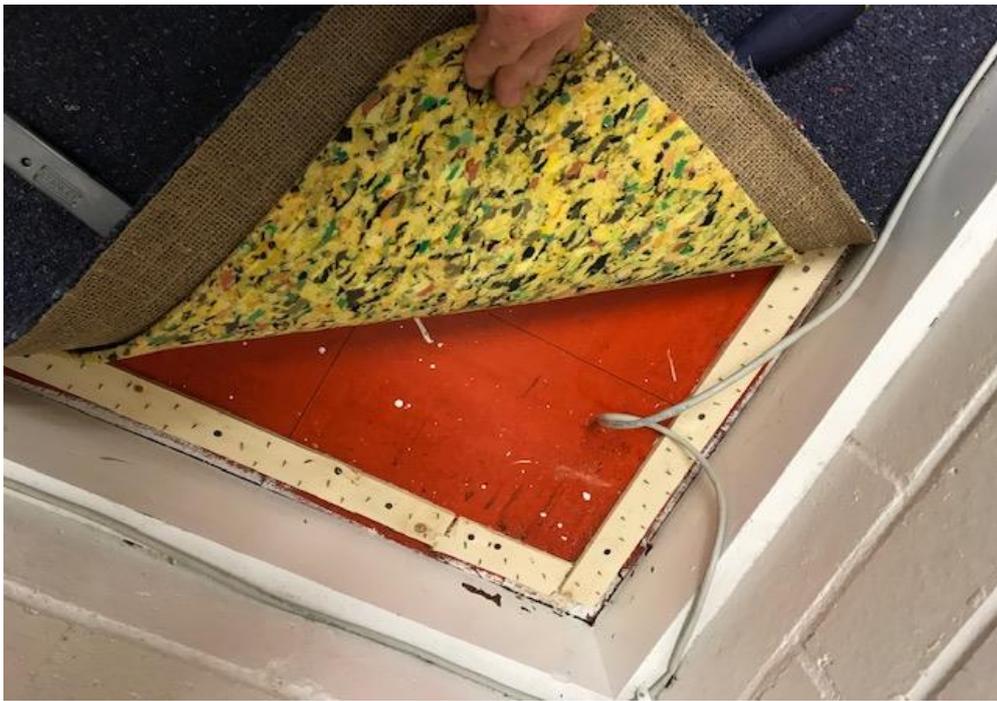
Photograph 3: B00A, R0013 - Design Room, floor, vinyl tiles, asbestos detected by analysis.

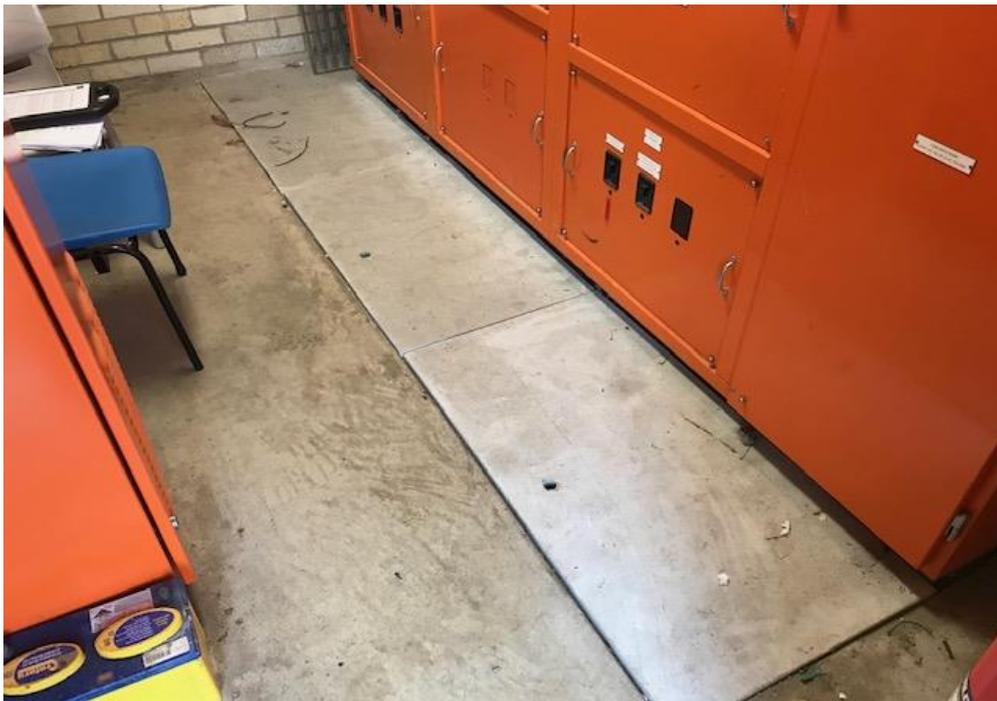
Photograph 4: B00A, R0019 - Main switchboard, floor, compressed fibre cement sheet, asbestos detected by analysis.

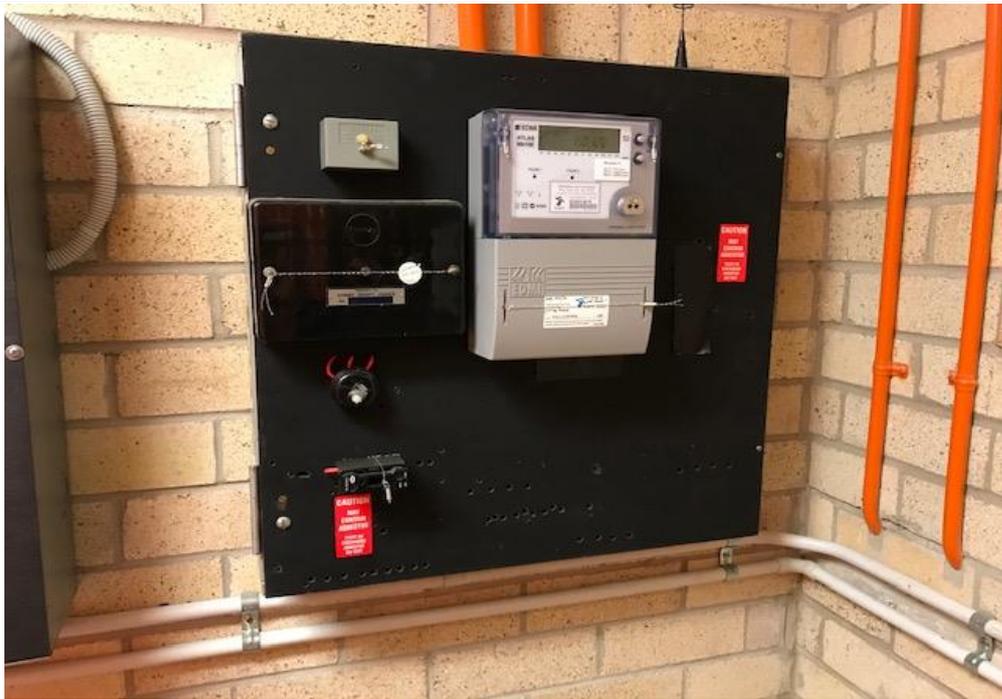
Photograph 5: B00A, R0019 - Main switchboard, electrical backing board, flat fibre cement sheet, asbestos (assumed).

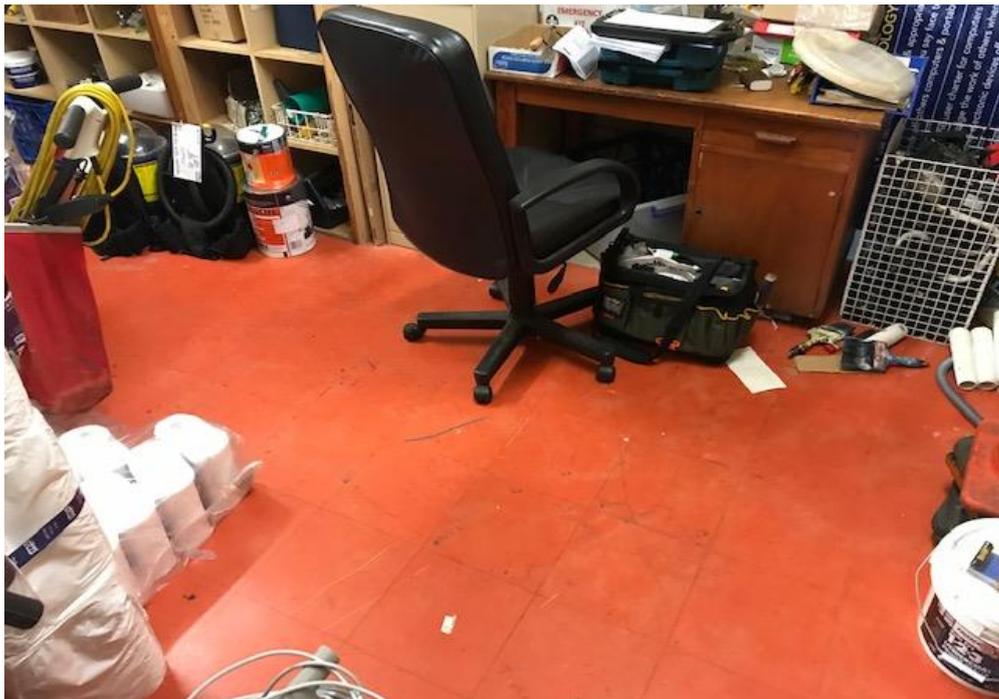
Photograph 6: B00A, R0022 - Sports Equipment Store , floor, vinyl tiles, asbestos detected by analysis.

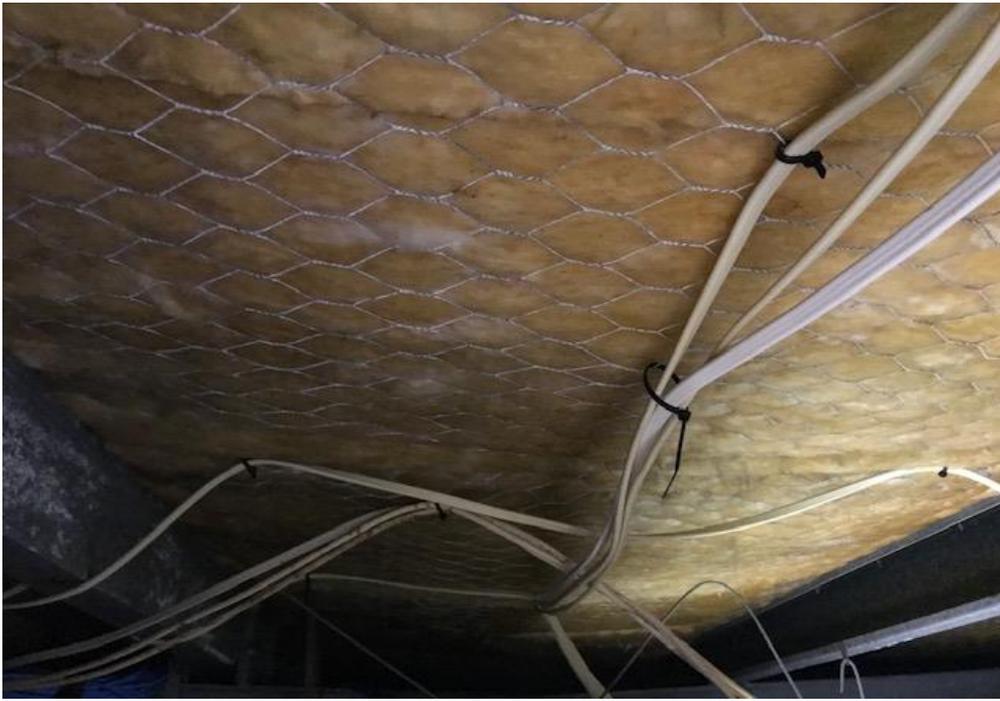
Photograph 9: B00A, Level 1, internal, ceiling voids, insulation, SMF identified visually.

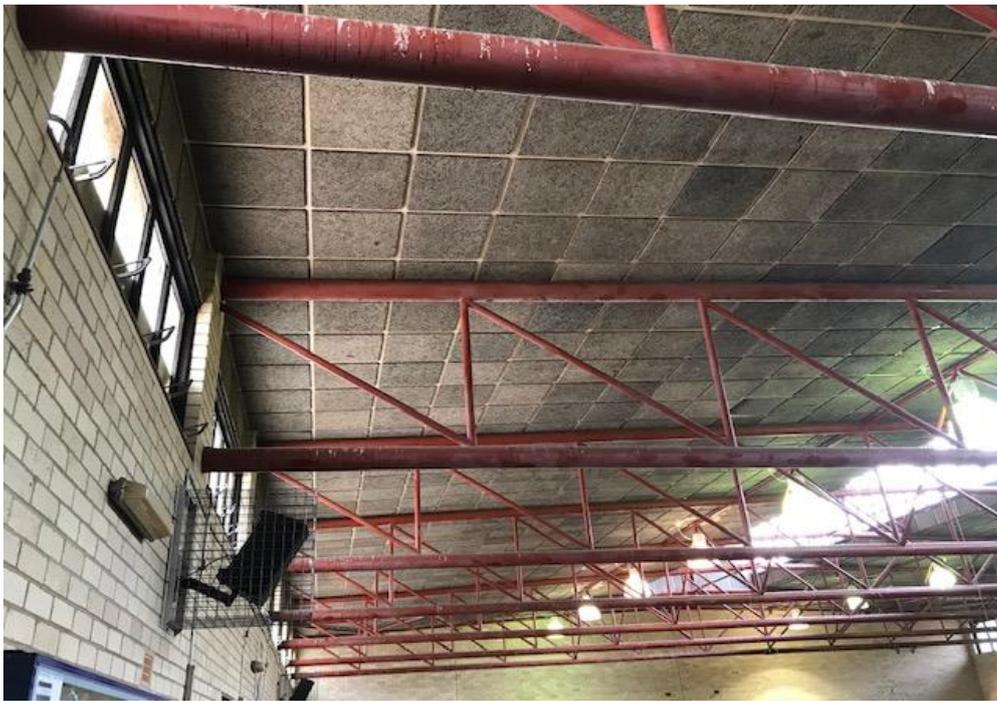
Photograph 11: B00A, R0024 - Gymnasium , steel beams, red paint, lead paint (assumed).

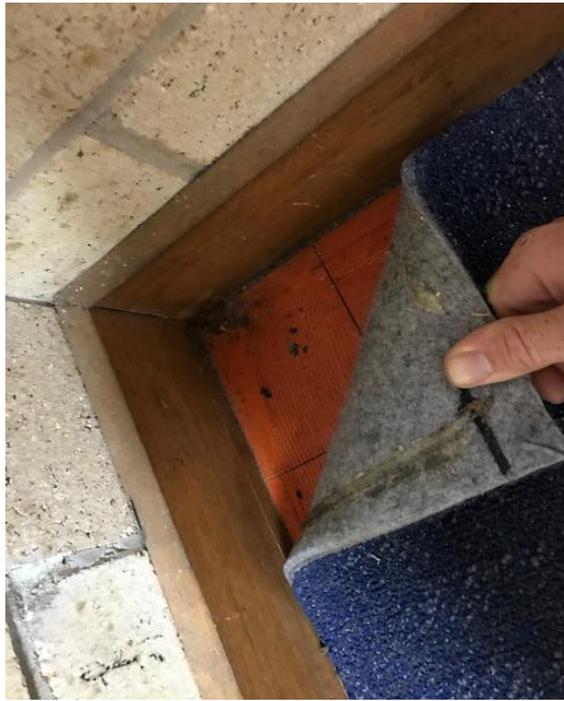
Photograph 13: B00A, R1033 - Classroom, floor, vinyl tiles, asbestos detected by analysis

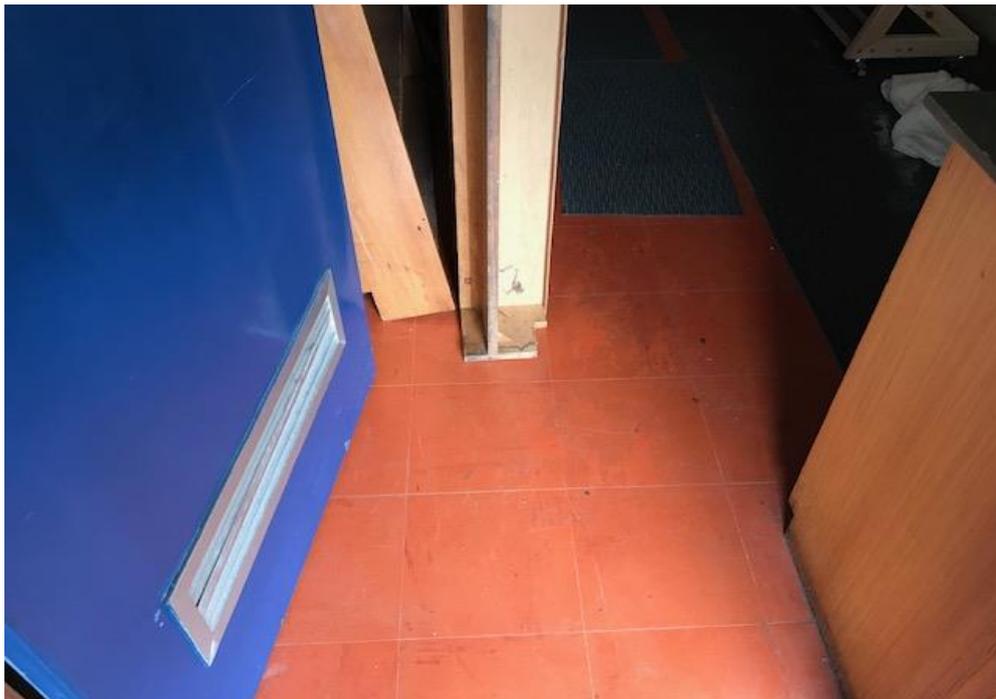
Photograph 14: B00A, R1017 - General Storeroom, floor, vinyl tiles, asbestos detected by analysis

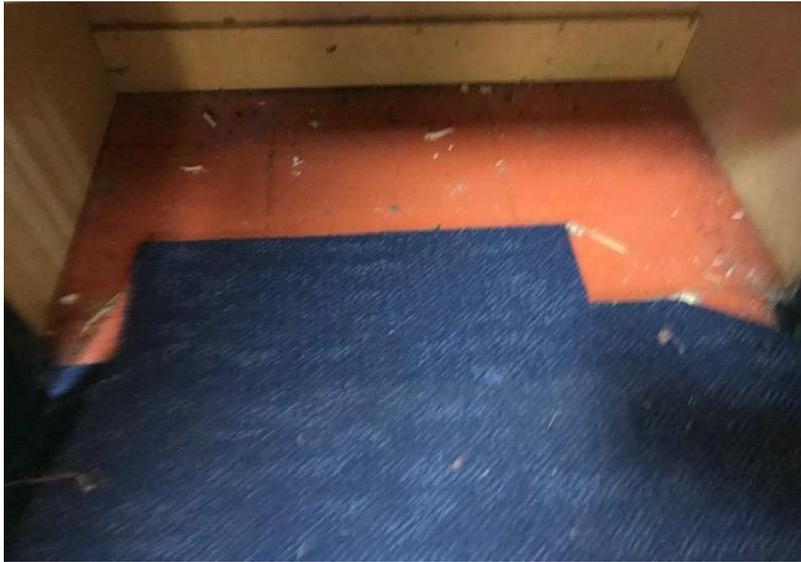
Photograph 15: B00A, R1034 - Control Room, floor, vinyl tiles, asbestos detected by analysis

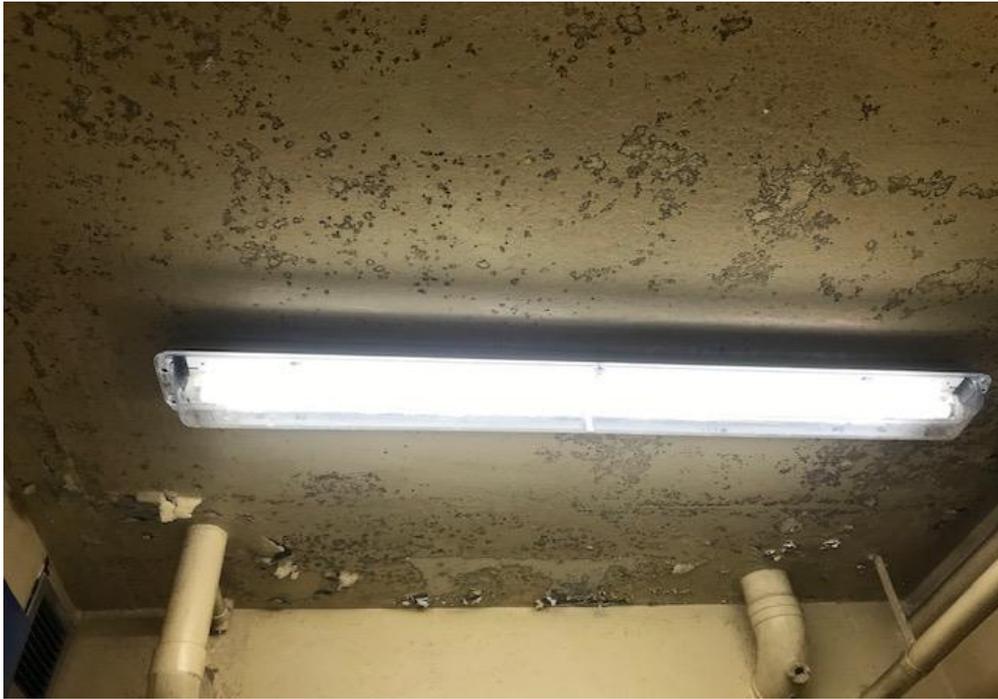
Photograph 1: B00B, R0002 - Staff Toilet, ceiling, yellow paint, positive for lead.

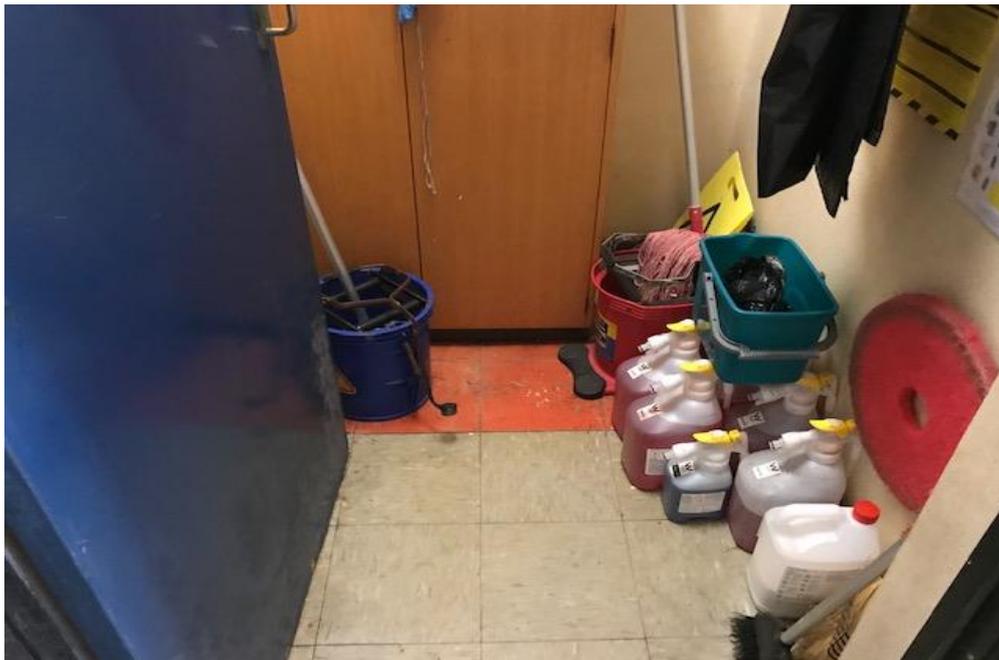
Photograph 2: B00B, R0003 - Cleaning Store, floor, vinyl tiles, asbestos detected by analysis.

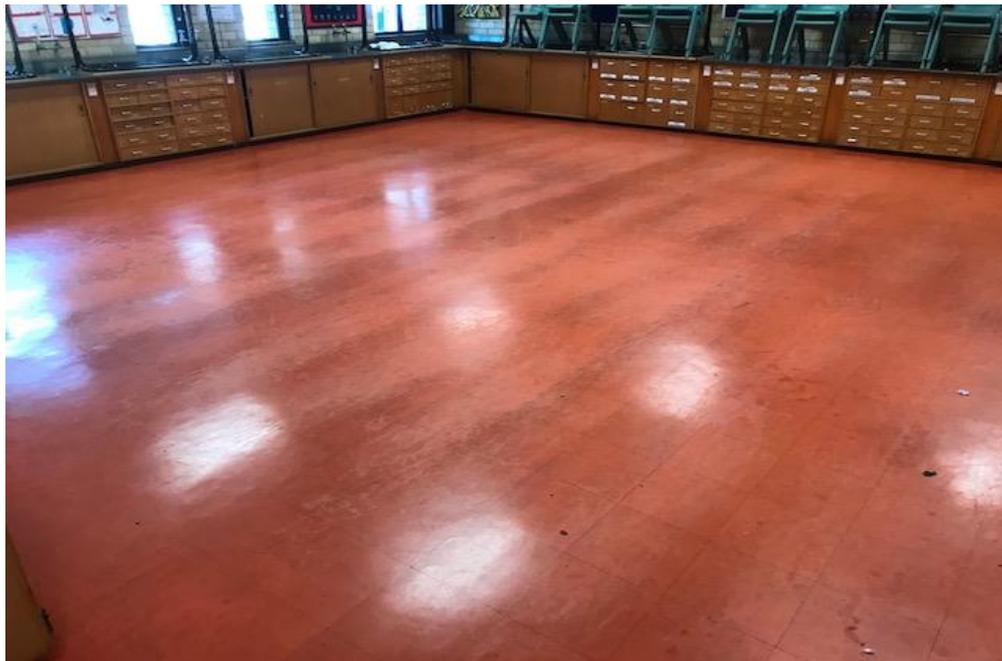
Photograph 4: B00B, R0011 - Laboratory , floor, vinyl tiles, asbestos detected by analysis.

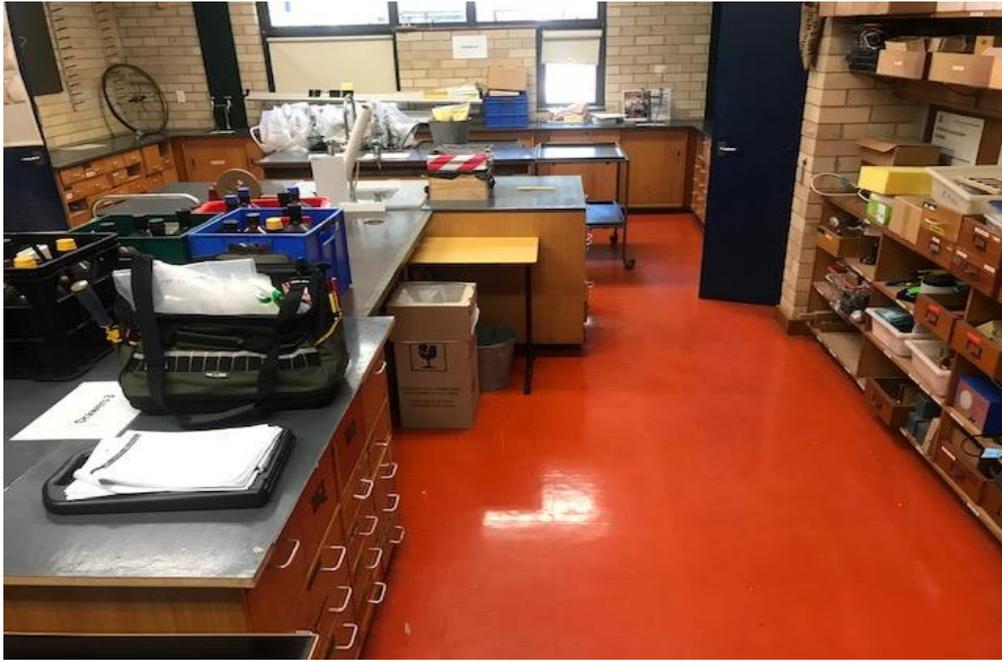
Photograph 5: B00B, R0012 - Preparation Room, floor, vinyl tiles, asbestos detected by analysis.

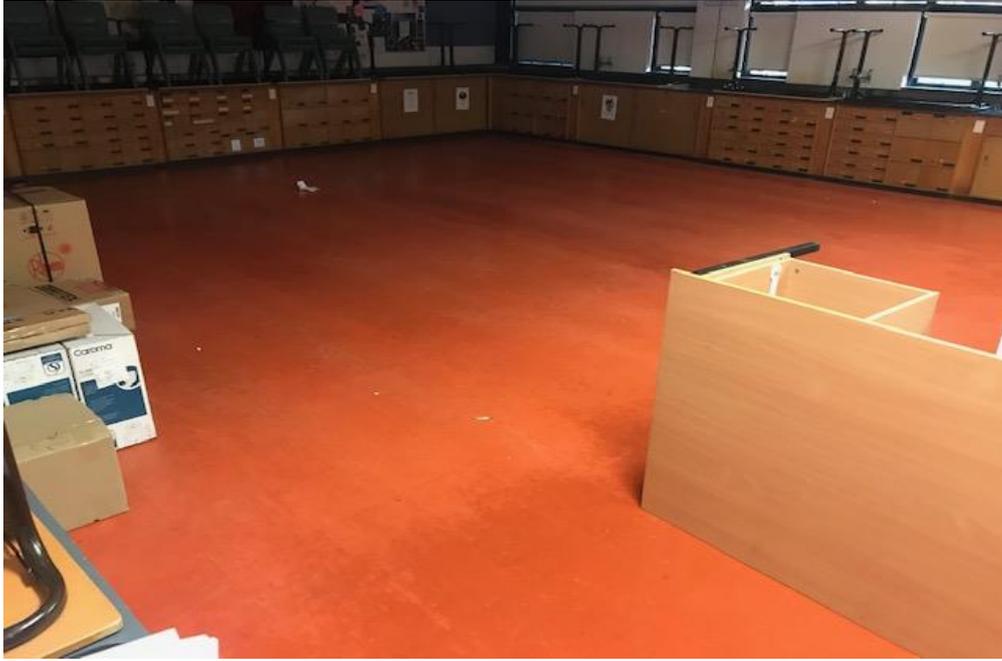
Photograph 7: B00B, R0014 - Laboratory , floor, vinyl tiles, asbestos detected by analysis.

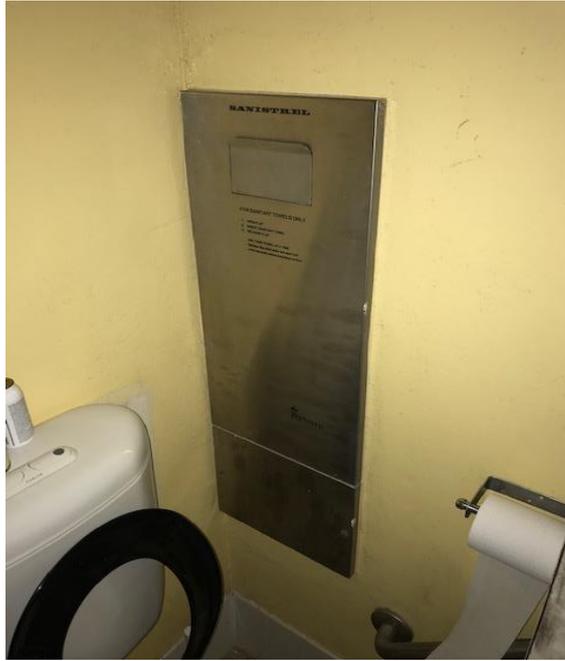
Photograph 9: B00B, R1002 - Staff Female Toilet, wall, incinerator, internal component(s), asbestos (assumed).

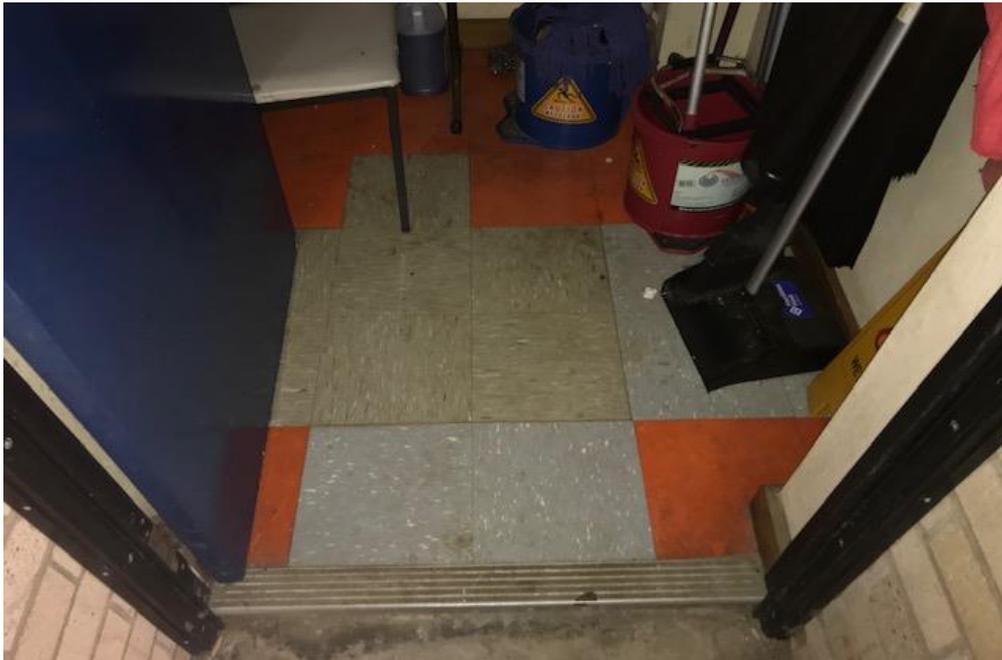
Photograph 10: B00B, R1003 - Cleaning Store , floor, vinyl tiles, asbestos detected by analysis.

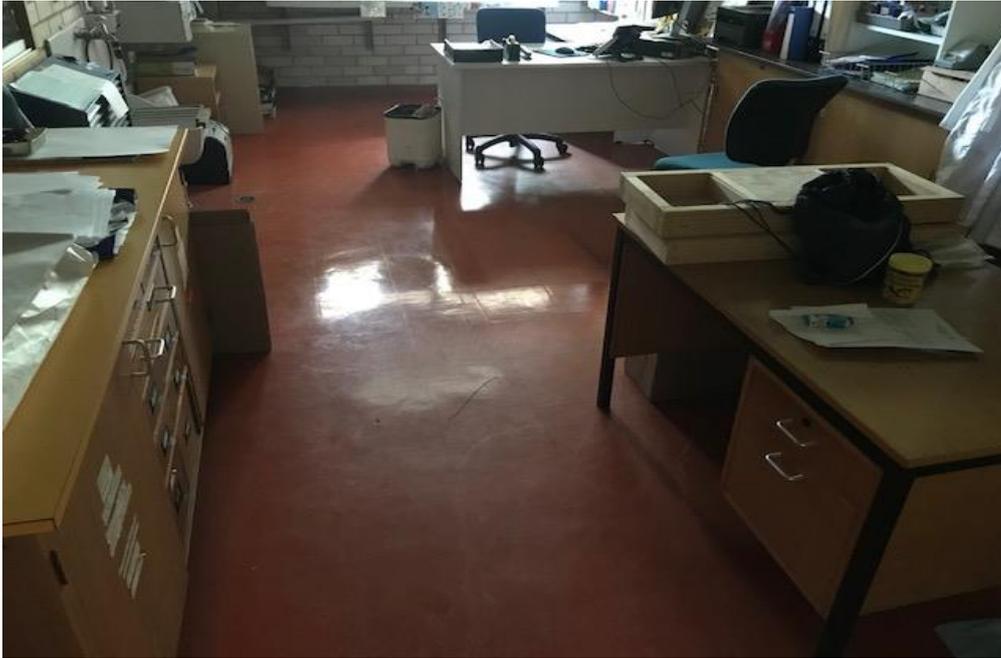
Photograph 11: B00B, R1004 - Office/store, floor, vinyl tiles, asbestos detected by analysis.

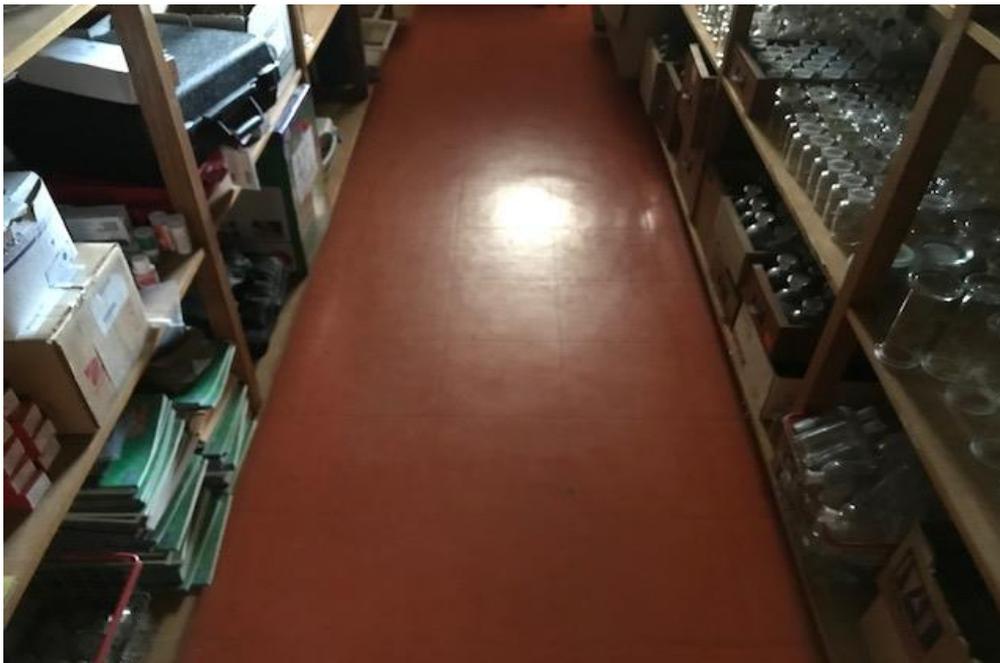
Photograph 12: B00B, R1005 - Chemical Store, floor, vinyl tiles, asbestos detected by analysis.

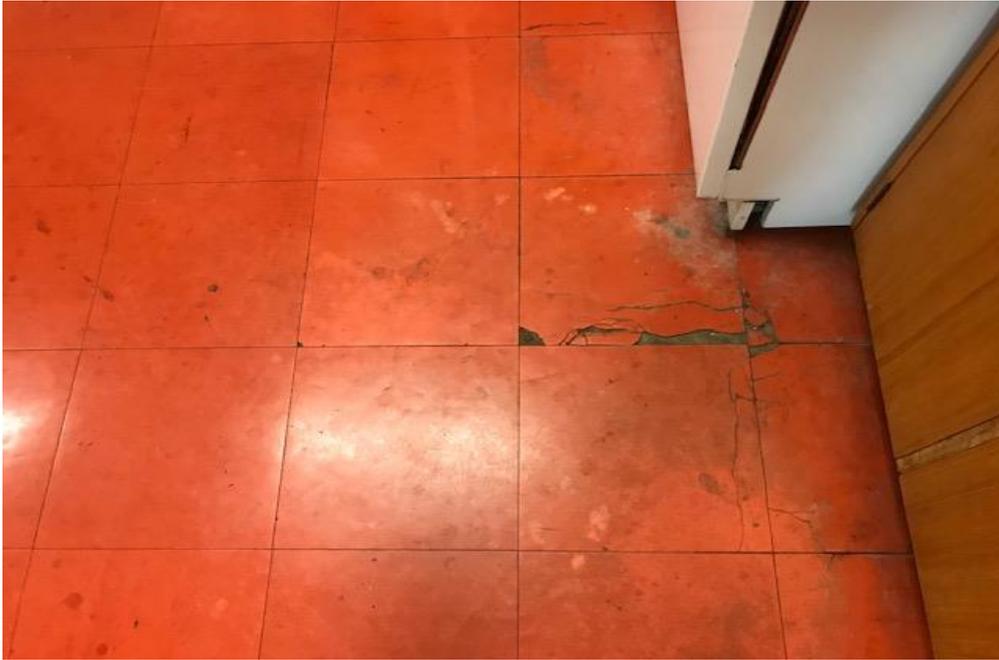
Photograph 13: B00B, R1007 - Laboratory, floor, vinyl tiles, asbestos detected by analysis.

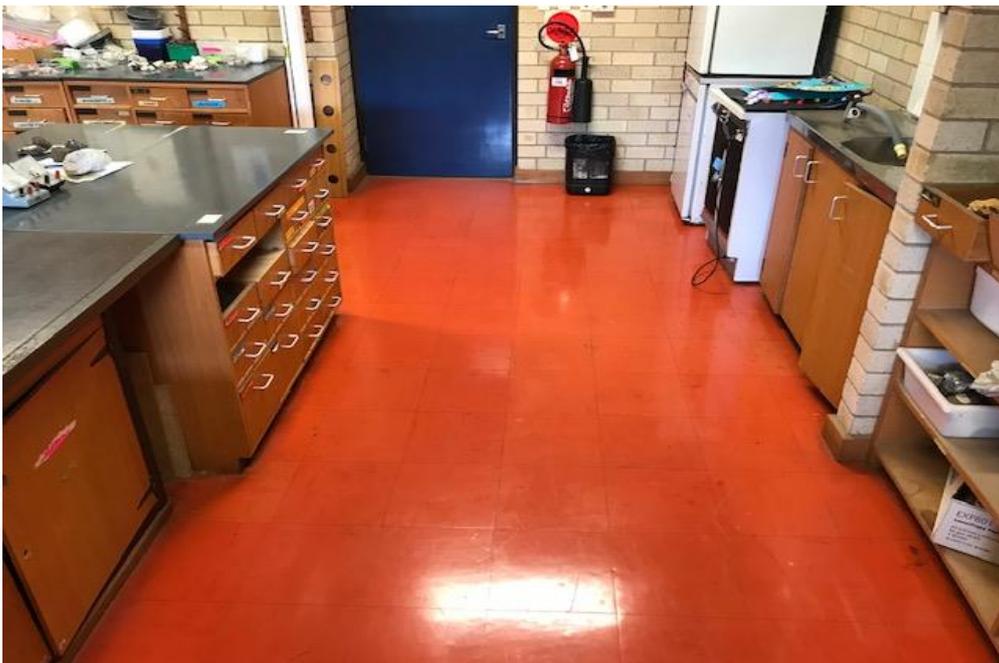
Photograph 14: B00B, R1009 - Preparation Room, floor, vinyl tiles, asbestos detected by analysis.

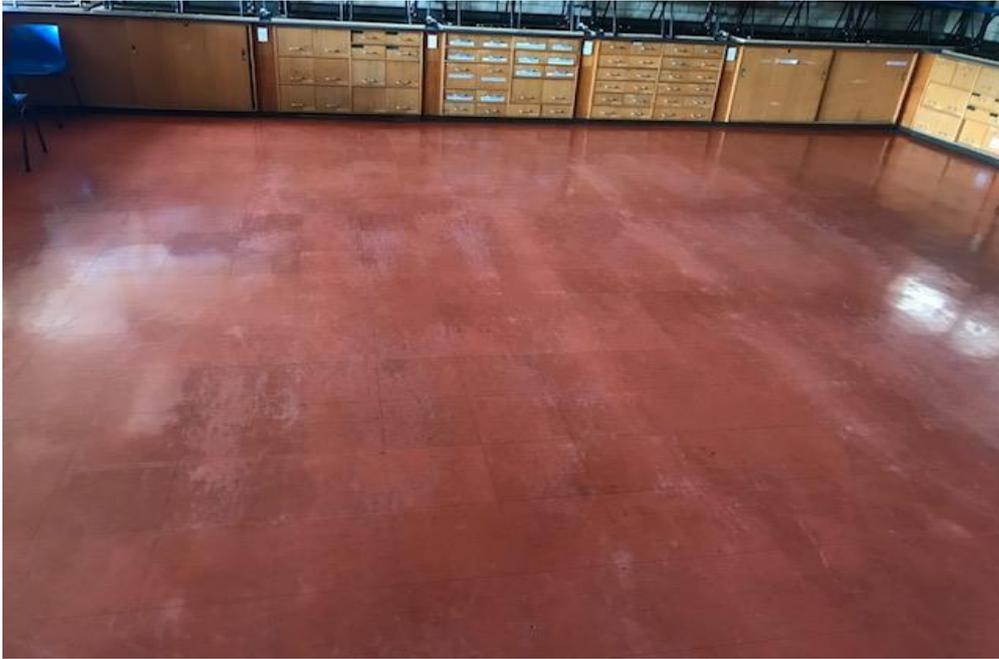
Photograph 15: B00B, R1010 - Laboratory , floor, vinyl tiles, asbestos detected by analysis.

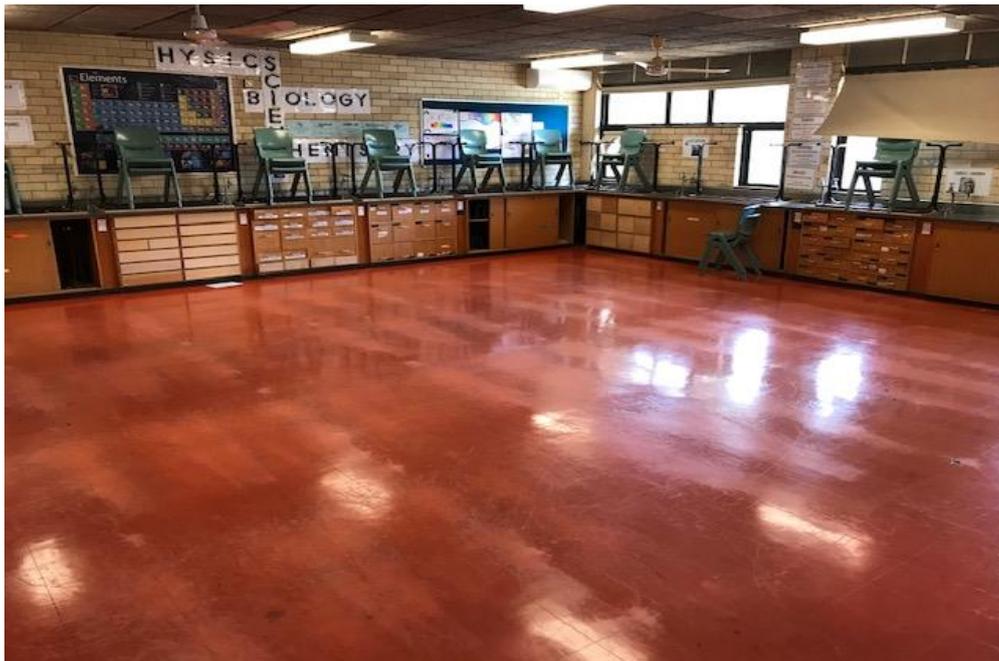
Photograph 16: B00B, R1011 - Laboratory, floor, vinyl tiles, asbestos detected by analysis.

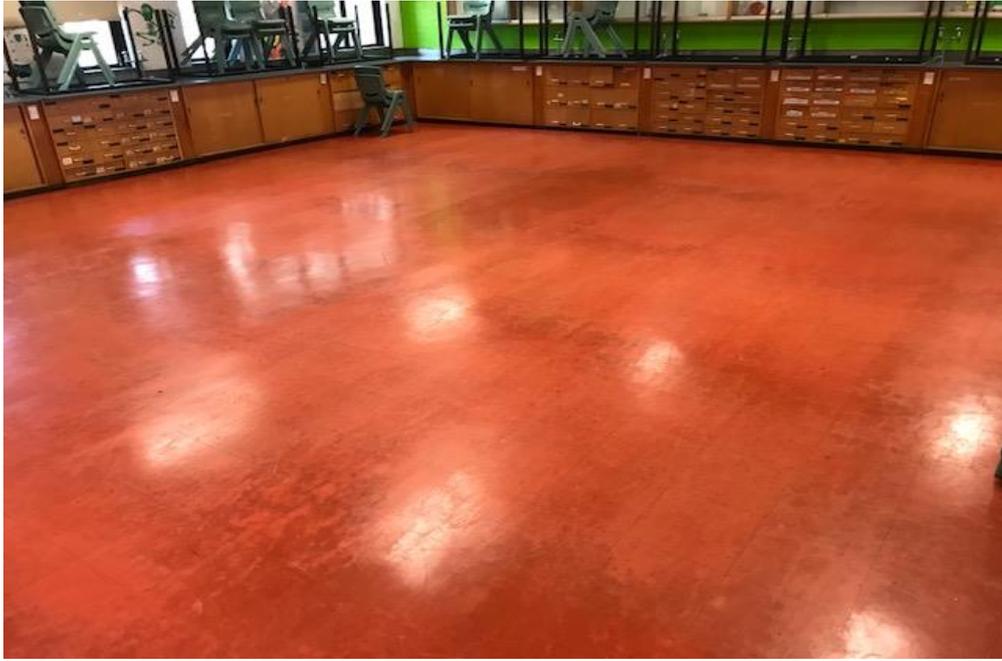
Photograph 17: B00B, R1012 - Laboratory, floor, vinyl tiles, asbestos (assumed).

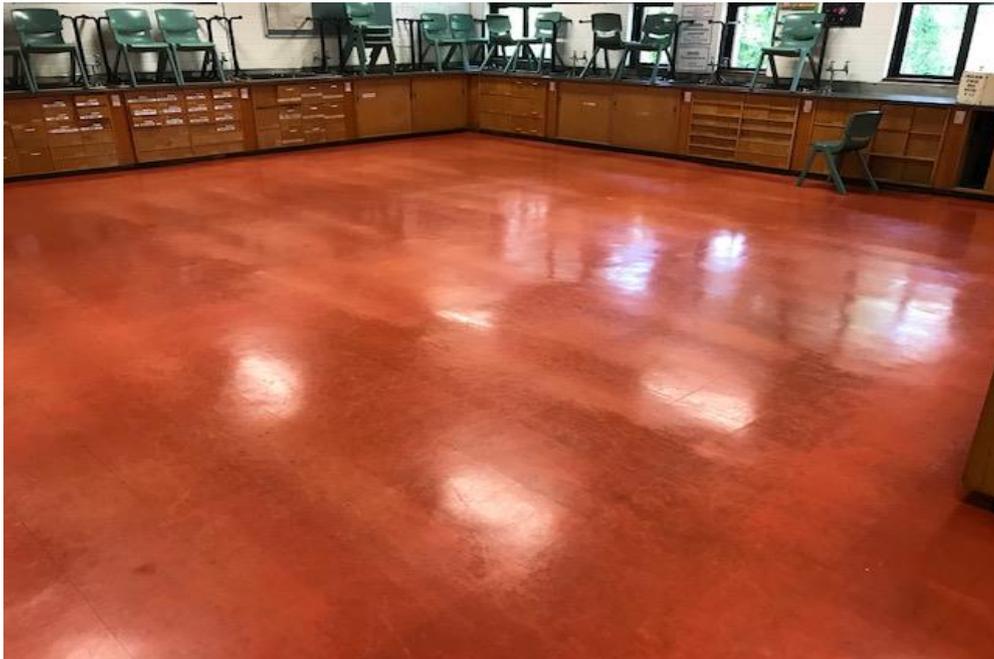
Photograph 18: B00B, R1014 - Laboratory, floor, vinyl tiles, asbestos detected by analysis.

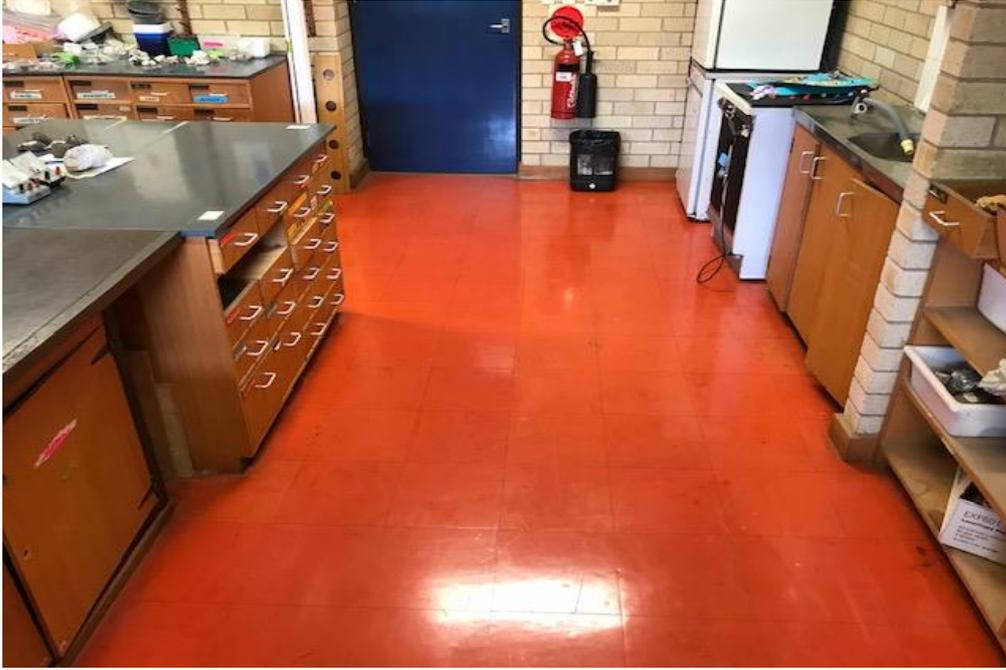
Photograph 19: B00B, R1020 - Preparation Room, floor, vinyl tiles, asbestos (assumed).

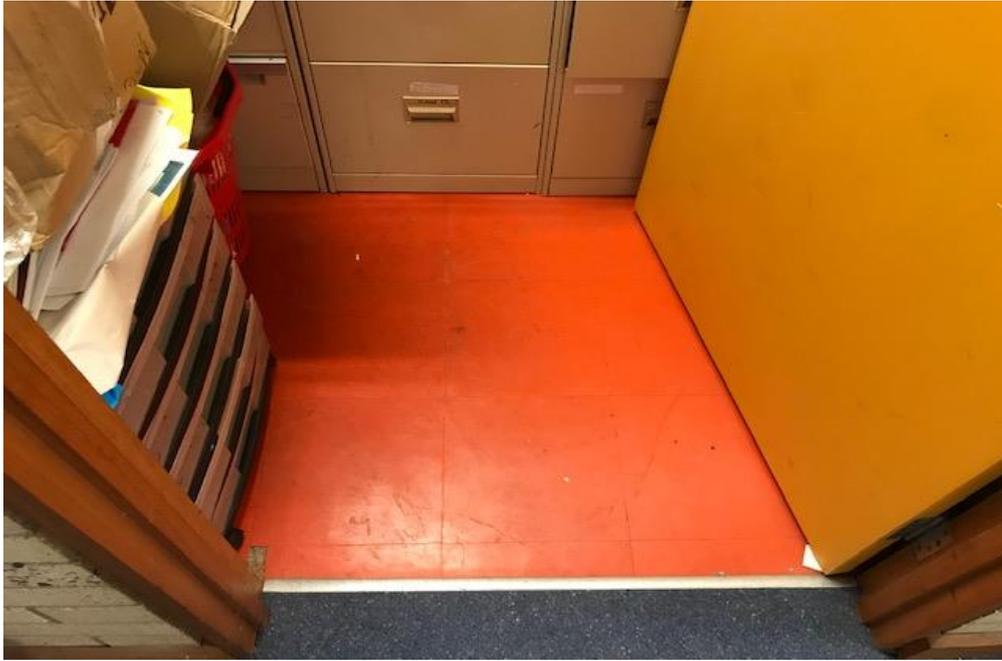
Photograph 1: B00C, R0013 - Resources Store , floor, vinyl tiles, asbestos detected by analysis.

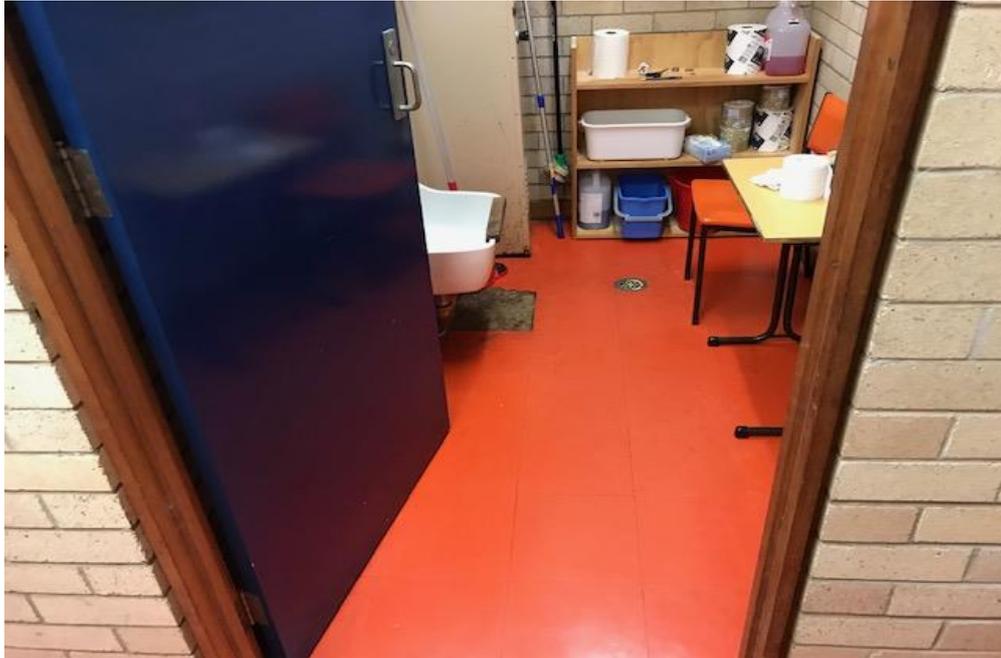
Photograph 3: B00C, R0015 - Cleaning Store, floor, vinyl tiles, asbestos detected by analysis.

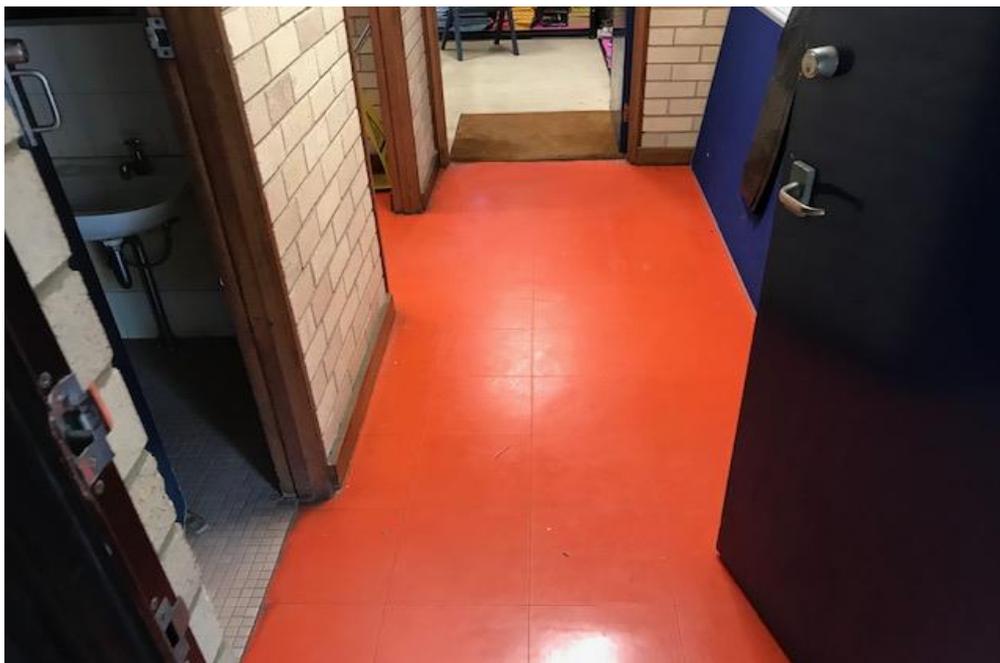
Photograph 4: B00C, R0017 - Movement, floor, vinyl tiles, asbestos detected by analysis.

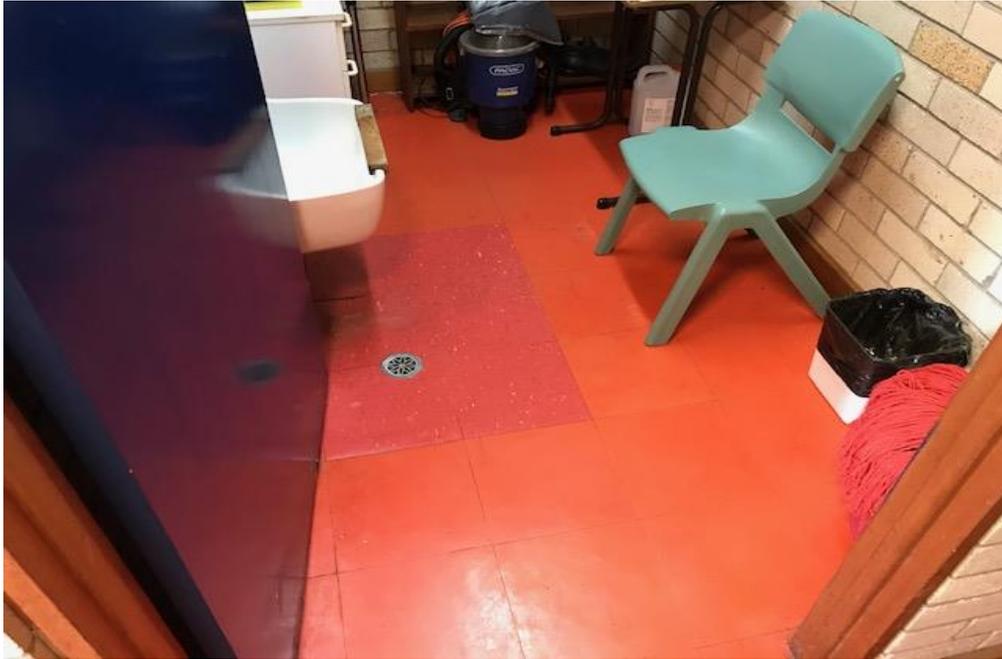
Photograph 5: B00C, R1017 -Cleaning Store , floor, vinyl tiles, asbestos detected by analysis.

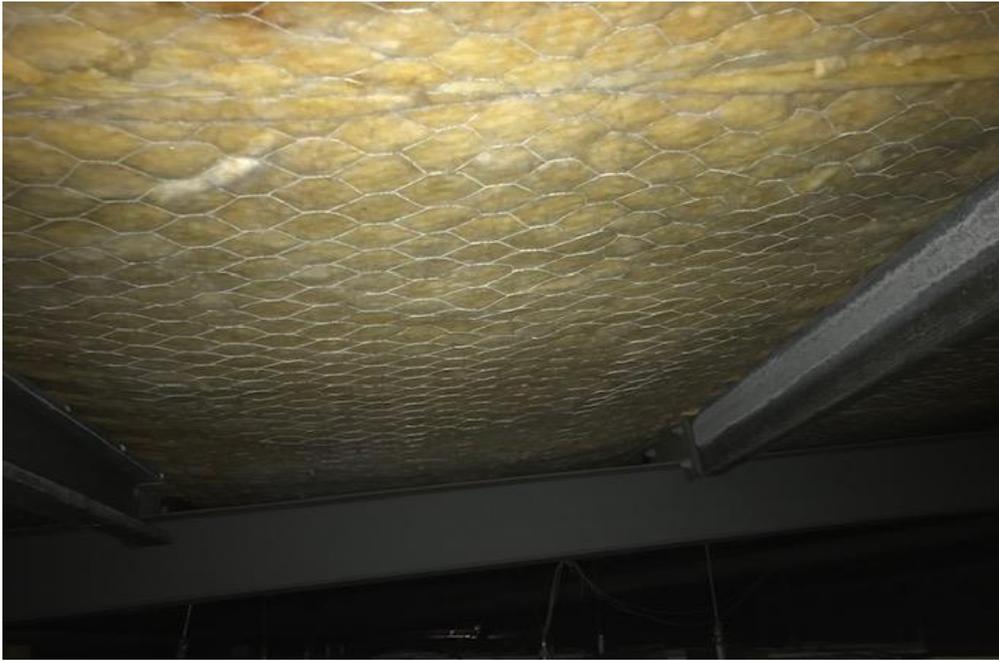
Photograph 7: B00C, first floor, ceiling cavity, insulation , SMF identified visually.

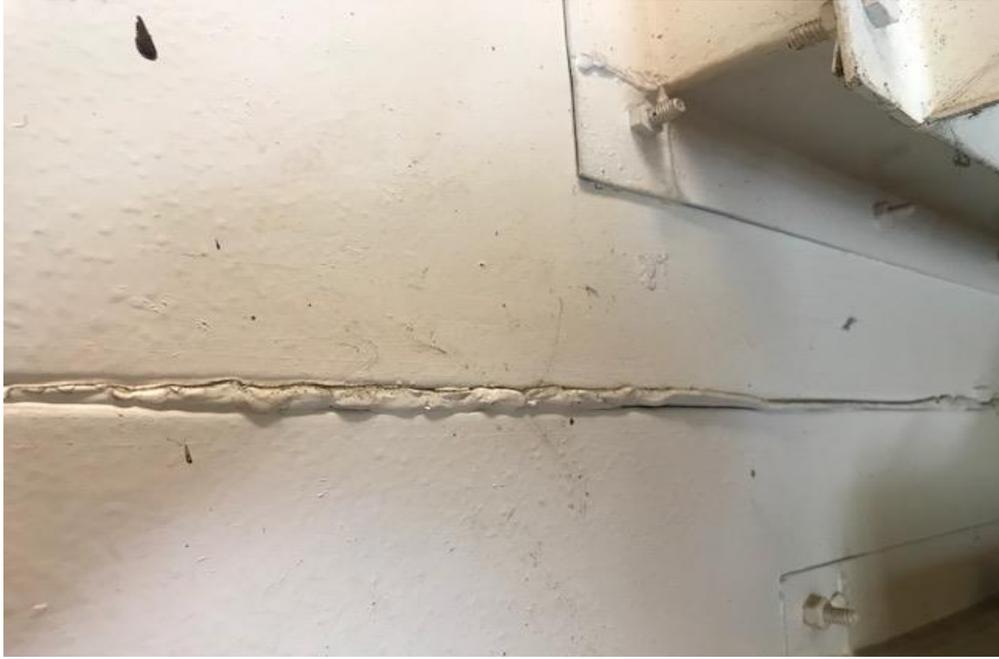
Photograph 1: B00D, throughout, air handling ductwork , mastic to duct, asbestos detected by analysis.

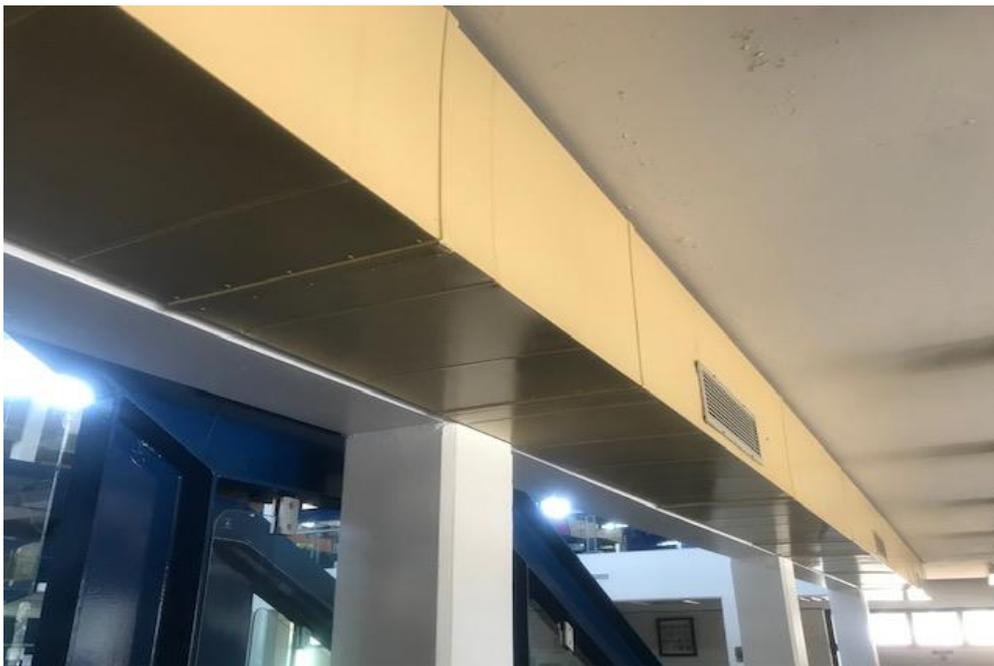
Photograph 2: B00D, R0011 - Main area, air handling ductwork , cream paint , positive for lead.

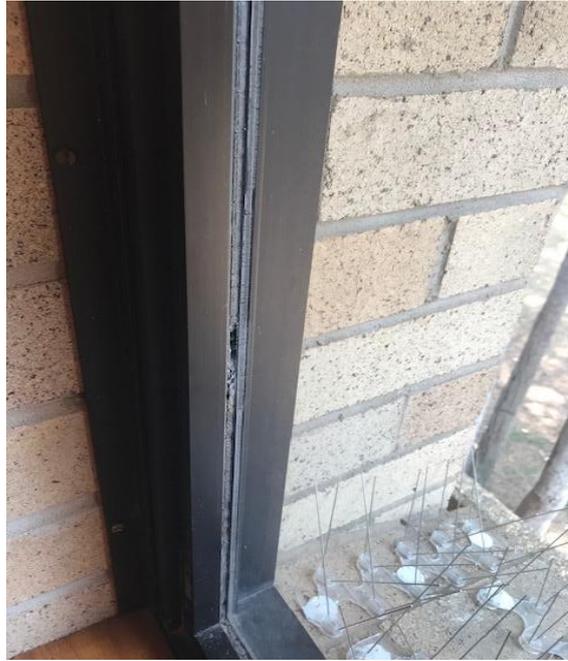
Photograph 5: B00D, internal, throughout, windows, mastic, asbestos detected by analysis.

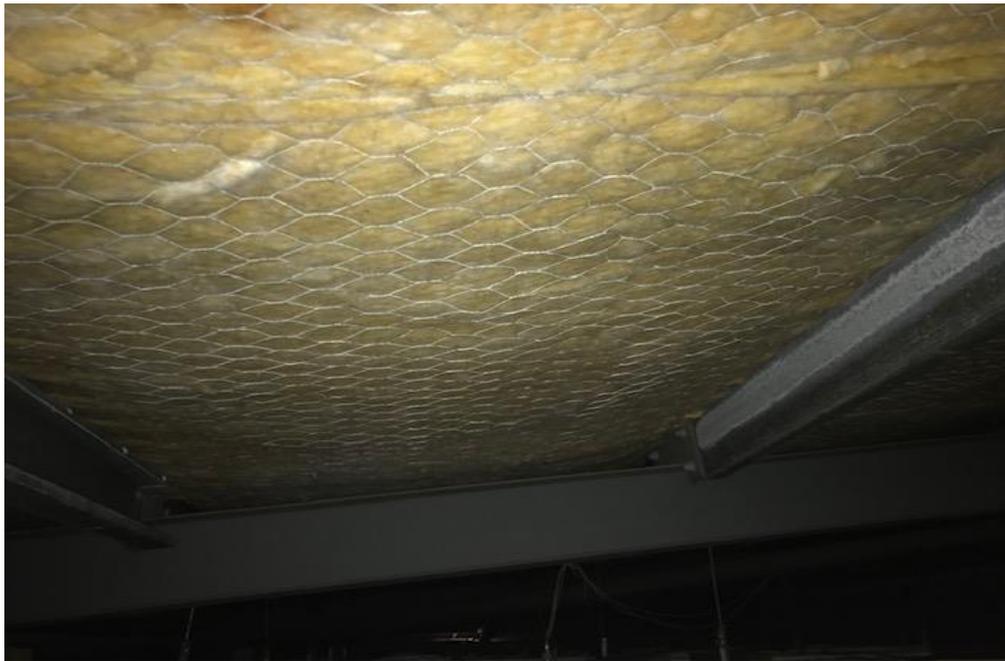
Photograph 6: B00D, internal, level 1, ceiling cavity, insulation, SMF identified visually.
