Hazardous Building Materials (HBM) Assessment

Narrabeen Sports High School (8512)

Project 86973.02  
March 2020

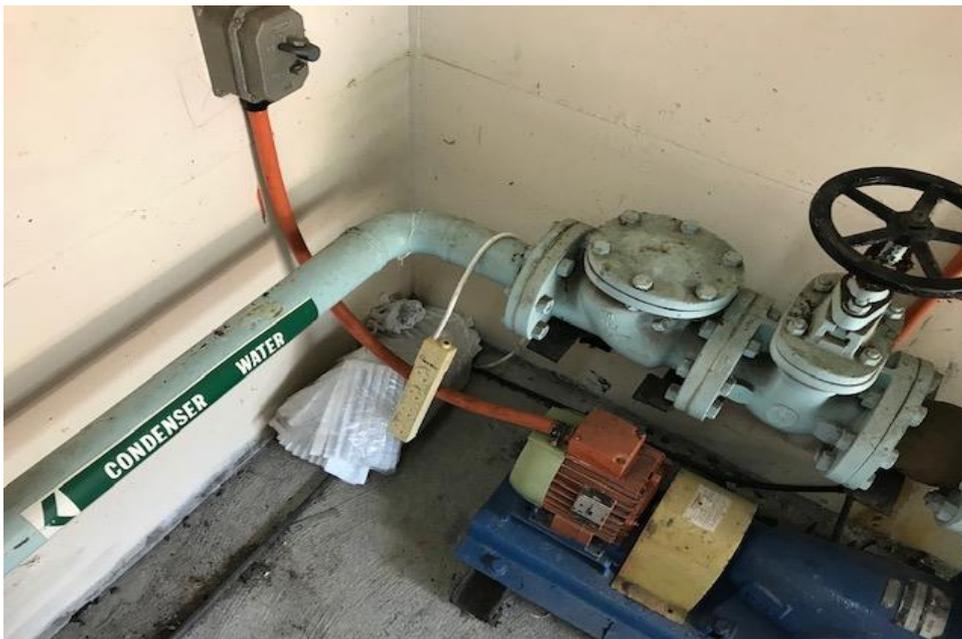
Photograph 8: B00D, R0002 - Plant, pipework, typical blue paint, positive for lead.

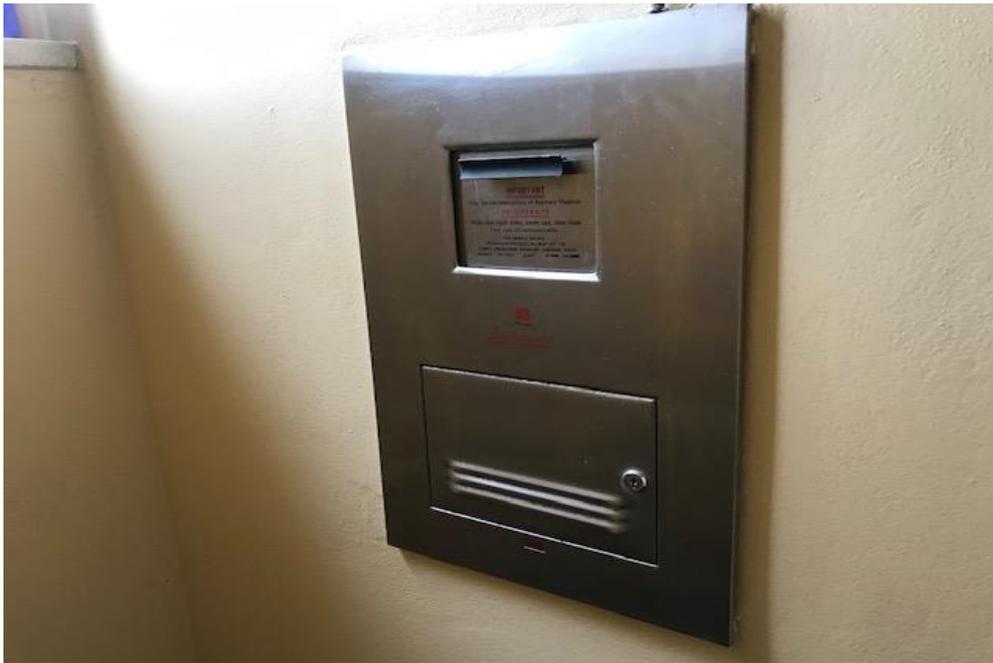
Photograph 2: B00E, R1012 - Staff Female Toilet, incinerator on wall, internal insulation and/or other components, asbestos (assumed).

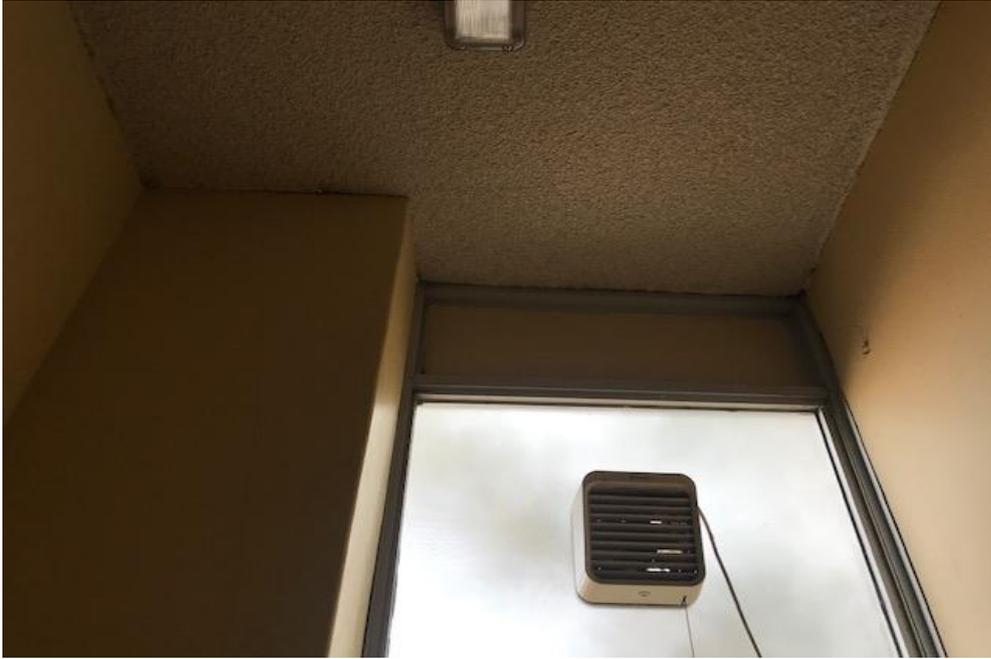
Photograph 3: B00E, R1012 - Staff Female Toilet, ceiling , vermiculite , refer Summary Recommendation.

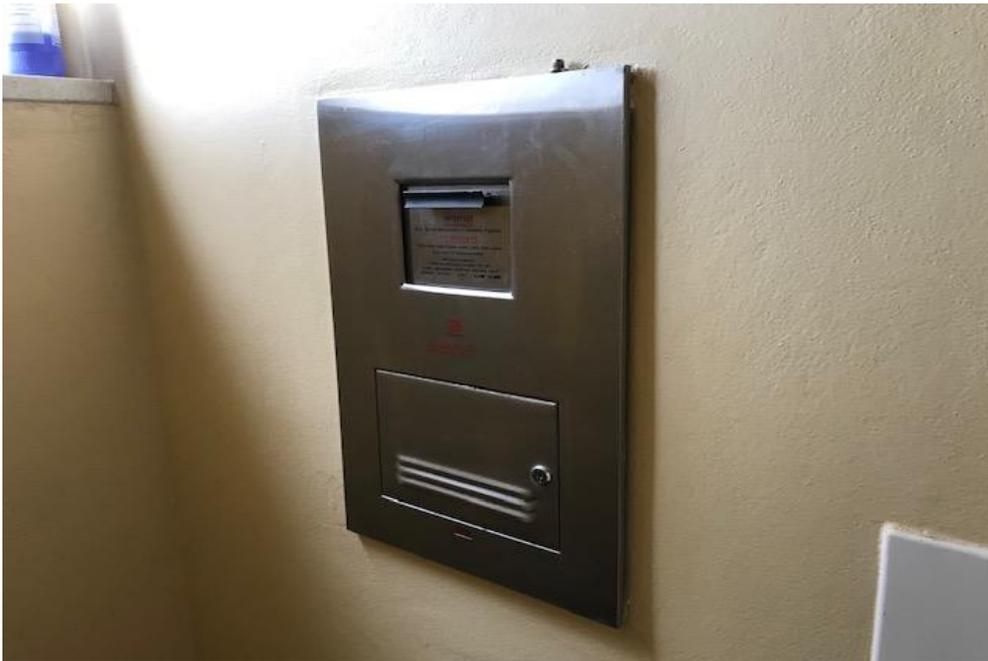
Photograph 4: B00E, R2010 - Staff female toilet , incinerator on wall, internal insulation and/or other components, asbestos (assumed).

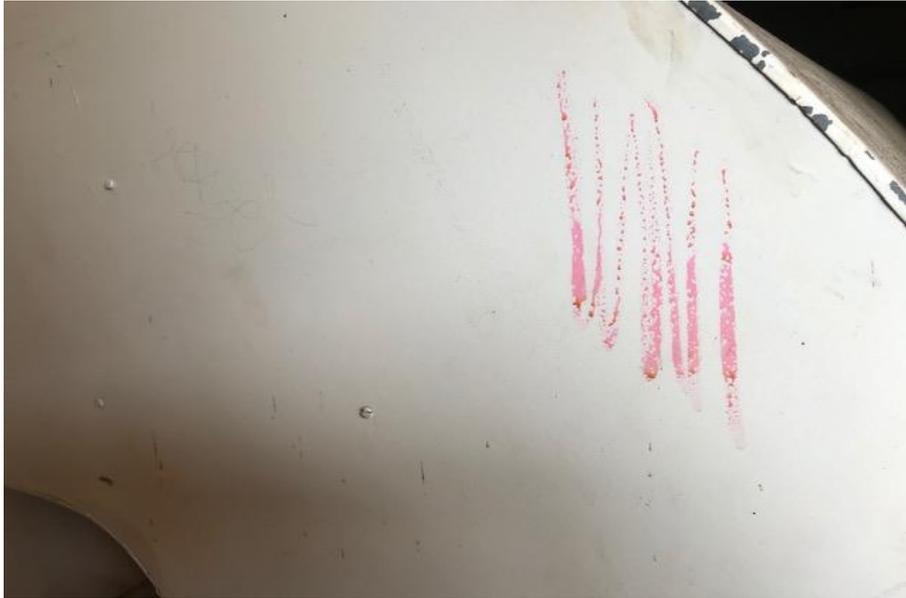
Photograph 7: B00E, R2019 - Plant Room, air handling duct work, white paint, positive for lead.

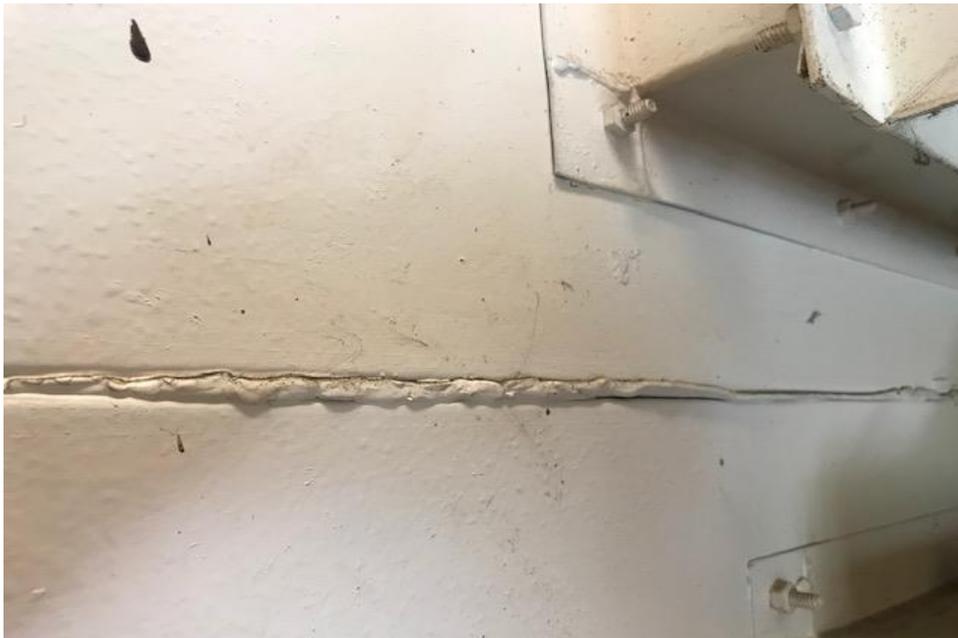
Photograph 8: B00E, R2019 - Plant Room, air handling duct work, mastic to duct, asbestos detected by analysis.

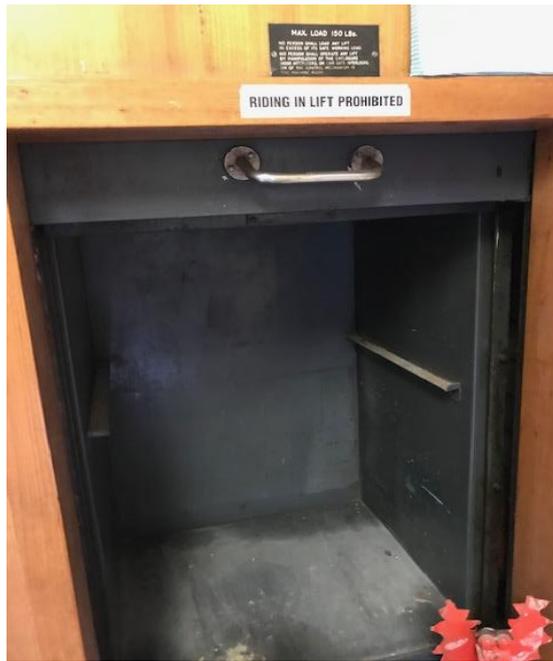
Photograph 3: B00F, R0006 - Lift , lift plant and lift shaft, internal components, asbestos (assumed).

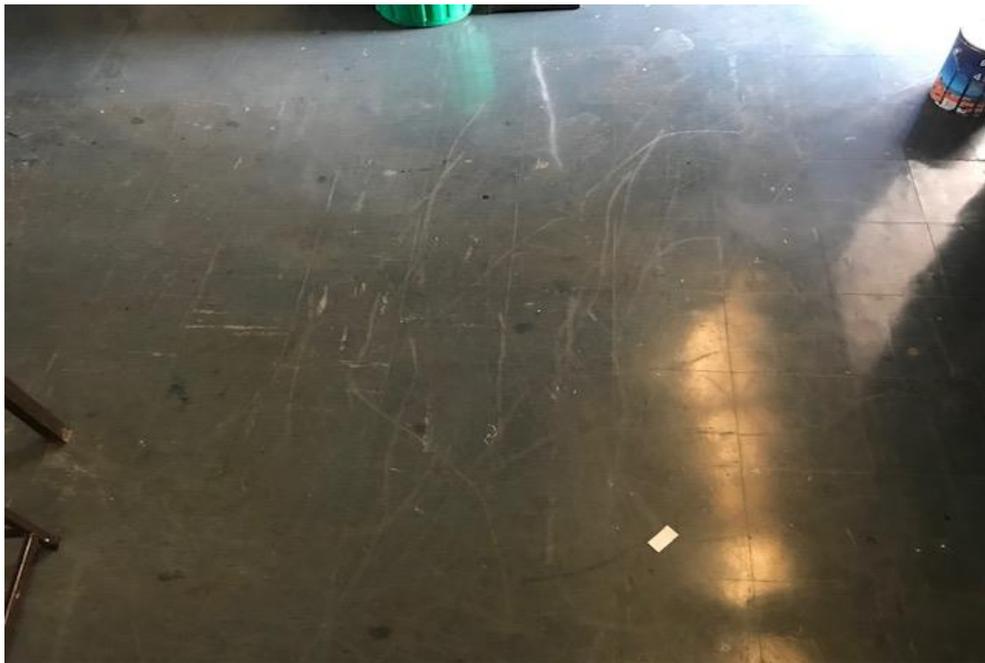
Photograph 4: B00F, R1001 - Art Learning Space , flooring, vinyl tiles, asbestos detected by analysis.

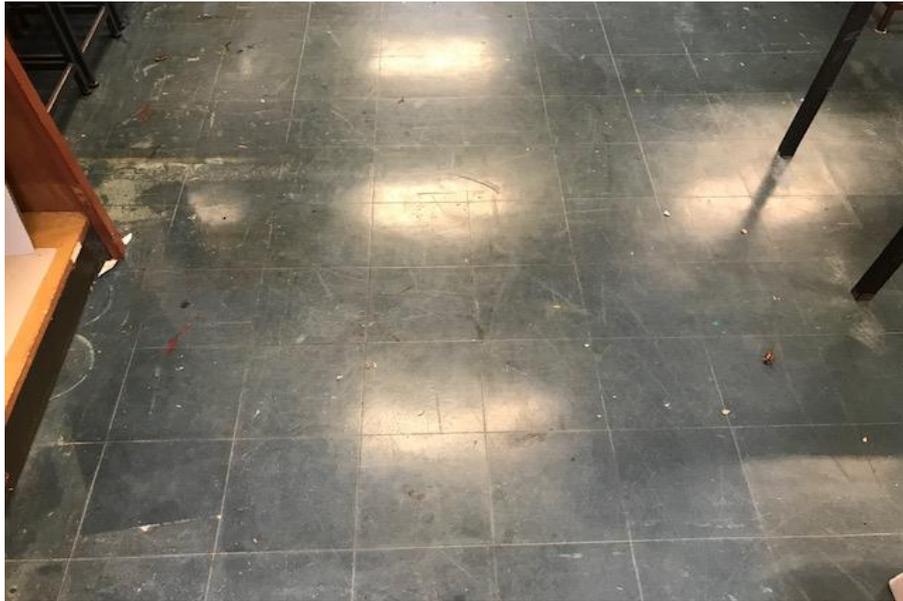
Photograph 7: B00F, R1005 - Art Learning Space, flooring, vinyl tiles, asbestos detected by analysis.

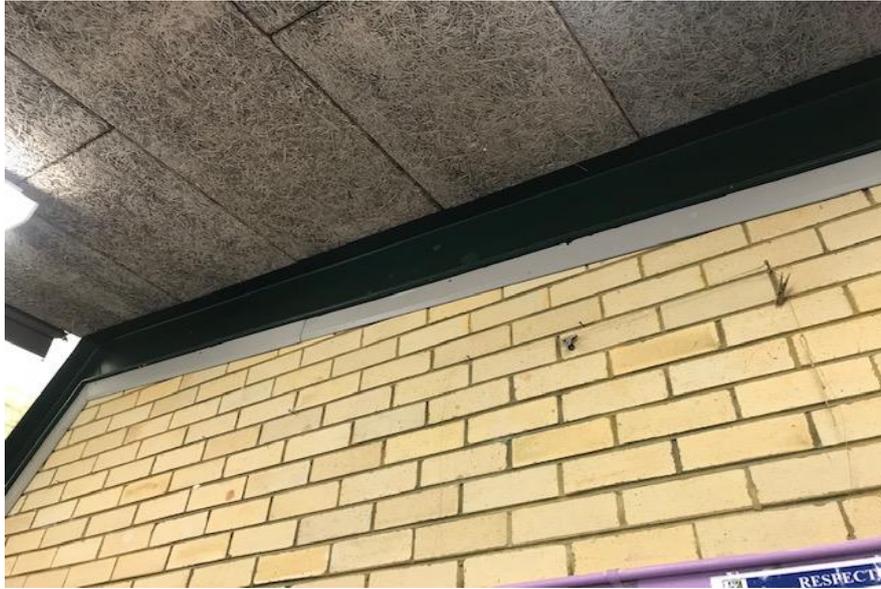
Photograph 9: B00F, R1005 - Art Learning Space, steel beams, undercoat beneath green paint, positive for lead.

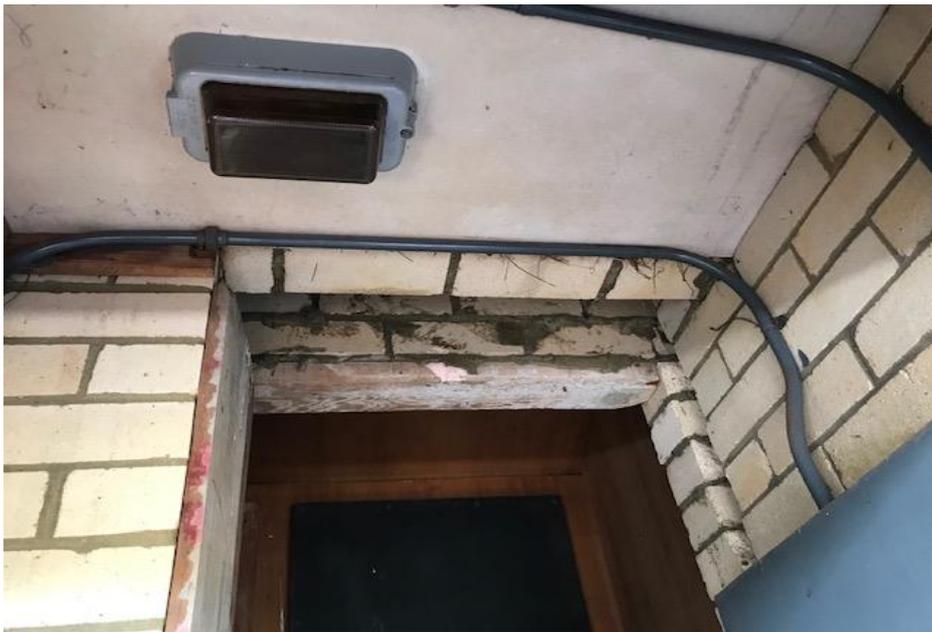
Photograph 10: B00F, R1009 - Plant , ceiling structure / lining , fibre cement sheet, asbestos detected by analysis.

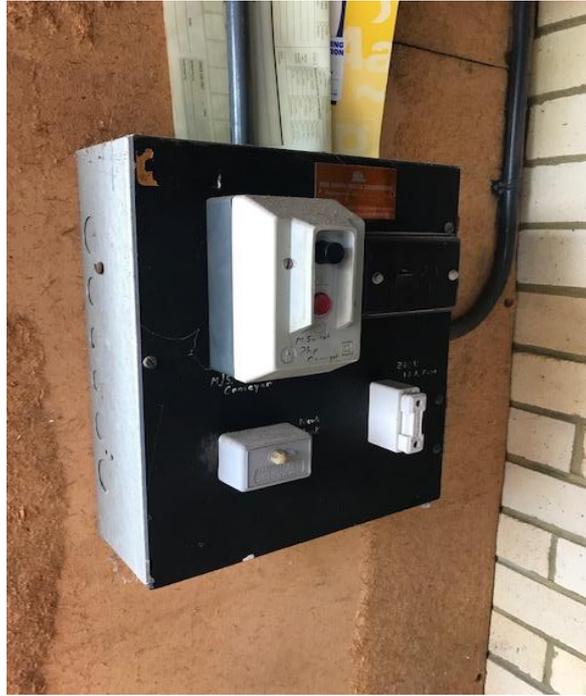
Photograph 11: B00F, R1009 - Plant, electrical backing board, backing board, asbestos detected by analysis.

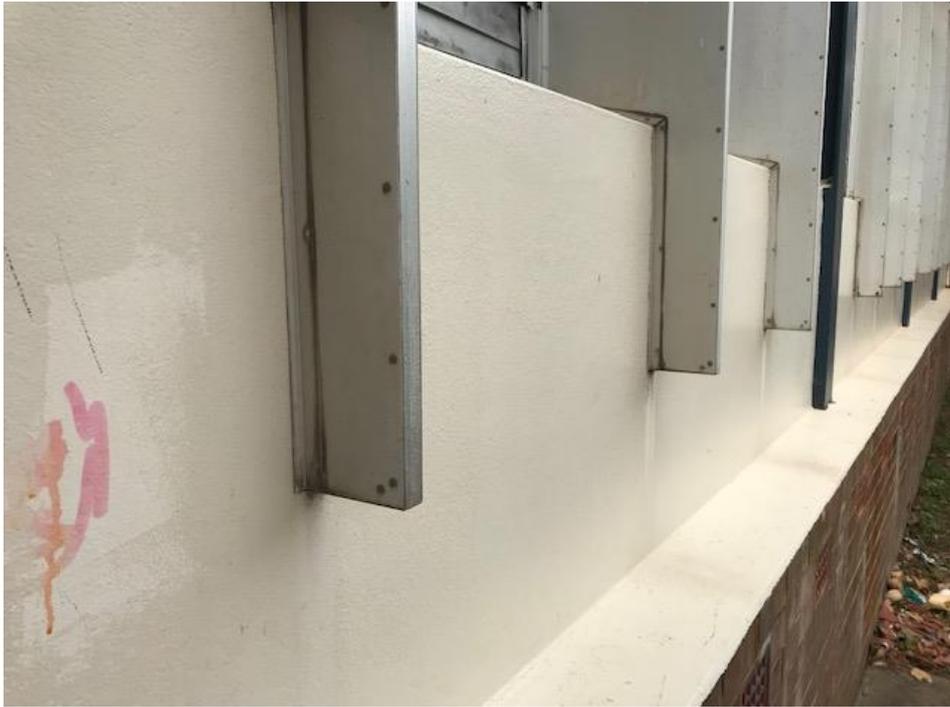
Photograph 1: B00G, exterior, walls, cream paint, positive for lead

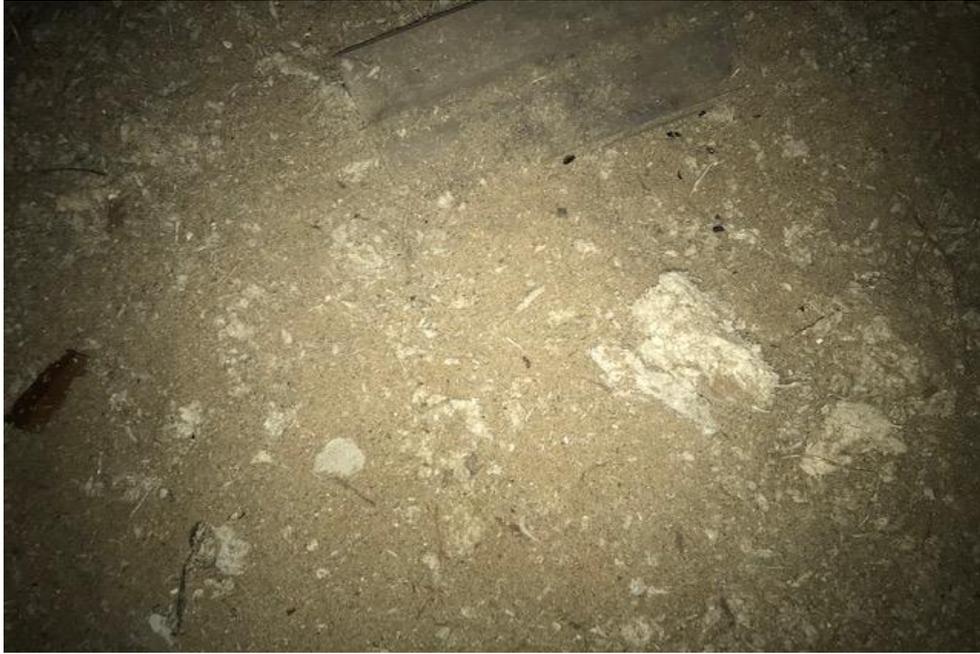
Friable asbestos, in the form of loose fibre and / or insulation material in poor condition, was identified in sand / soil in the subfloor of building B00G. The source of the asbestos could not be clearly identified and, while contamination is generally assumed present throughout the building subfloor, the extent of any potential contamination beyond this area could not be confirmed. Visual inspection of the subfloor also indicated relatively recent and unauthorised occupation of the subfloor (possibly by school students).

Photograph 3: B00G, exterior, subfloor, throughout, loose fibre in sand/soil, asbestos detected by analysis

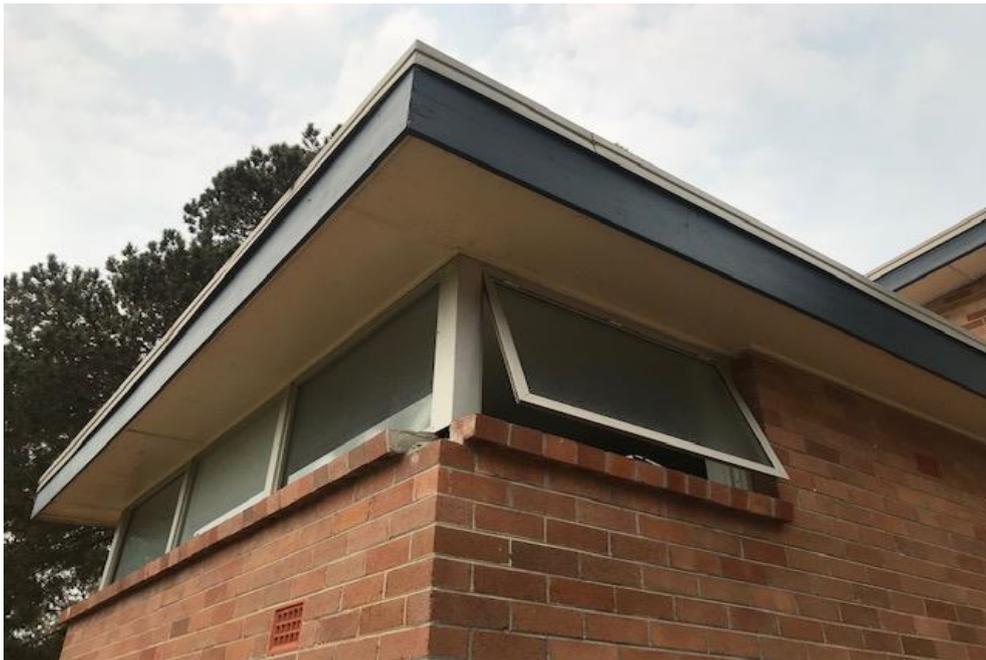
Photograph 4: B00G, exterior, north, south, east and west eave linings, flat fibre cement sheet, asbestos detected by analysis

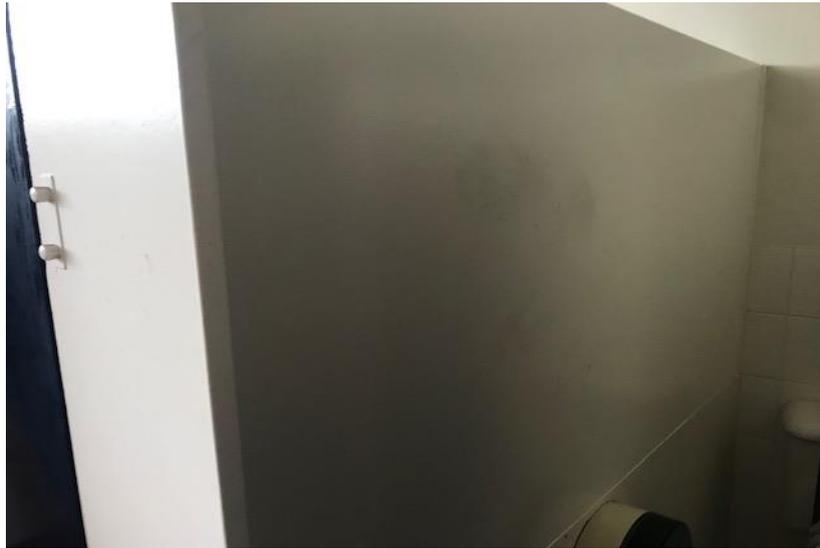
Photograph 5: B00G, R0026 - Girls toilet, cubicle partitions, compressed fibre cement sheet, asbestos detected by analysis

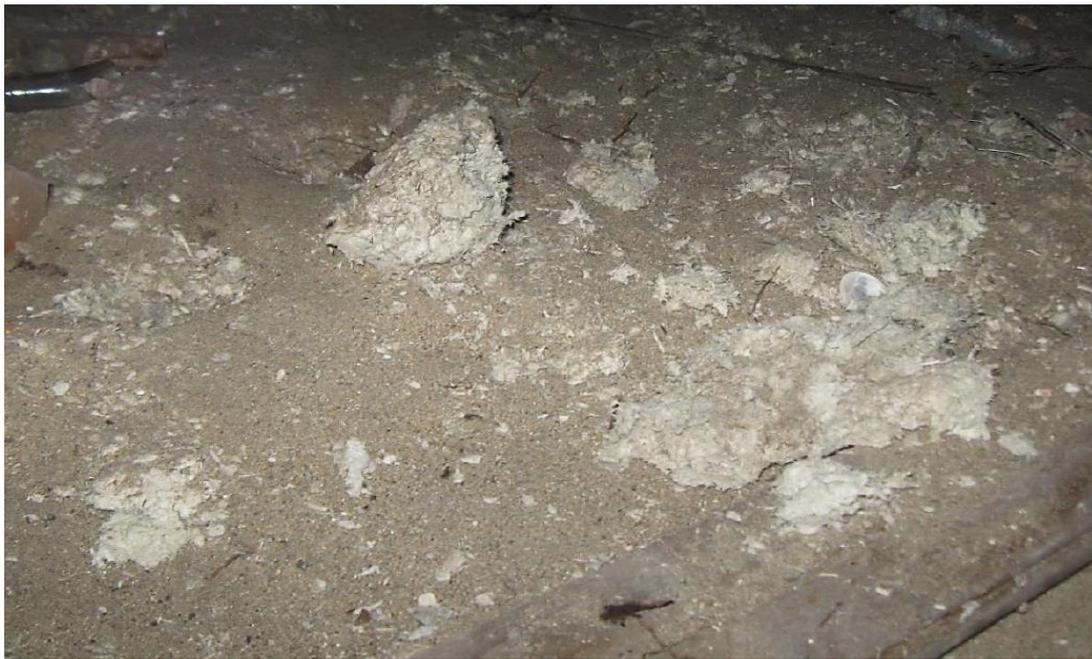
Photograph 6: B00G, exterior, subfloor, throughout, loose fibre in sand/soil, asbestos detected by analysis

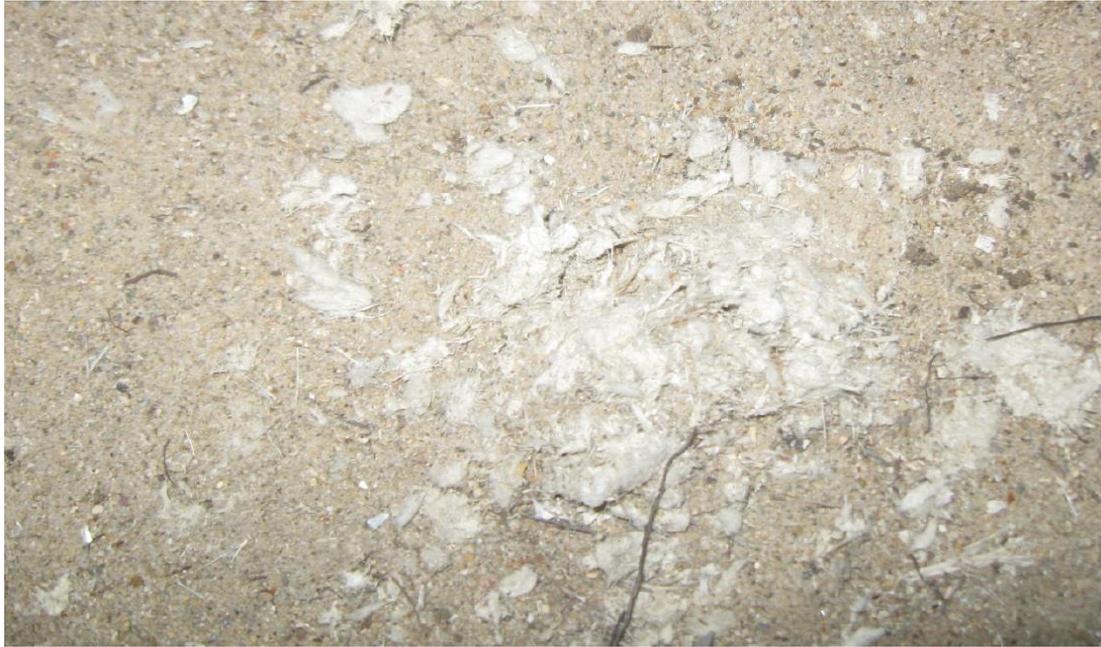
Photograph 7: B00G, exterior, subfloor, throughout, loose fibre in sand/soil, asbestos detected by analysis
