# Geotechnical Assessment

**Project:** Alterations & Additions  
21 Park Street, Collaroy NSW

**Ref:** AG 24195  
10 July 2024

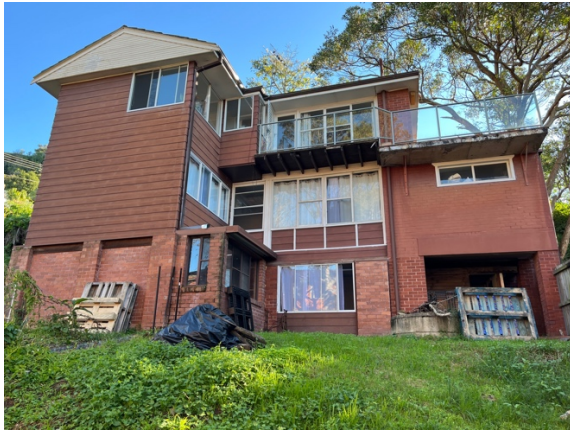
**Photo 1:** Eastern side of residence

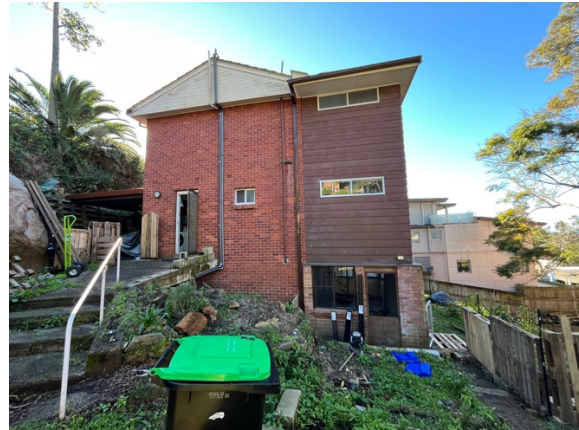
**Photo 2:** Southern side of residence

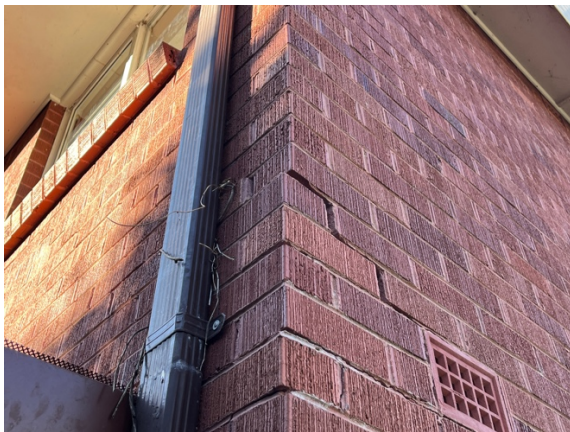
The existing building at the site is a three-storey house which is in dilapidated condition and shows signs of differential settlement, particularly at the southwestern corner where the brickwork has cracked and rotated (Photo 4). The pool and surrounding area is in poor condition, with a significant crack observed in the concrete wall upslope of the western side of the pool (Photo 7).

- The damage observed in the existing structure (photo 4) is attributed to inadequate and inconsistent foundation materials, potentially in combination with point loads from the boulder shown in Photo 6 which is in direct contact with the brickwork, as opposed to slope instability more generally.
- The property is classified as **Area D & E** with reference to Northern Beaches Council WLEP – Warringah Landslip Risk Map (**Image 2**).

**Photo 4:** Cracking and rotation of brickwork in south-western corner of the residence

| Recommendation | Description |
|---|---|
| <b>Footings</b> | <p>We recommend that all new footings are taken to and socketed no less than 500mm into the underlying shale bedrock (Unit 3) using piers as required.</p> <p>The allowable bearing pressure for footings taken to competent weathered bedrock of at least low strength is <b>600kPa</b>. Higher allowable bearing capacities may be achievable subject to inspection and certification of excavated footings by AscentGeo.</p> <p>Pier footings should be of sufficient diameter to enable effective base cleaning to be carried out during construction. Small diameter piers that cannot be cleaned should be designed for shaft friction, resulting in a longer rock socket.</p> <p>To mitigate the risk of differential settlement, it is essential that all footings are founded on competent bedrock of similar consistency.</p> <p><b>It is essential that the foundation materials of all footing excavations be inspected and approved before steel reinforcement and concrete is placed. This inspection should be scheduled while excavation plant and operators are still on site, and before steel reinforcement has been fixed or the concrete booked.</b></p> |

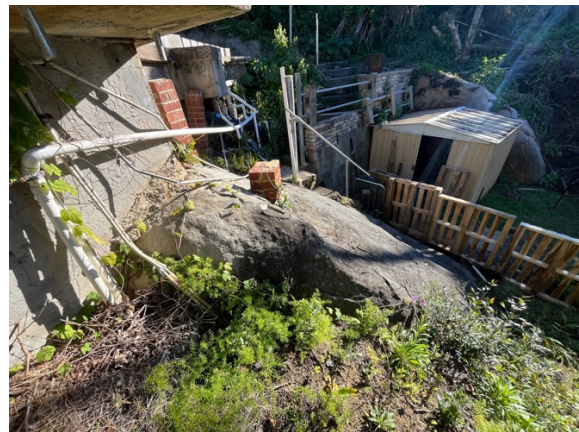
**Photo 5:** Sandstone boulder under pool

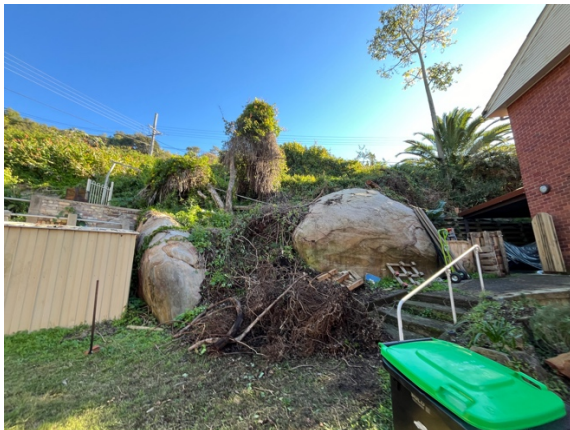
There are three very large sandstone boulders are present within the southern portion of the site (Photos 5 & 6). The pool has been founded partly on the boulder of Photo 6. The boulders are embedded within the soil profile and are likely to have originated from the Hawkesbury Sandstone unit represented in the current escarpment of Collaroy Plateau in an historical (>1000 year) rock fall event. A fourth boulder is present at the south-western corner of the house, under the concrete slab and where the brickwork of the existing house has been cut to fit, the boulder sits upon uncontrolled fill, sandy materials and brick pieces and is indirect contact with the brickwork (Photo 7). Bedrock was not outcropping on the subject site.

**Photo 5:** Two large sandstone boulders to the south west of the residence

| Recommendation | Description |
|---|---|
| <p><b>Sandstone Boulder Excavation / Removal</b></p> | <p>AscentGeo should be contacted once the specific details of the proposed sandstone boulder removal are decided upon.</p> <p>Generally, we would recommend the boulders be demolished in a staged, top-down approach, with consideration to be given to portions of the slope or structures (i.e. the pool) that the boulders may be supporting.</p> <p>Where the geometry of the boulder are unknown (e.g. where the boulder is deeply embedded in the soil, or covered by the pool structure) and where significant removal of rock is proposed, we will recommend the boulder be removed in its entirety to eliminate uncertainties about the geometry and</p> |

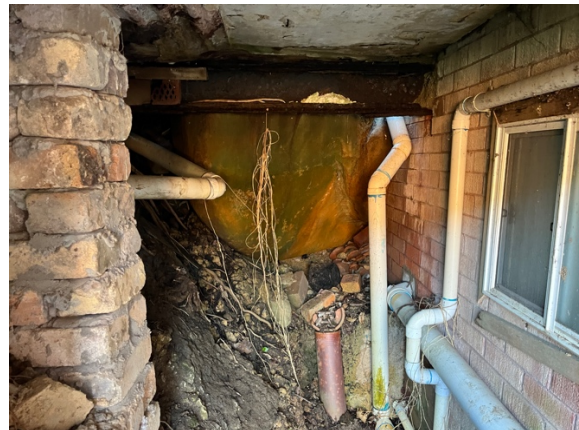
**Photo 6:** Sandstone boulder under the slab at the south-western corner of the house sits upon uncontrolled fill, sandy materials and brick pieces.
