DILAPIDATION REPORT

Bubalo Street, Warriewood

Prepared by: Rezoning Pty Ltd t/as Effective Building & Consultancy

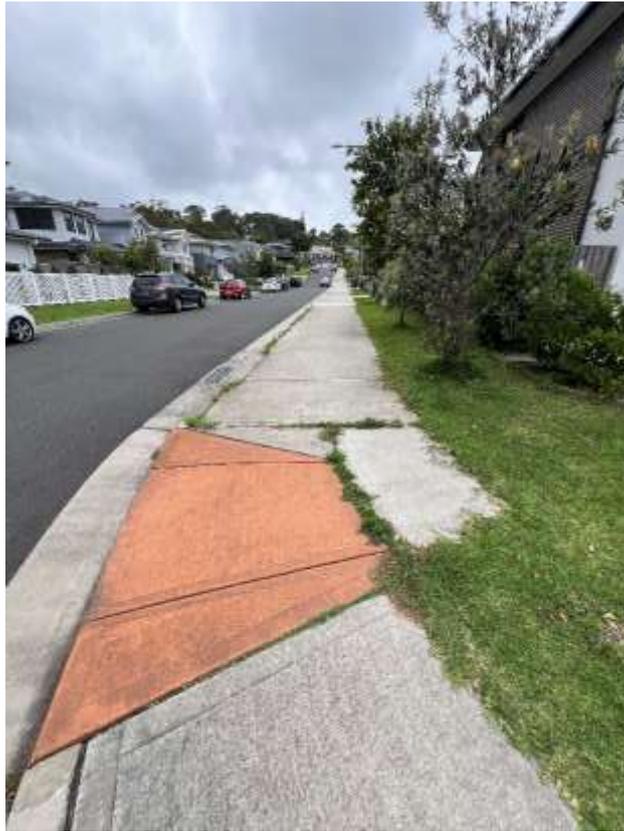
Figure 5 – General condition of the footpath.

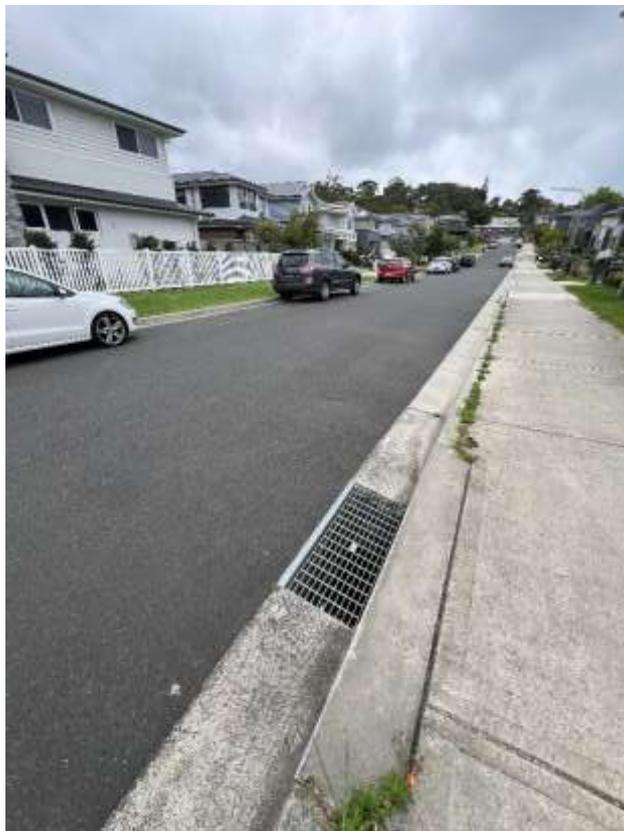
Figure 6 – General condition of the road/pit.

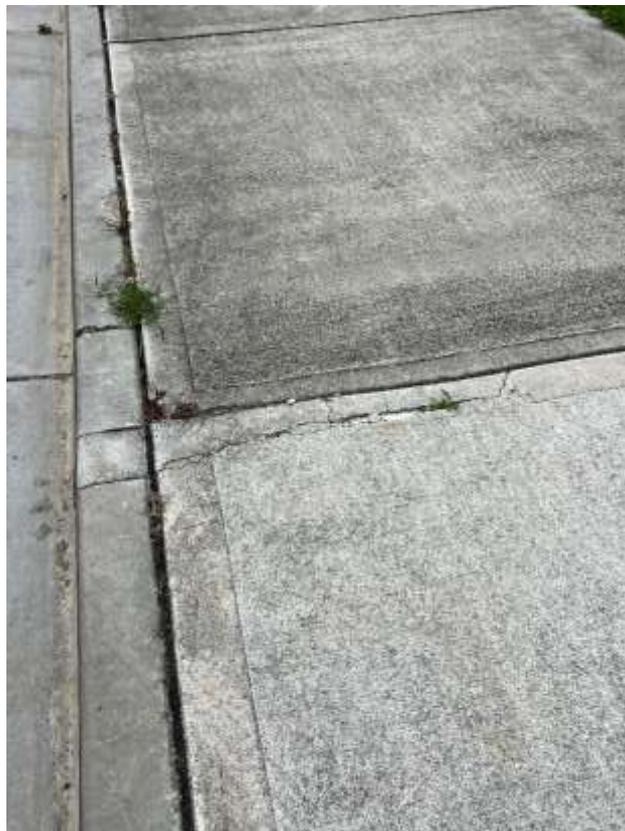
Figure 18 – Crack is evident to the footpath outside 19 Bubalo Street Warriewood.

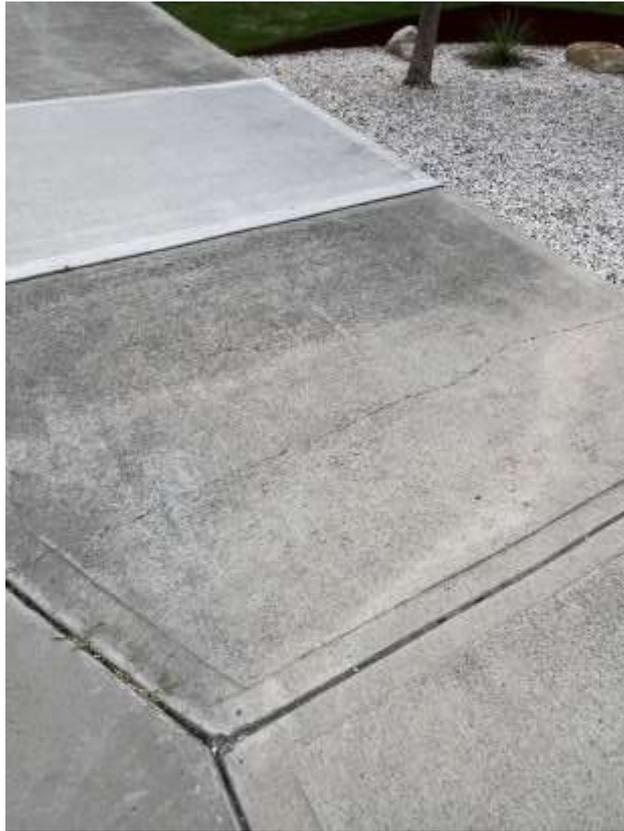
Figure 25 – Crack is evident to the footpath outside 15 Bubalo Street Warriewood.

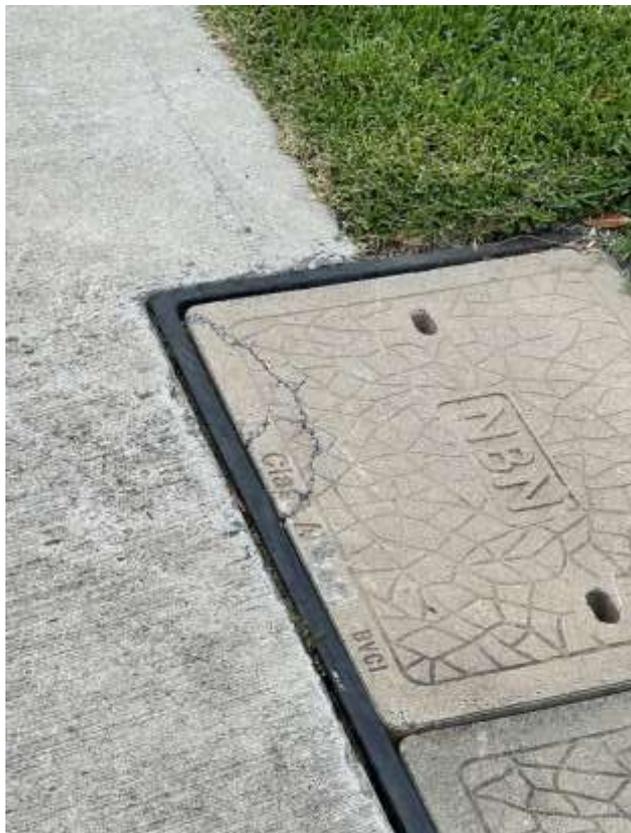
Figure 30 – Crack is evident to the pit outside 13 Bubalo Street Warriewood.

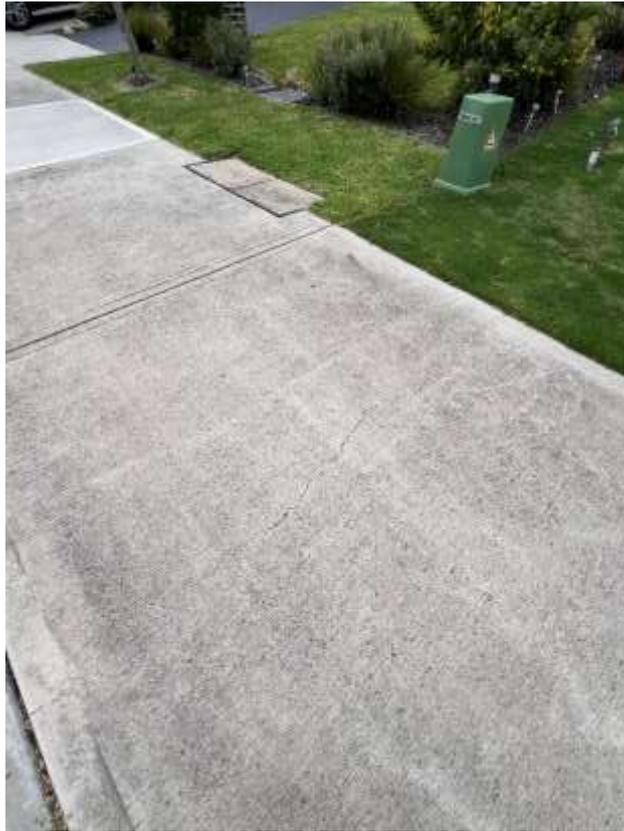
Figure 31 – Crack is evident to the footpath outside 13 Bubalo Street Warriewood.

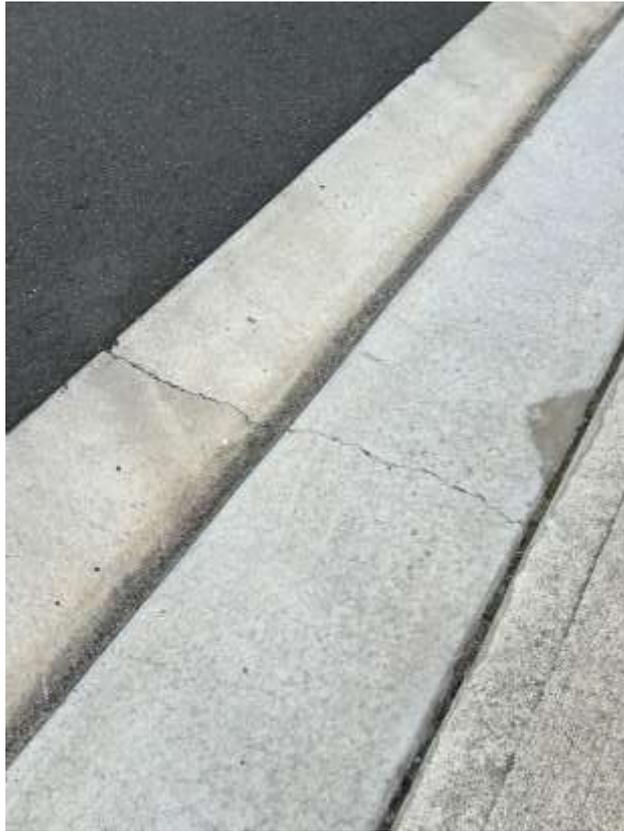
Figure 53 – Crack is evident to the layback outside 3 Bubalo Street Warriewood.

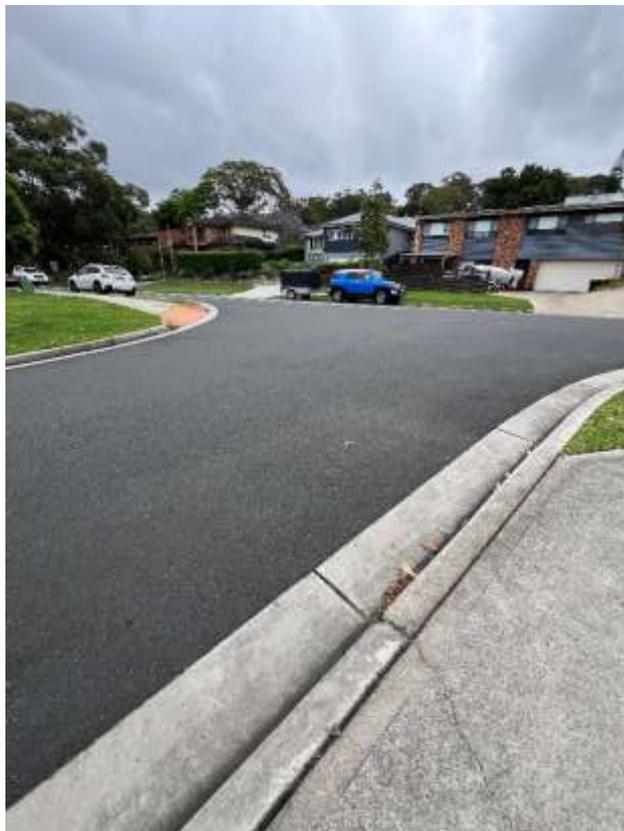
Figure 66 – Crack is evident to the footpath outside 61 Warriewood Road Warriewood.

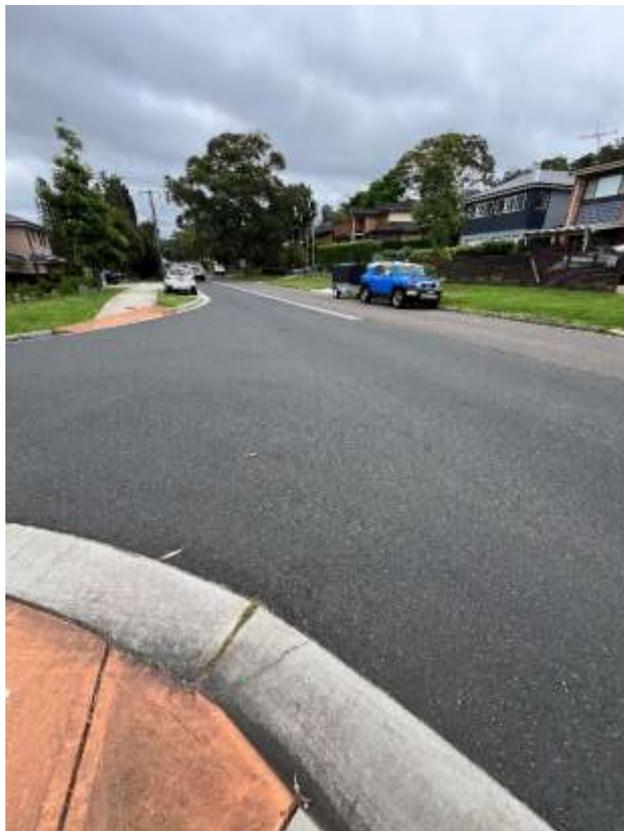
Figure 74 - Crack is evident to the layback outside 61 Warriewood Road Warriewood.

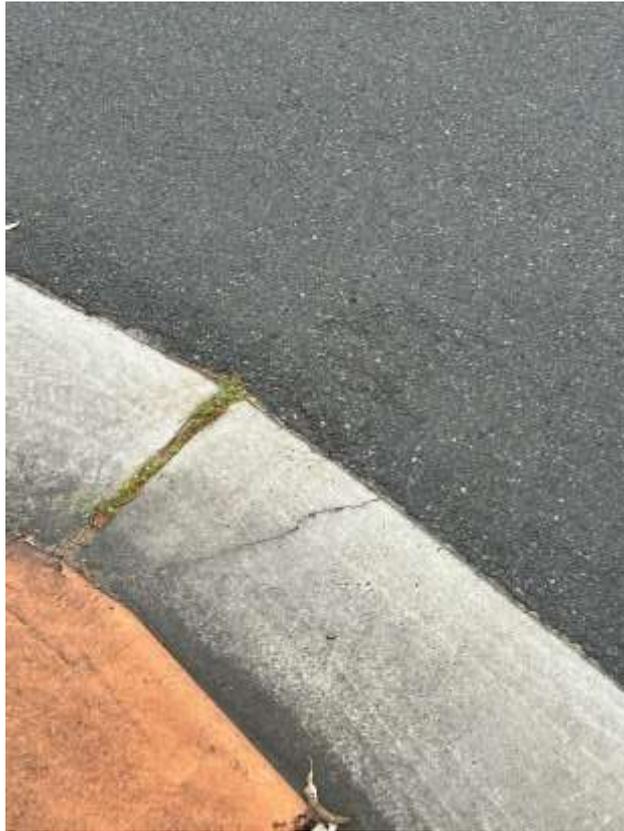
Figure 75 – Crack is evident to the layback outside 61 Warriewood Road Warriewood.

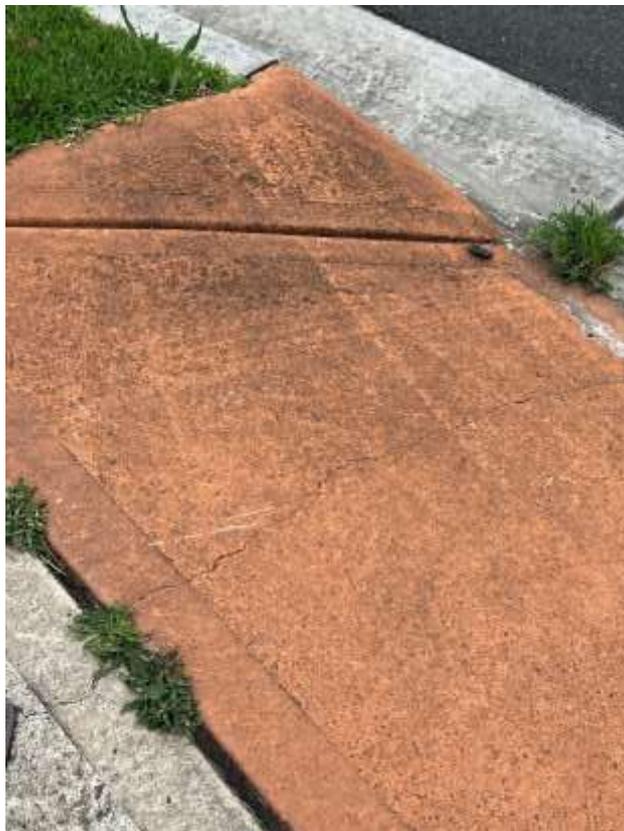
Figure 80 – Crack is evident to the layback outside 63 Warriewood Road Warriewood.
