Geotechnical Assessment

Project: Alterations & Additions
11 Mulgowrie Crescent, Balgowlah Heights

Ref: AG 25466
28 October 2025

11 Mulgowrie Crescent, Balgowlah Heights NSW

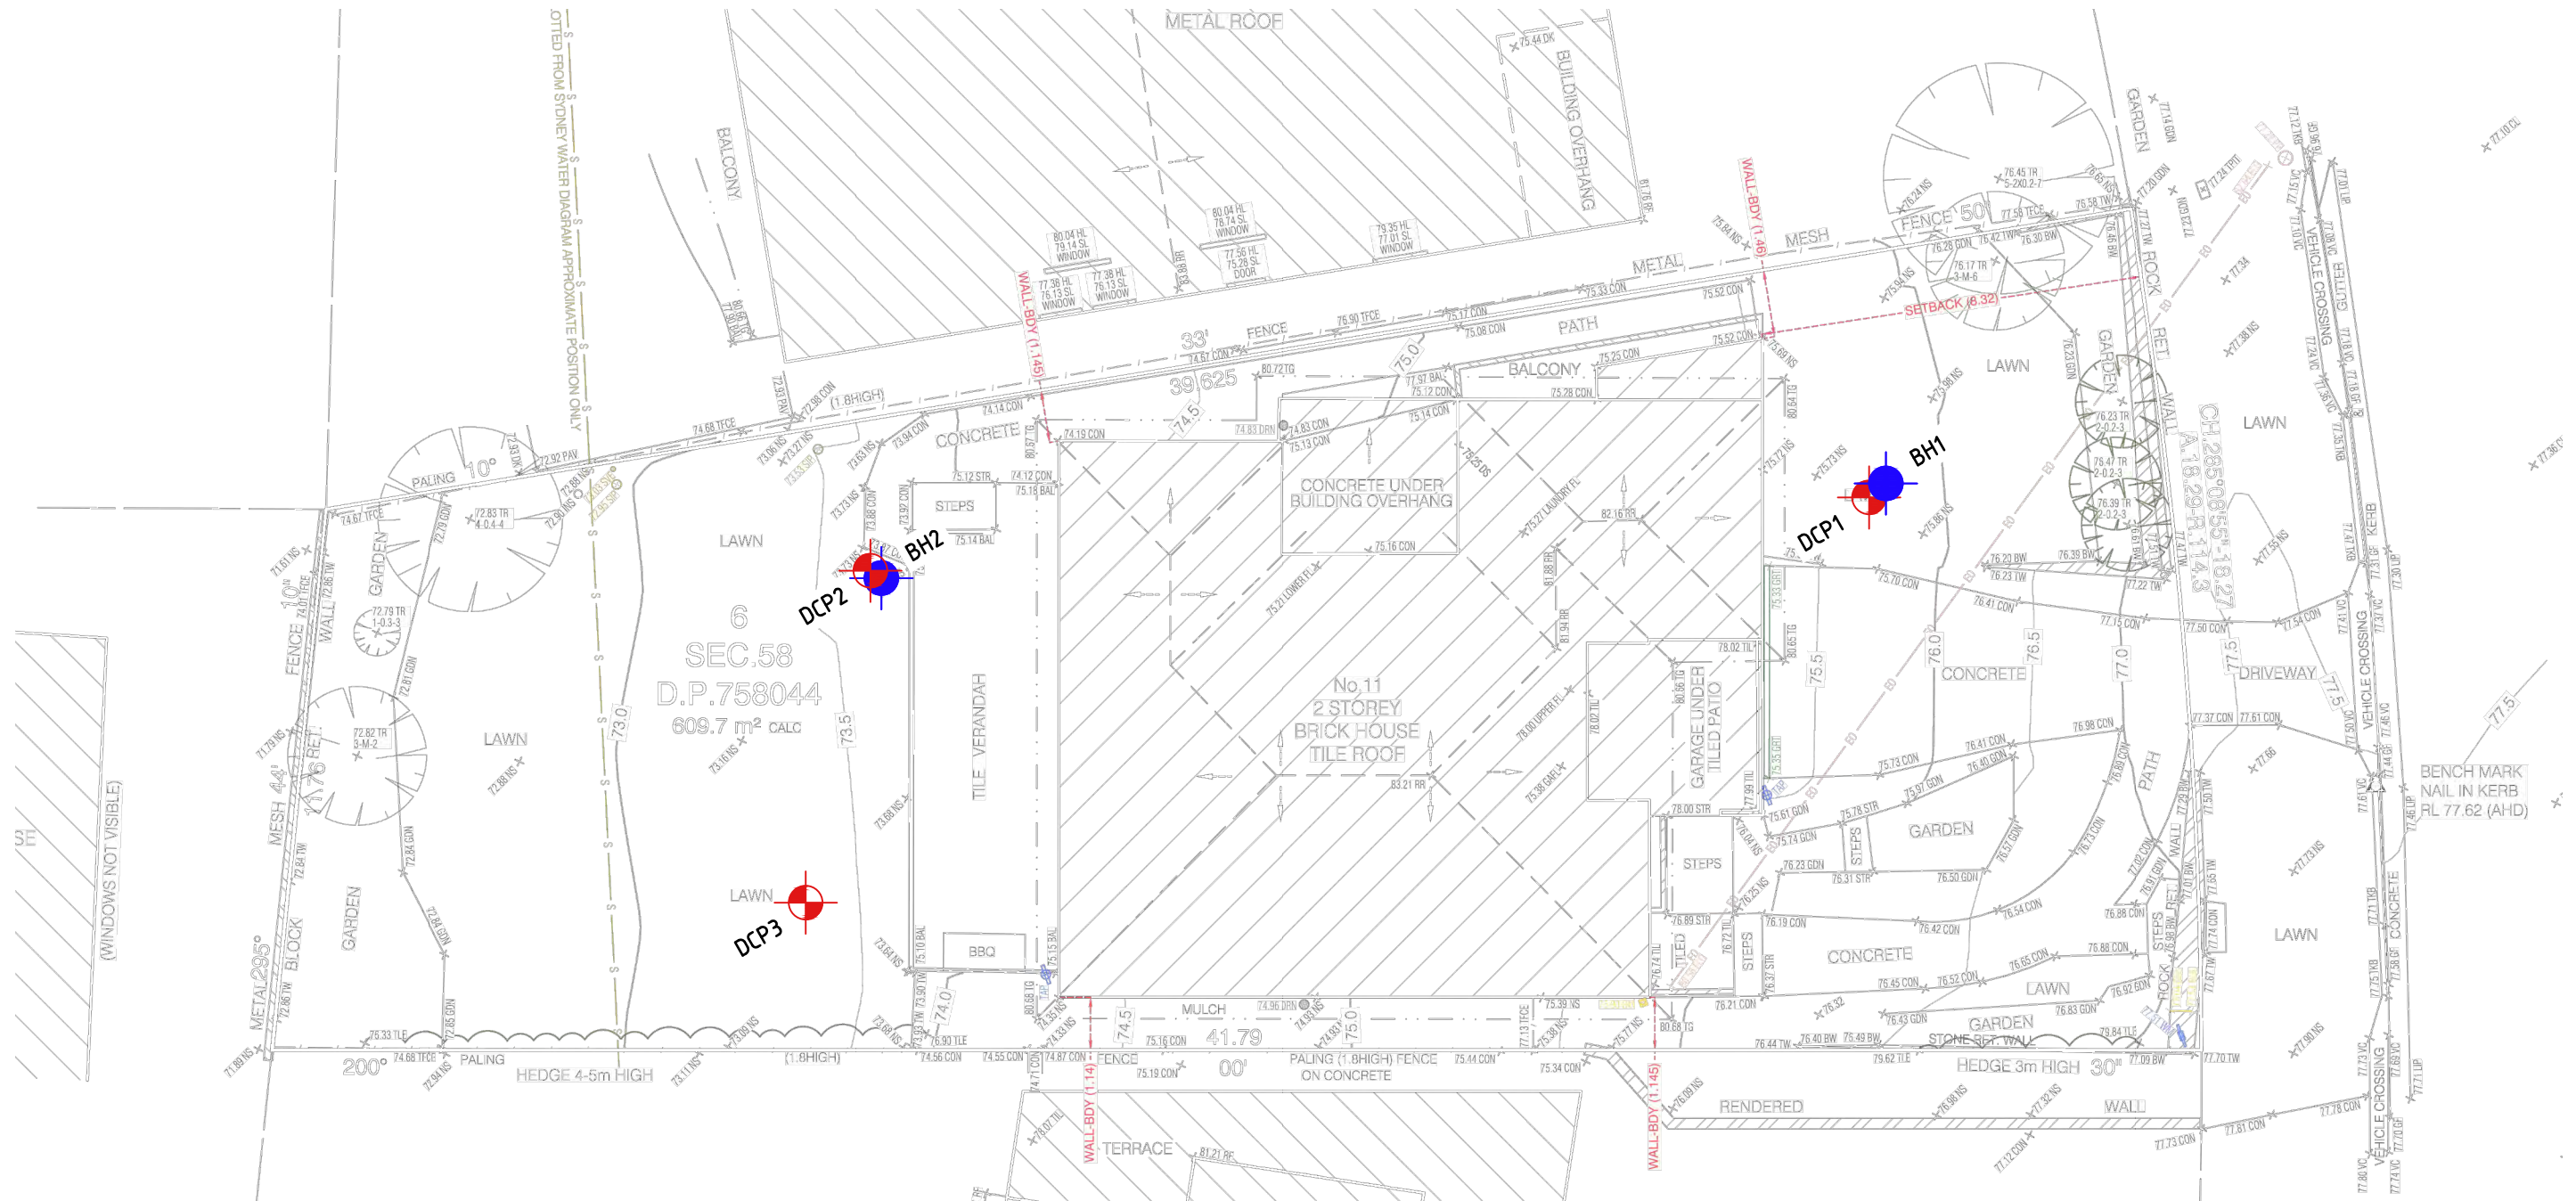
SITE PLAN/GROUND TEST LOCATIONS
SCALE NTS

Test	Summary
DCP 1	Refusal @ 1.1m Bouncing on bedrock. Brown clayey sand on very moist to wet tip.
DCP 2	Refusal @ 1.7m Bouncing on bedrock. Grey sand on wet tip.
DCP 3	Refusal @ 1.3m Bouncing on bedrock. Grey sand on wet tip.

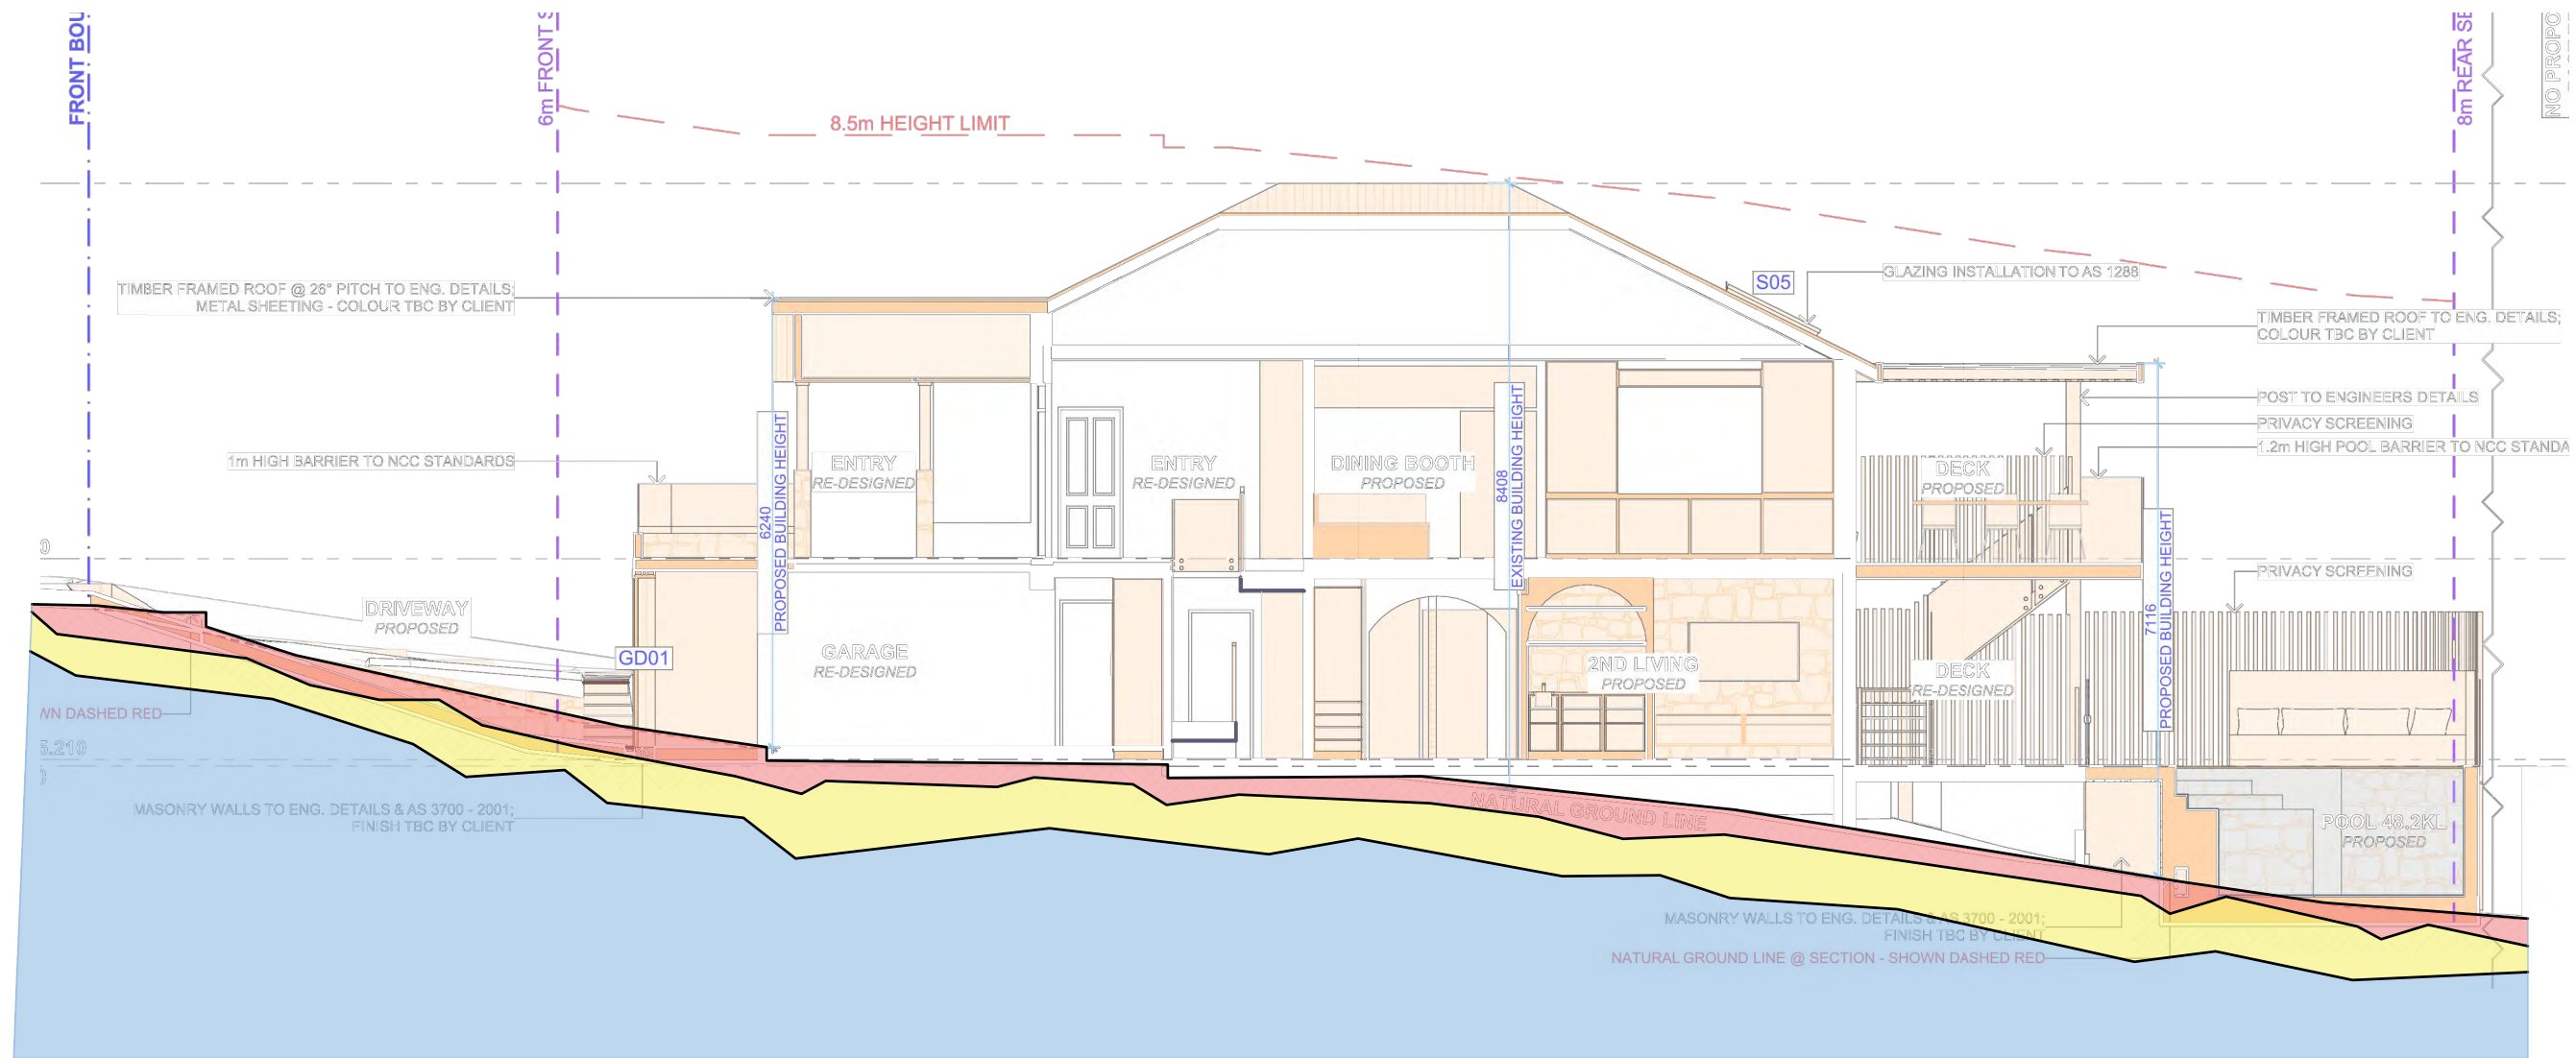
Unit	Material	Comments
1	Topsoil / Fill	Sandy topsoil and fill material. Unit 1 is inferred to be uncontrolled and poorly compacted.
2	Sand	Fine to medium grained Sand. Very loose to medium dense in consistency.
3	Sandstone	Medium strength or greater sandstone bedrock (Class III+*) expected to be found below the weathered crust (Class IV-V*).

INTERPRETED SUBSURFACE SECTION ONLY.
ACTUAL GROUND CONDITIONS MAY VARY.

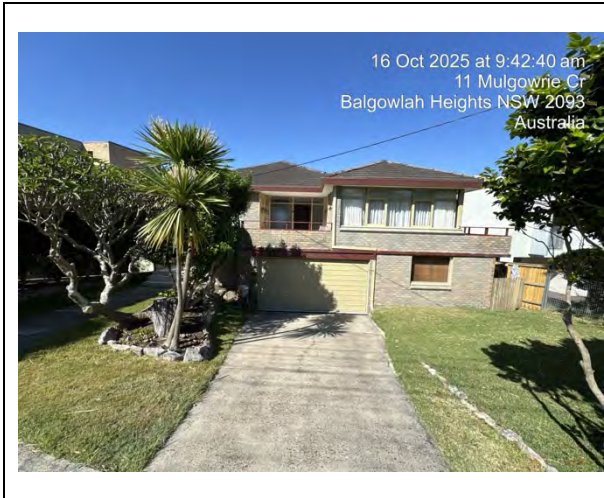
Photo 1: Site frontage, looking south-west.

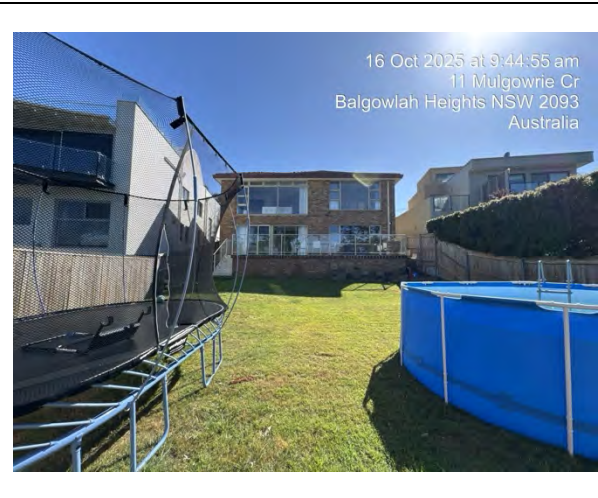
Photo 2: Site Backyard, looking north-east.

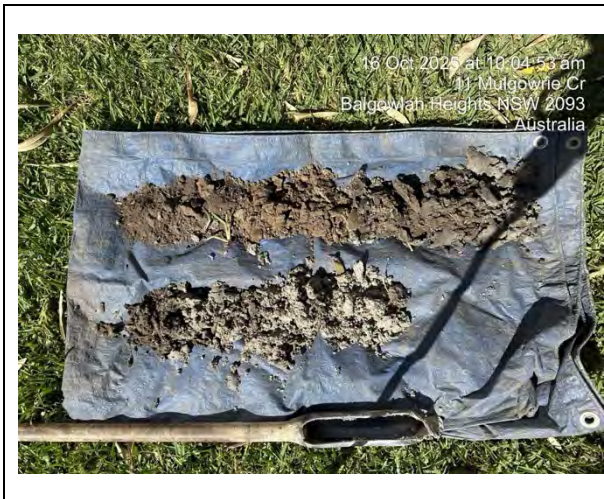
Photo 3: Subsurface soil profile of BH1.

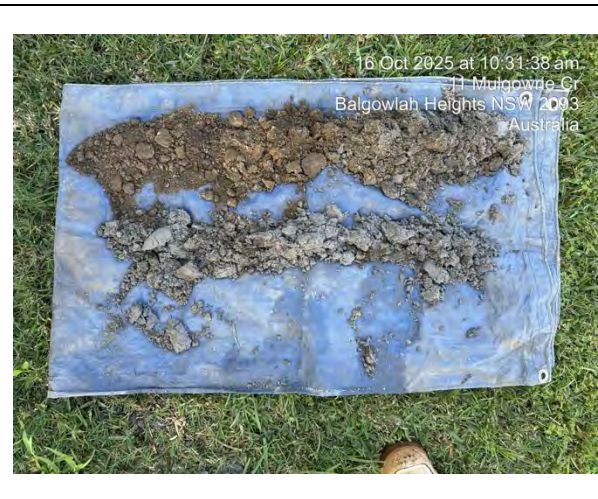
Photo 4: Subsurface soil profile of BH2.
