Project 222043.00
16 January 2025
R.004.Rev0
DEM:kn

Geotechnical Assessment

Proposed Inclinor – 212 Hudson Parade, Clareville

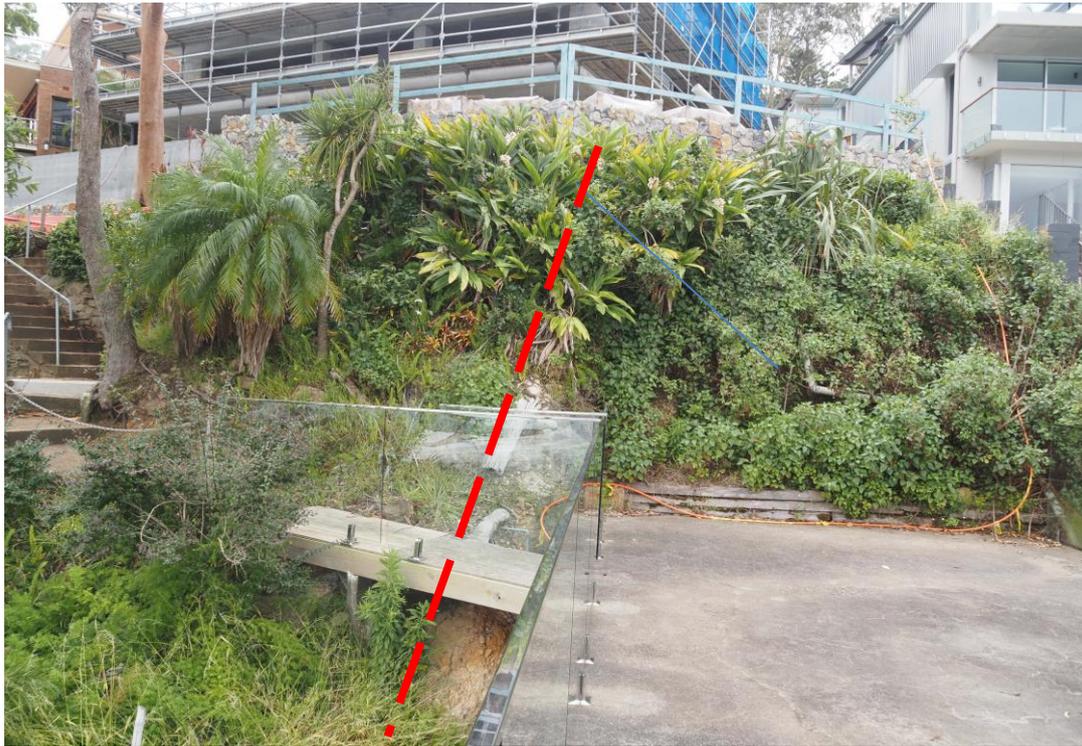
Very low strength, highly weathered siltstone is exposed through the vegetation cover beside the boatshed on the proposed inclinor alignment. Layers of medium to high strength sandstone are visible elsewhere on the slope and are also expected to lie below the inclinor alignment at relatively shallow depth.

Photo 1: Approximate alignment of proposed inclinometer (viewed from boatshed roof)

Note extremely weathered silstone bedrock outcrop

It is recommended that all foundations for the inclinator are taken down to and also be socketed into the in-situ bedrock of at least low strength on the slope.

It is expected that any piers located within the highly weathered siltstone bedrock will need to be extended to socket within stronger underlying bedrock. Any highly weathered or fractured bedrock layers exposed on the slope will require support by a retaining structure or shotcrete protection to prevent future erosion.

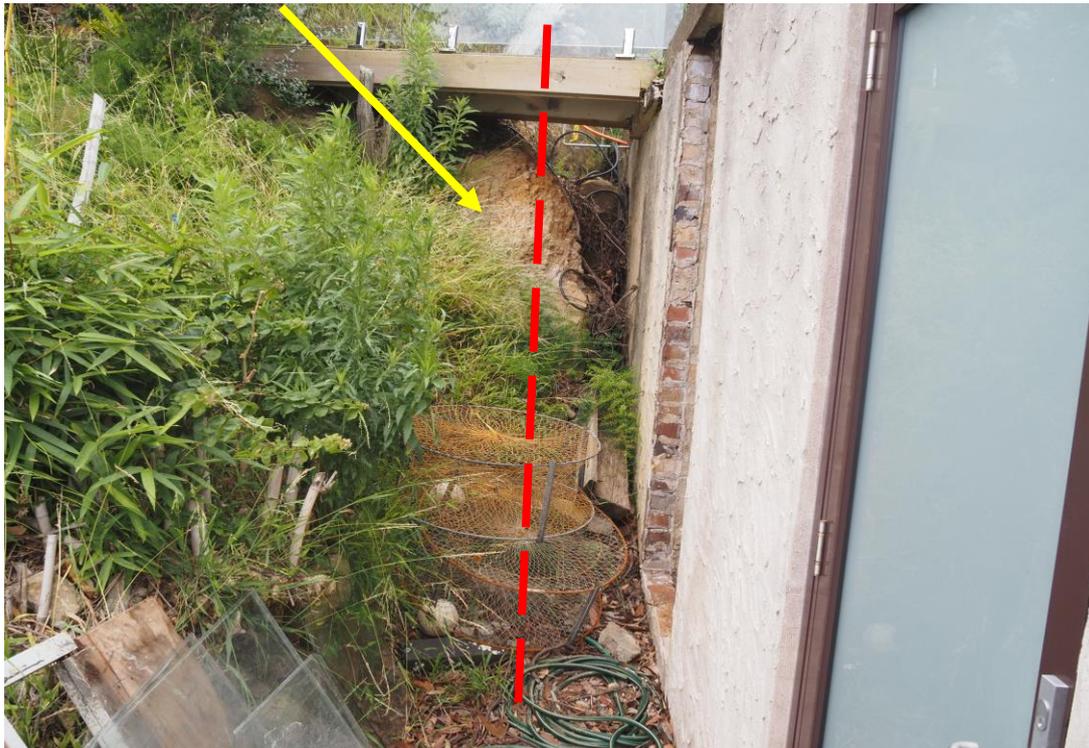
Photo 2: Approximate alignment of proposed inclinometer (viewed from western side of boatshed)
