Geotechnical Assessment

Project: New Dwelling
139-141 Riverview Road, Avalon Beach NSW

Prepared for:
MMIG Developments Pty Ltd

Ref: AG 24222
10 July 2025

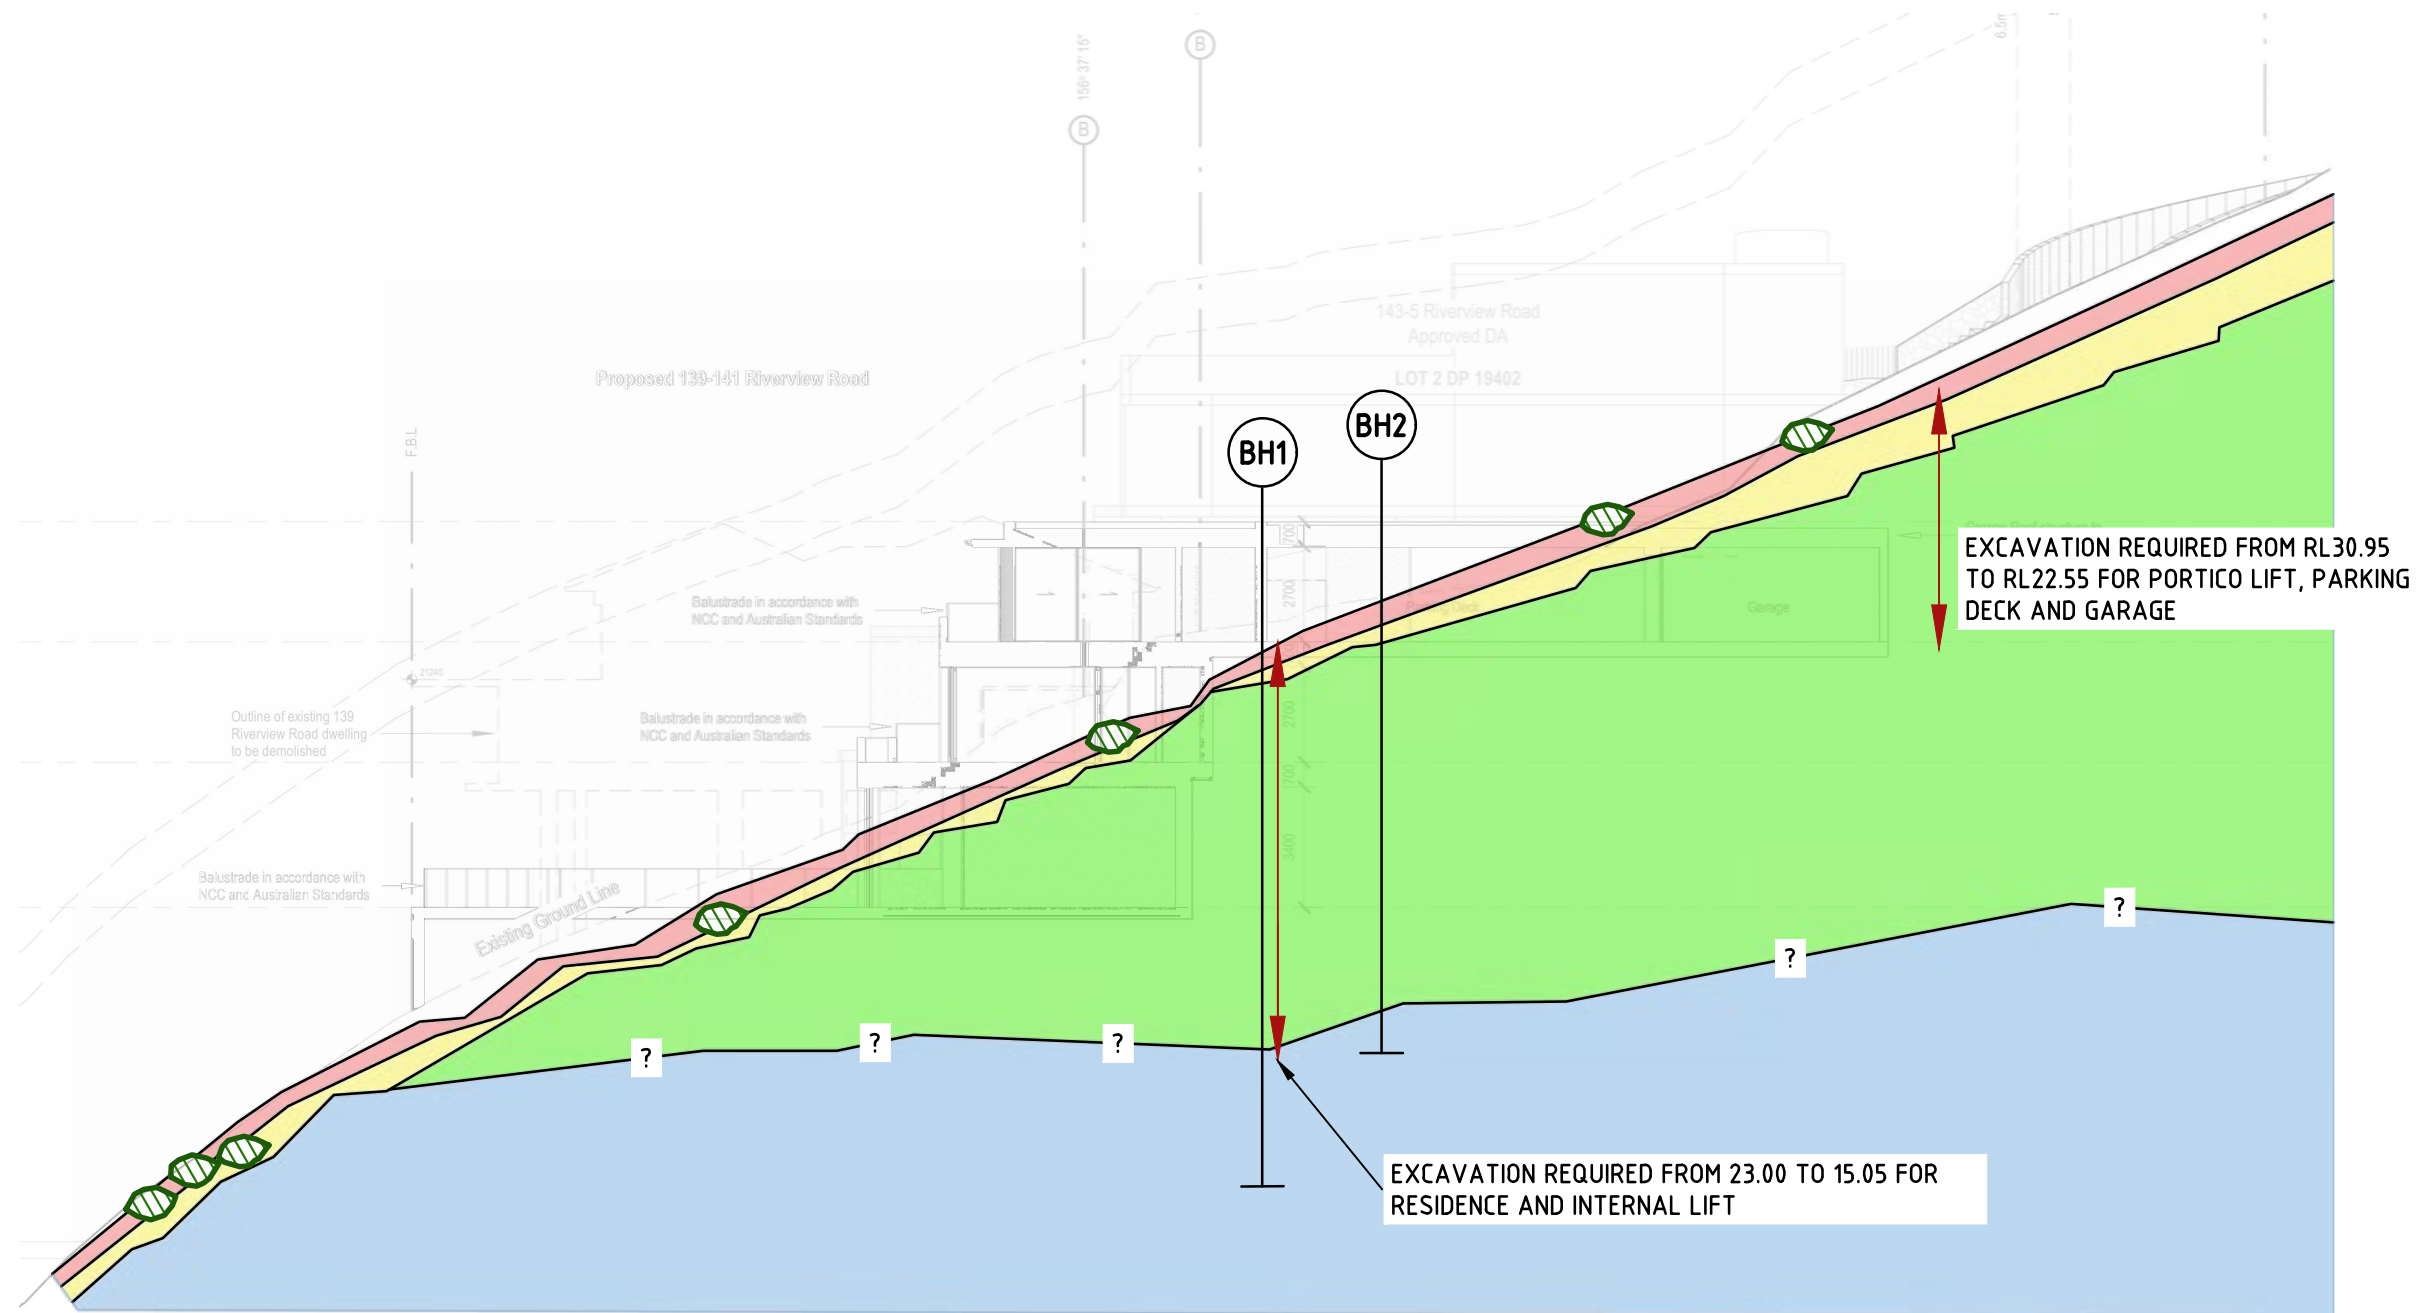
INFERRED GEOLOGICAL SECTION
SCALE NTS

INTERPRETED SUBSURFACE SECTION ONLY.
ACTUAL GROUND CONDITIONS MAY VARY.

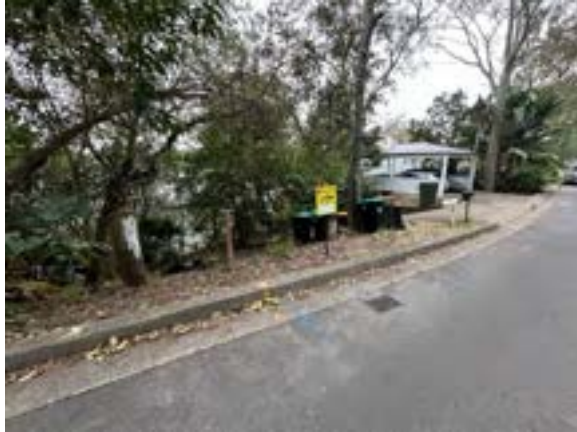
Photo 1: Site frontage at Riverview Road

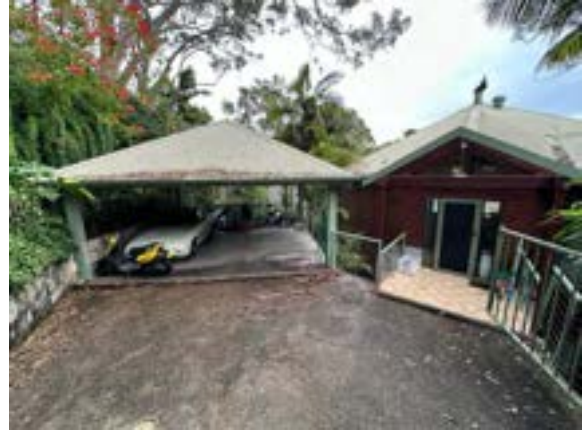
Photo 2: Residence frontage and carport

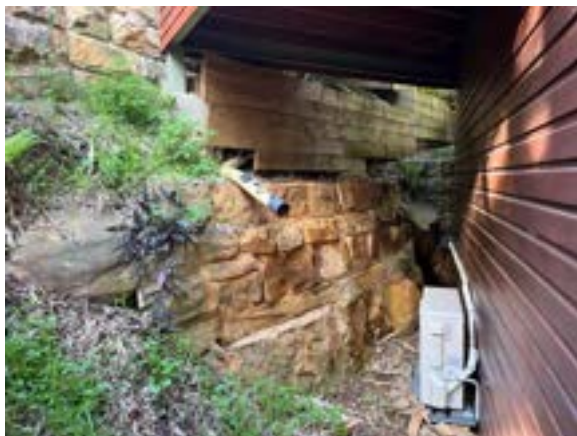
Photo 3: Wall structures at residence frontage and outcropping sandstone bedrock

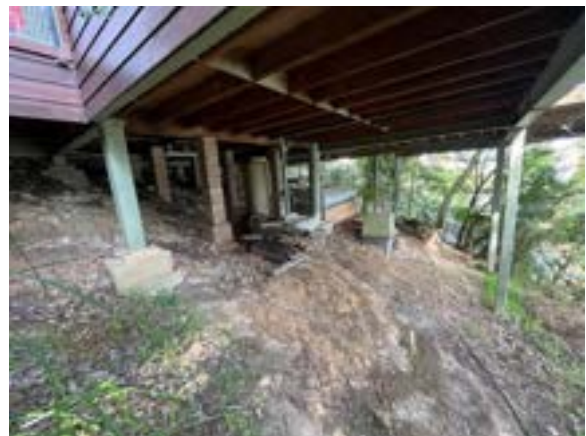
Photo 4: Slope under residence rear

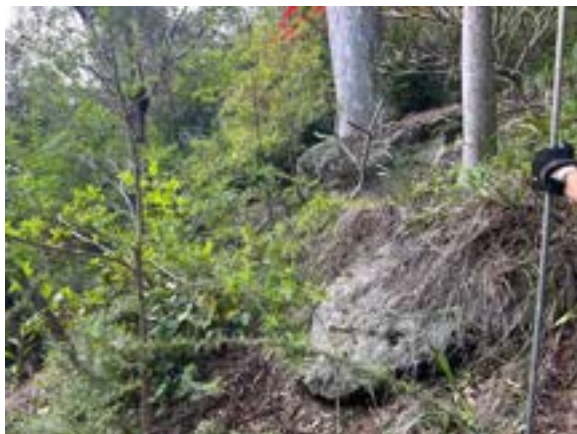
- **Hazard One:** The potential mobilisation of detached sandstone boulders on site.
- **Hazard Two:** Landslip / failure of fill / soils from proposed excavation works
- **Hazard Three:** Rock topple / rock slide from defects, joints or weak rock from proposed excavation works.

Photo 3: Example of sandstone boulders on the slope, to the west of the existing residence

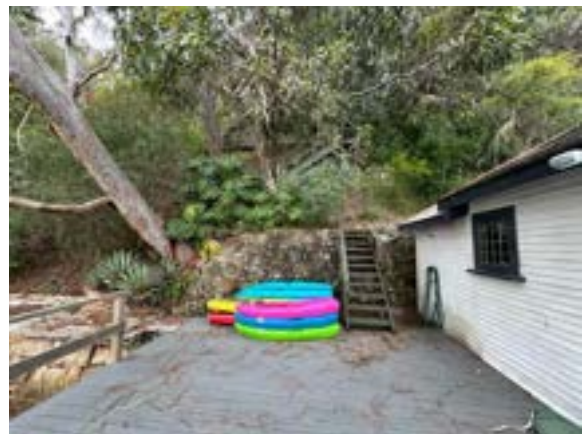
Photo 4: Looking east at the subject site from the jetty and boatshed at the western boundary

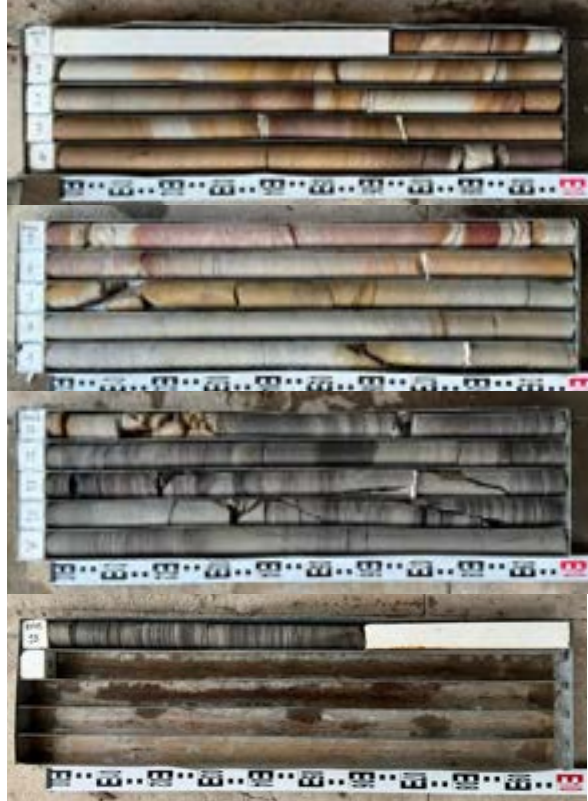
Photo 1: Bore Hole 1 core sample

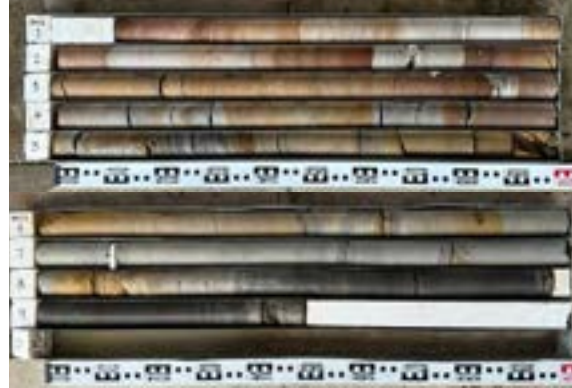
Photo 2: Bore Hole 2 core sample
