ARBORICULTURAL ASSESSMENT

DEVELOPMENT IMPACT REPORT

1112 – 1118 BARRENJOEY ROAD
PALM BEACH NSW

JUNE 2009

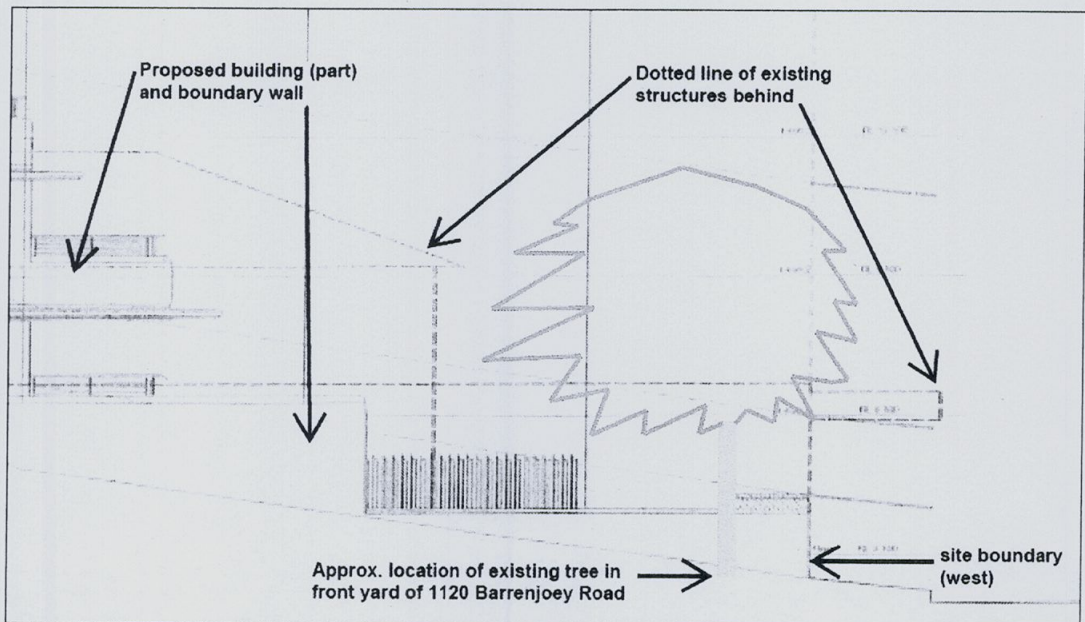
- 3.3.6 The proposed frontage of the development will not impinge upon the canopy of the tree (see Figure 1, page 7), although damage to the crown of the tree could occur during demolition.

Figure 1 Mark up of north elevation showing the setback from the proposed building to the street frontage. The development will be well clear of the crown of Tree 7.

3.3.7 As long as this tree is appropriately protected during demolition of the existing general store, and soil disturbance beyond the site boundary is avoided during excavation and construction, the tree should not experience any impact from the proposal.

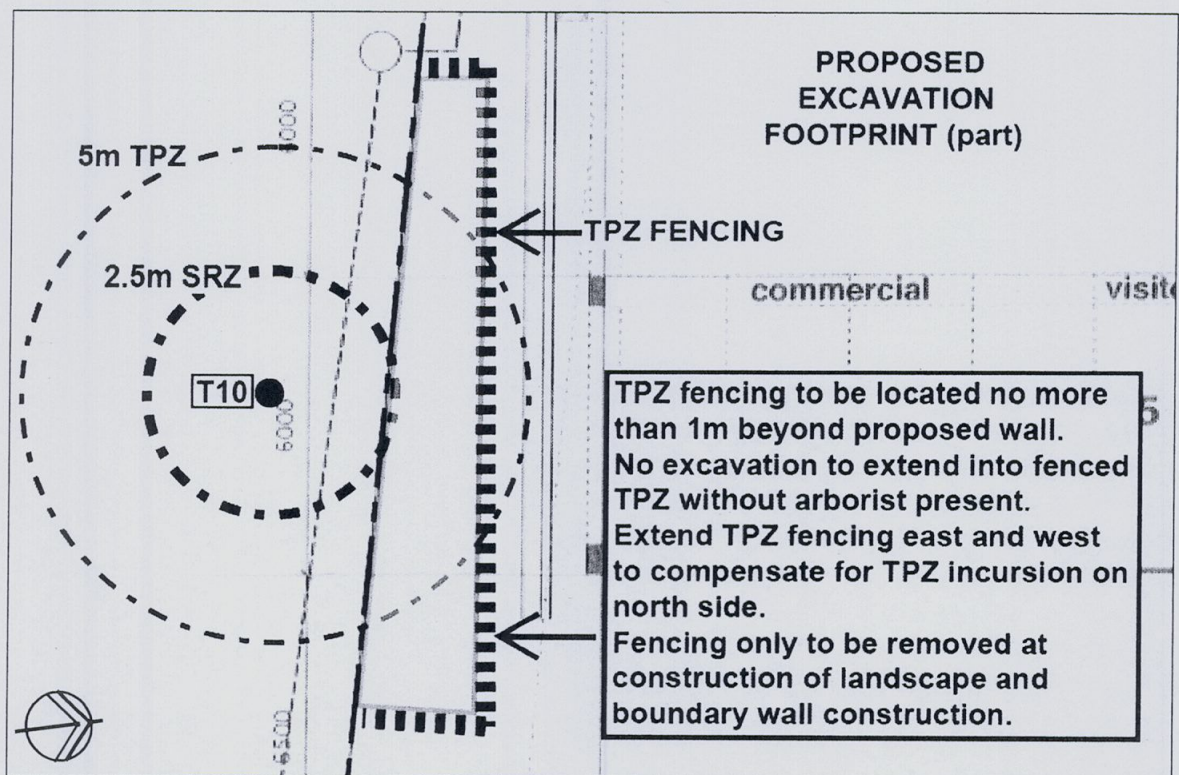
Figure 2 Protection fencing is required as shown during excavation of the development footprint. The project arboriculturist is to supervise works for landscape and boundary walls within the TPZ. Fencing may only be removed or relocated at the discretion of the arboriculturist.

- Rigid, immovable fencing is to be placed as shown in Figure 2, page 11.
- Fencing is to be in accordance with section 5.3 of this report.
- Sediment control devices are to be installed upslope of the tree to avoid any movement of loose material over the root zone.
- Fencing and other protection devices are to be inspected and certified as satisfactory by a qualified arboriculturist, prior to works commencing.

- An AQF5 arboriculturist is to supervise works within 5 metres of this tree, including construction of boundary walls.

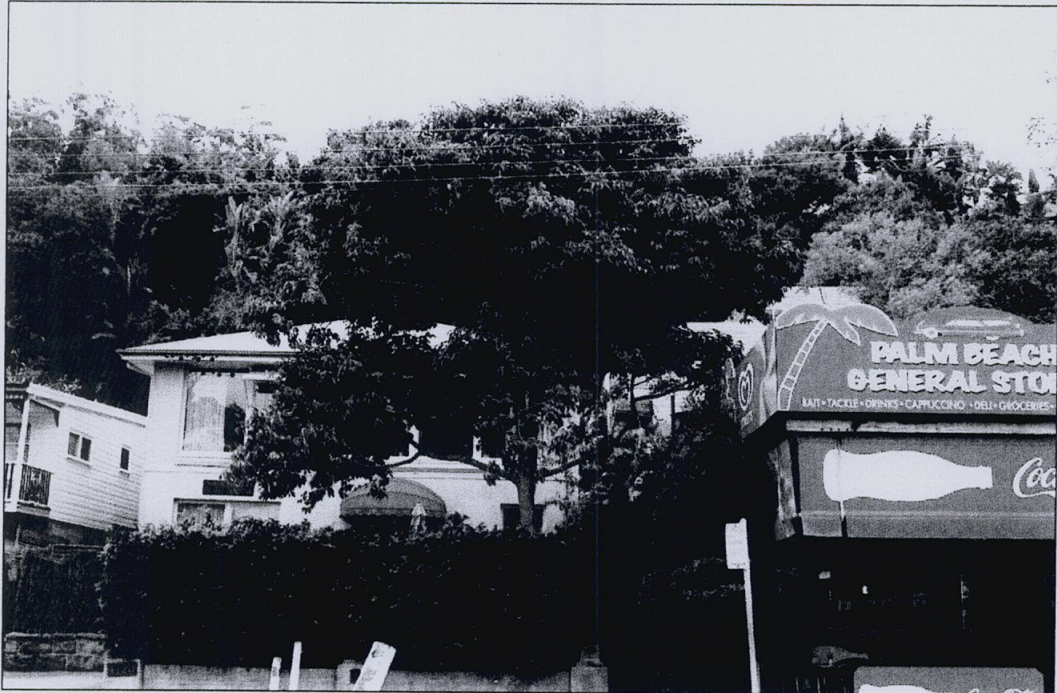
Plate 1 (above)

This is a semi-mature *Melicope elleryana* (Pink-flowered Doughwood) located in the adjoining property to the north. The tree is approximately 2 – 2.5 metres from the north boundary wall of the existing general store at 1118 Barrenjoey Road.

- 3.3.3 The tree has an estimated radial *Structural Root Zone* (SRZ) of 2.3 metres, indicating a possibility that structural roots may meet the wall of the existing general store. If there are any woody roots at this location they are more than likely to run parallel to the building as there would be little opportunity for woody roots to grow beyond this wall.

Tree 7, located in the front yard of 1120 Barrenjoey Road. The crown of the tree slightly overhangs the existing general store on the site.

- Prior to demolition, an Australian Qualification Framework Level 5 (AQF5) arboriculturist is to meet with the demolition contractor and arrange appropriate protection measures to avoid damage to the overhanging branches of the tree.
- Demolition of footings within 5 metres of the tree is to be supervised by an AQF5 arboriculturist.
- Excavation within 5 metres of the tree is to be supervised by an AQF5 arboriculturist.
- The face of the excavation within 5 metres of the tree is to be lightly watered and covered with thick fabric, such as layers of hessian or jute, to minimise soil moisture losses from the tree's root zone.
- Plastic is NOT to be used to cover the face of excavation as it can heat up and burn exposed tree roots.

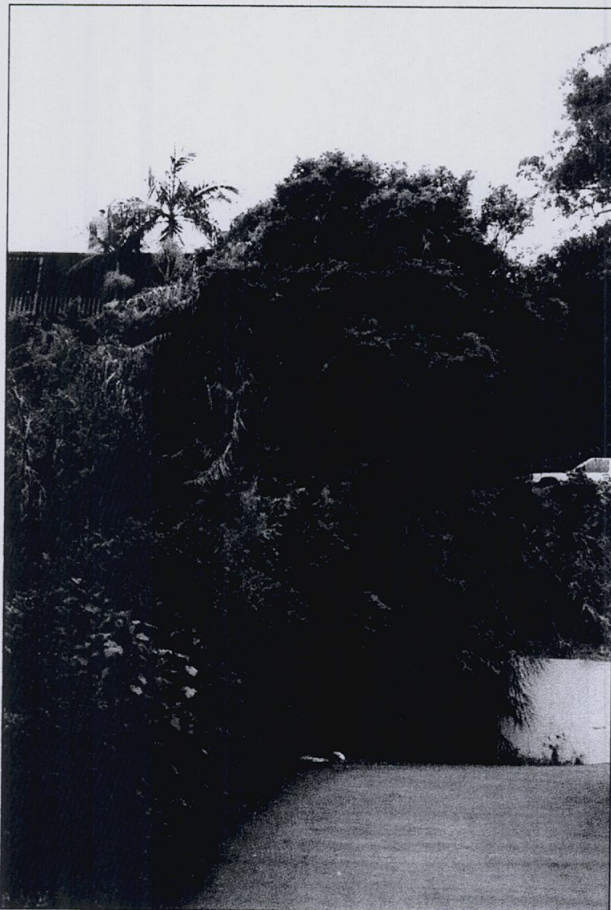
Plate 2 (left)

This is a semi-mature *Glochidion ferdinandi* (Cheese Tree) growing on a slope within the adjoining property to the south of the site. The density of undergrowth around the tree precludes any visual assessment of the stability of the trees supporting root system, particularly as I could not get close to the tree.

3.3.9 The proposed excavation is at an acceptable distance from the tree, and the south external wall would impact on less than 6% of the tree's 5 metre *Tree Protection Zone* (TPZ). However, the upper landscape terraces in the south east corner of the site include boundary walls which, at construction, may encounter woody anchor roots at the edge of the tree's 2.5 metre SRZ.

- 3.3.10 The changes in landscape levels may affect around 24% of the tree's estimated TPZ. As there is dense undergrowth currently occupying much of the southeast portion of the site, competition for soil resources may be discouraging roots of this tree from growing into the site. There is a relatively unrestricted area within the adjoining site, in which the tree grows, where soil resources are available for continued root growth, and there appears to be little, if any impedance to water movement from upslope and southeast of the tree.
- 3.3.11 Based on our current assessment of T10 an appropriate TPZ has been developed as detailed in 5.2.2 of this report. This TPZ may however need to be amended when the site vegetation is cleared and a closer inspection of the tree can be undertaken.

Tree 10, located in 1110 Barrenjoey Road, and close to the site's south boundary.

5.1.2 Removal of vegetation within 5 metres of Tree 10 is to undertaken by hand.

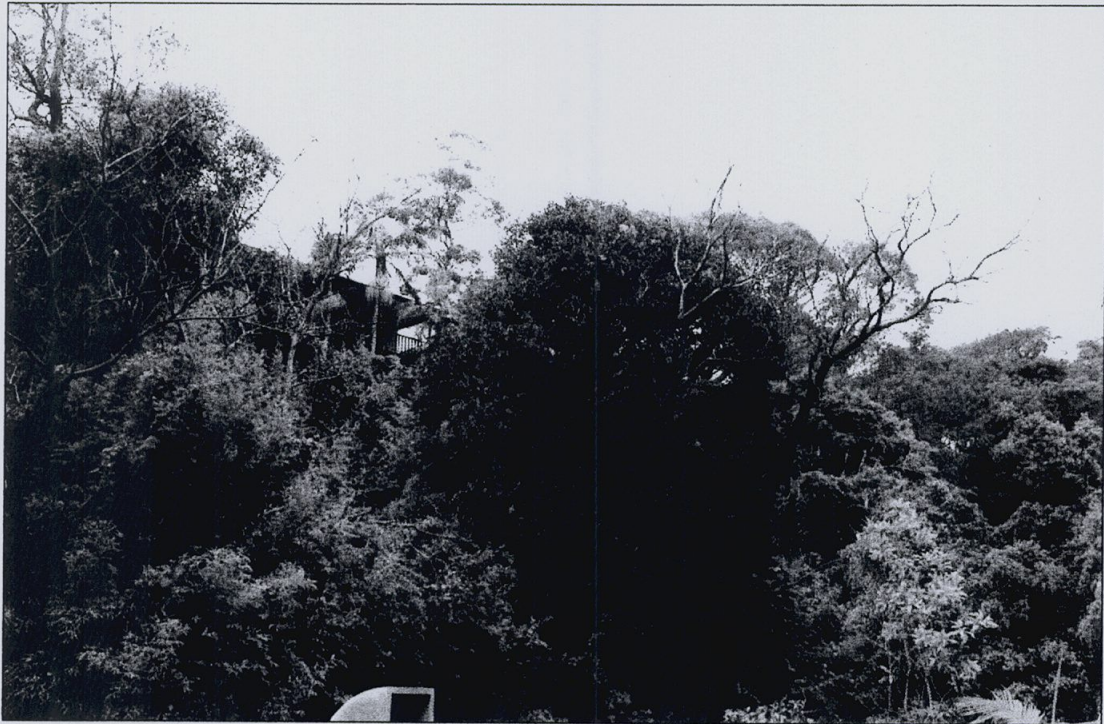
Plate 3 Looking south/southeast from roofline of 1118 Barrenjoey Road. Dense, weedy trees and undergrowth occupy the southeast part of the site. Note native trees have been killed by competing vegetation.

5.1.1 Remove existing trees and weeds from the site.

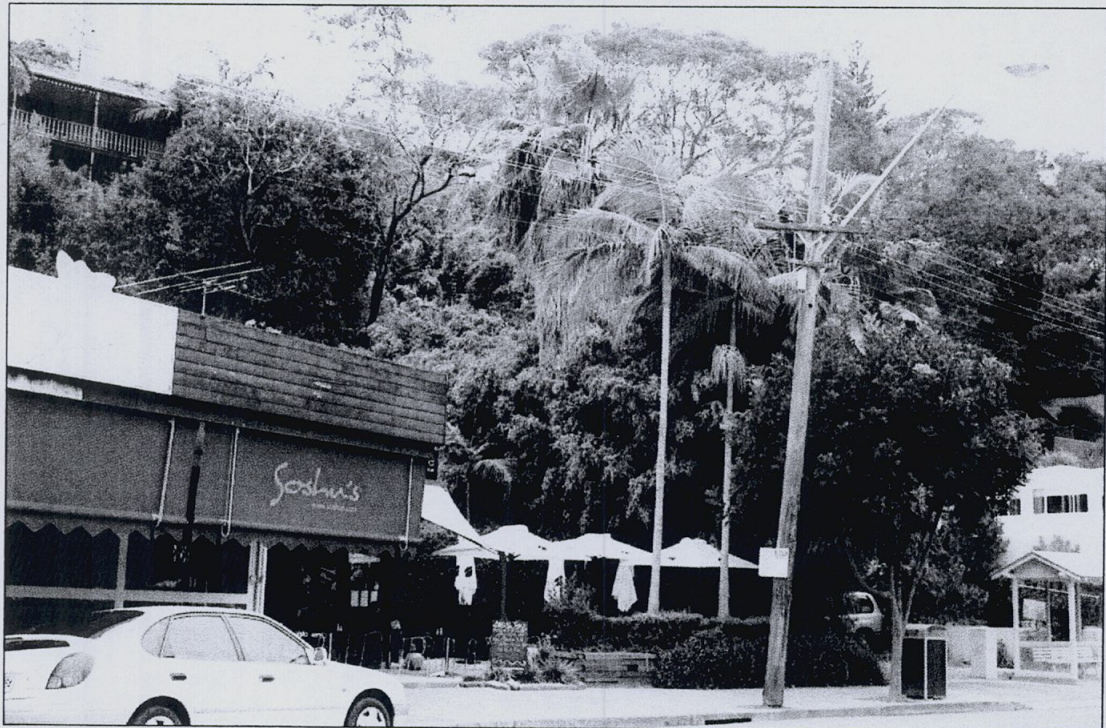
Plate 4 Looking southeast from Barrenjoey Road. Introduced palms and a Weeping Fig divide the café seating area from the car park (just visible behind vegetation).
