948 Barrenjoey Road, Palm Beach

Comments on Updates to Plans

GEOTECHNICAL INVESTIGATION:

Minor Works at **948 Barrenjoey Road, Palm Beach**

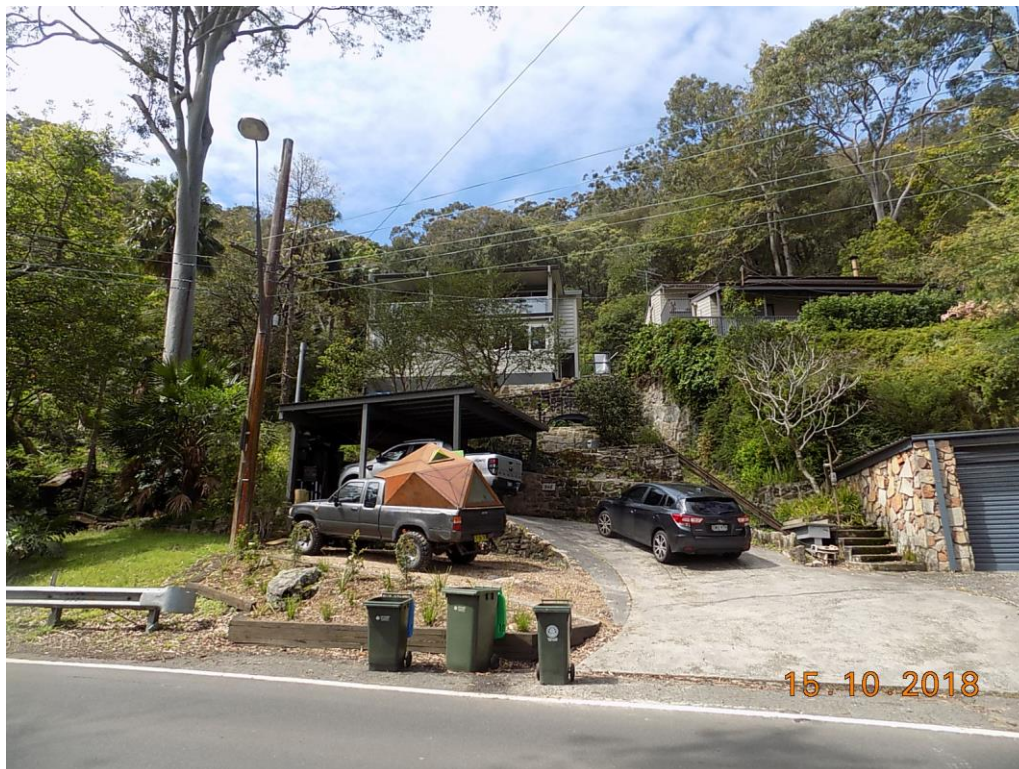
Photo 1

- 2.3** At the road frontage a concrete driveway runs to a car parking area and carport on the downhill side of the property (Photo 1). A cut has been made into the slope for the parking area (Photo 2). The cut is supported by a stable dimensioned sandstone retaining wall. The slope between the carport and the house is terraced with a series of mortared dimensioned sandstone block retaining walls reaching a maximum height of ~1.8m (Photo 3). To maintain ongoing stability for these types of walls they require occasional maintenance which may involve re-mortaring or repointing. There was evidence of such maintenance in the form of new mortar on some areas of the walls.

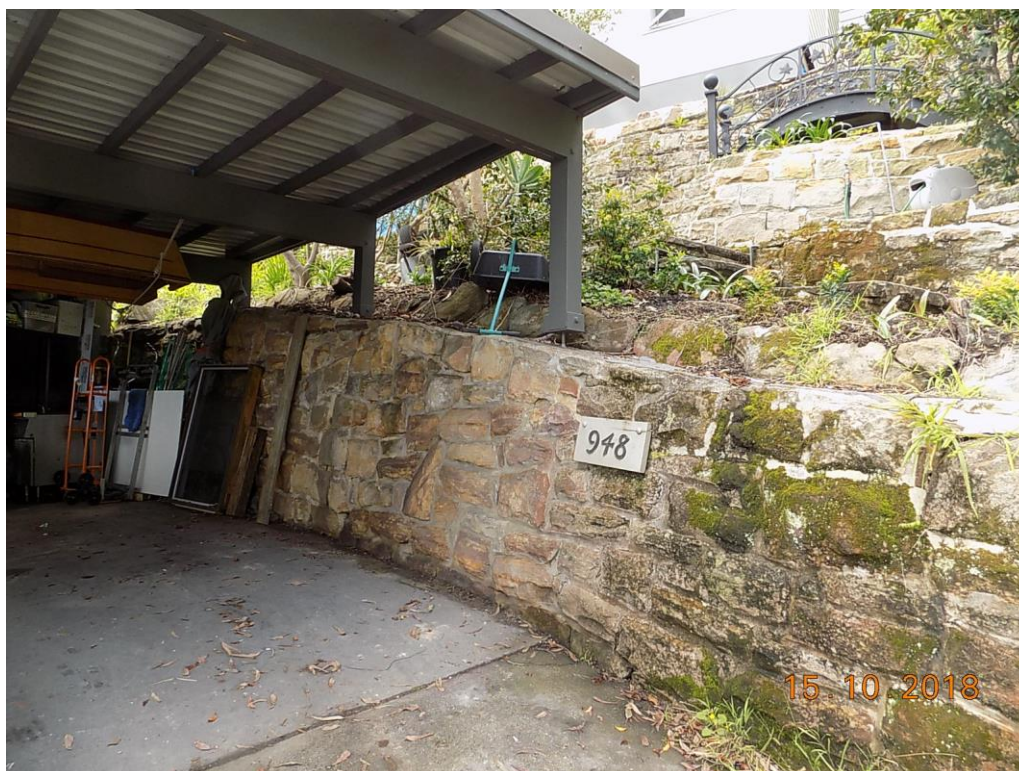
Photo 2

The property is extensively terraced in mortared stone walls (Photos 2, 3, 4, 8 & 9). These types of walls require occasional maintenance to ensure ongoing stability in the future. As such, it is recommended that the owners inspect the walls on an annual basis or after extreme rainfall events, whichever occurs first. A photographic record of these inspections is to be kept. We can carry out these inspections upon request. Should cracking, bulging or tilting in the wall face be observed the wall is to be assessed for stability by a geotechnical consultant. The risk assessment in **Section 8** is conditional on these inspections being carried out.

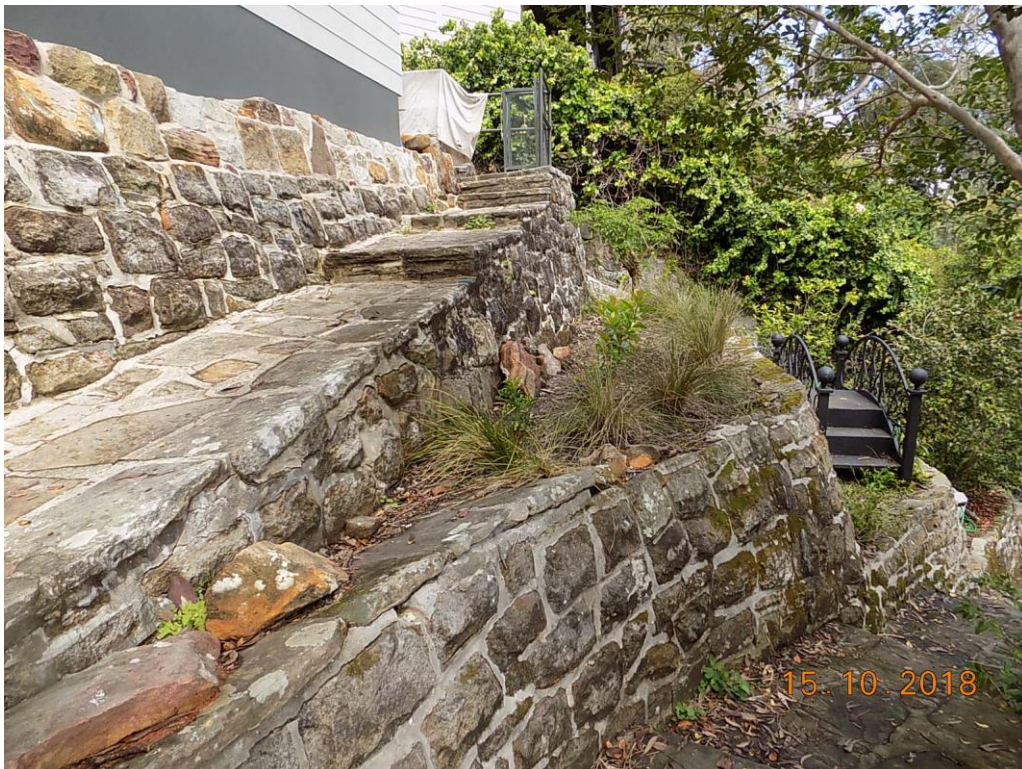
Photo 4

A ~3.0m cut has been made for an inclinometer on the S side of the property (Photo 4). It is supported by a continuation of mortared dimensioned sandstone retaining walls that terrace the slope front. The wall shows some cracking but is currently considered stable (Photo 14 & 15). See **Section 13** "Site Maintenance" for treatment of the cracking. Medium Strength Sandstone was observed outcropping in the lower portions of the wall at the S boundary and bedrock was also present in the creek bed that flows down the slope to the N of the property (Photo 5 & 6). The part two-storey rendered masonry and timber clad house is supported by rendered masonry walls and was undergoing renovations at the time of the inspection (Photo 7 & 8). No significant signs of movement or cracking was observed in the external supporting walls of the house. Two dimensioned sandstone block walls terrace the slope above the house (Photo 9 & 10). The lower wall reaches a maximum height of ~2.0m and levels the area for the lower ground floor. The upper wall reaches a maximum height of ~1.0m and levels an area for a deck attached to the ground floor. Both walls are slightly angled back into the slope and are considered stable. The slope above the house gradually increases to steep angles to the uphill boundary. It is densely vegetated (Photo 11). Large dislodged sandstone joint blocks that have historically fallen from the slope above were observed outcropping randomly on the slope (Photo 12 & 13). Most are obscured by the vegetation but those visible are partially embedded in the slope so have been in place for a long time and are considered stable.

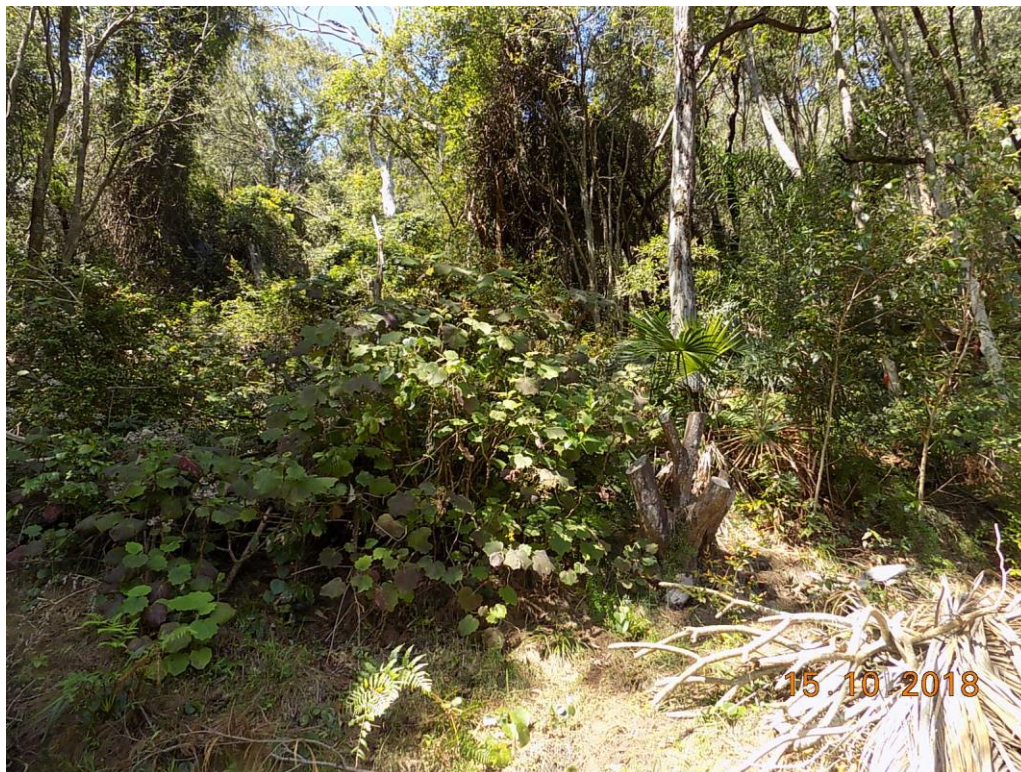
Photo 11

HAZARDS	Hazard One
TYPE	The large dislodged sandstone joint blocks above and on the property falling onto the house. (Photo 11 & 12).
LIKELIHOOD	'Rare' (10^{-5})
CONSEQUENCES TO PROPERTY	'Medium' (20%)
RISK TO PROPERTY	'Low' (2×10^{-5})
RISK TO LIFE	9.9×10^{-7} /annum
COMMENTS	This level of risk is 'ACCEPTABLE'.

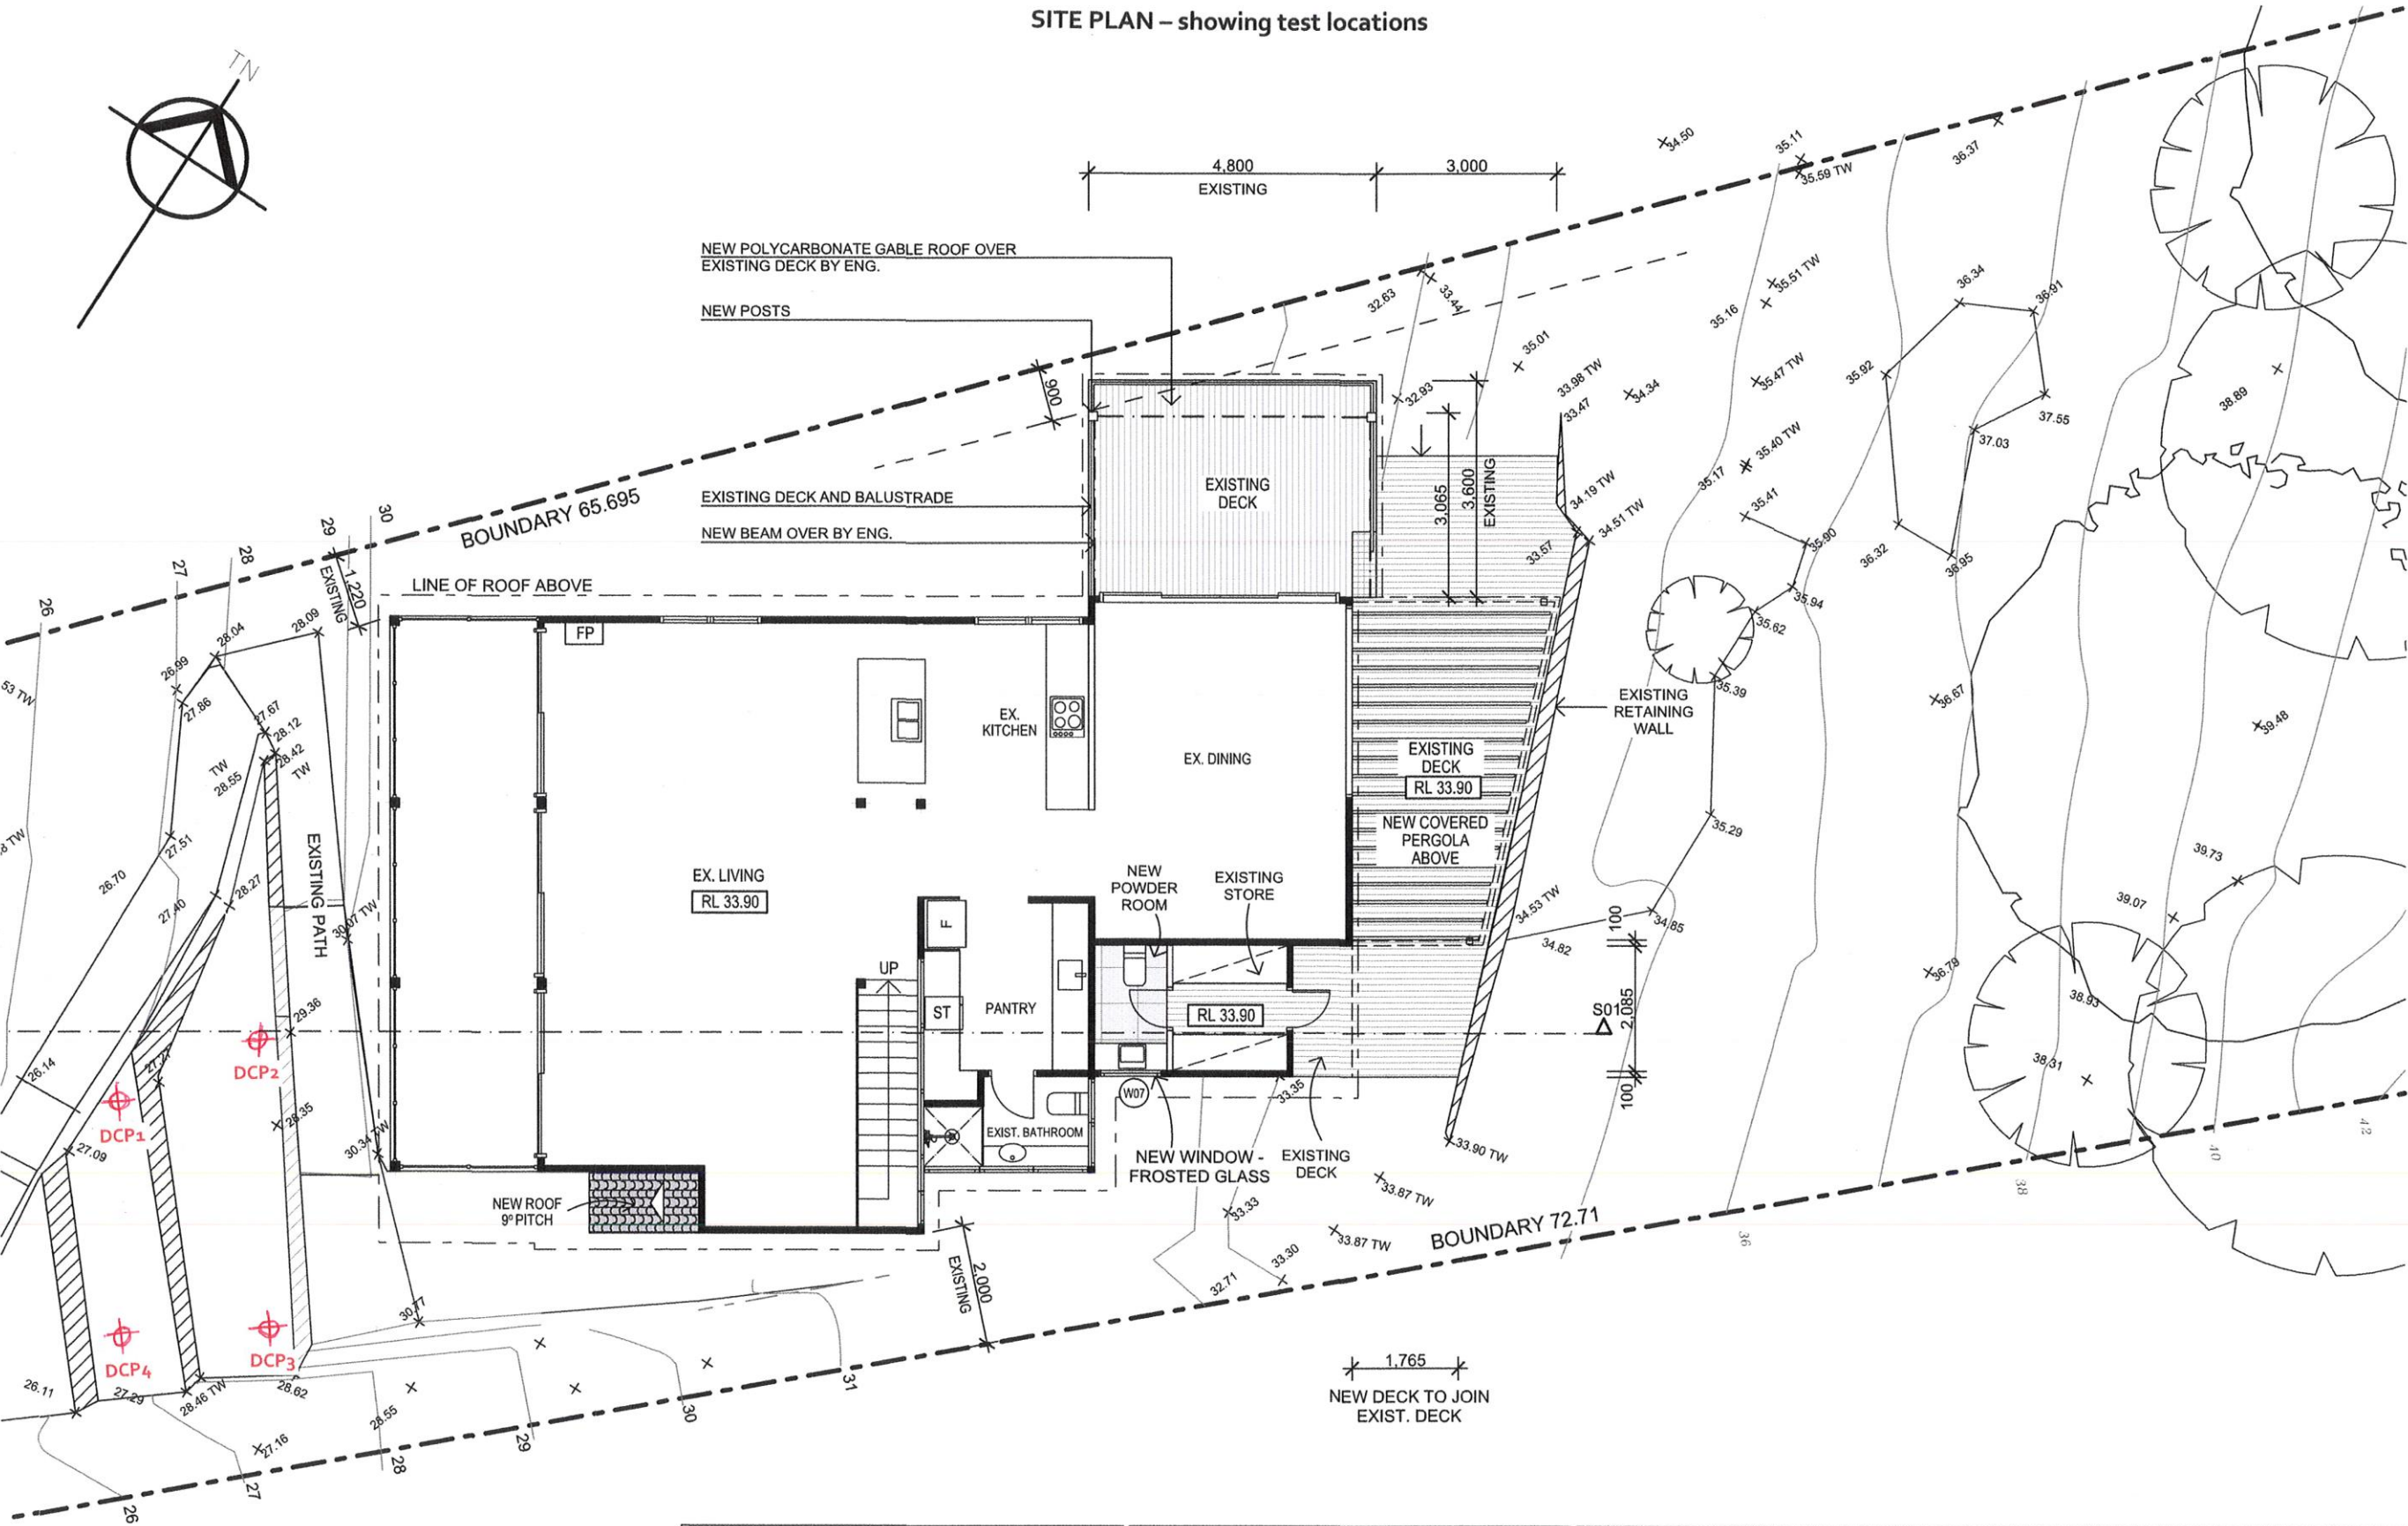
SITE PLAN – showing test locations

Four Dynamic Cone Penetrometer (DCP) tests were put down to determine the relative density of the overlying soil and the depth to weathered rock. The locations of the tests are shown on the site plan. It should be noted that a level of caution should be applied when interpreting DCP test results. The test will not pass through hard buried objects so in some instances it can be difficult to determine whether refusal has occurred on an obstruction in the profile or on the natural rock surface. This is not expected to be an issue for the testing on this site and the results are as follows:
