**ON  
GEOTECHNICAL ASSESSMENT**  
(In Accordance with Geotechnical Risk Management Policy for  
Northern Beaches Council)

**FOR  
PROPOSED ALTERATIONS AND ADDITIONS**

**AT  
7 PAVILION STREET, QUEENSCLIFF, NSW**

**17 April 2019  
Ref: 30038SYrpt**

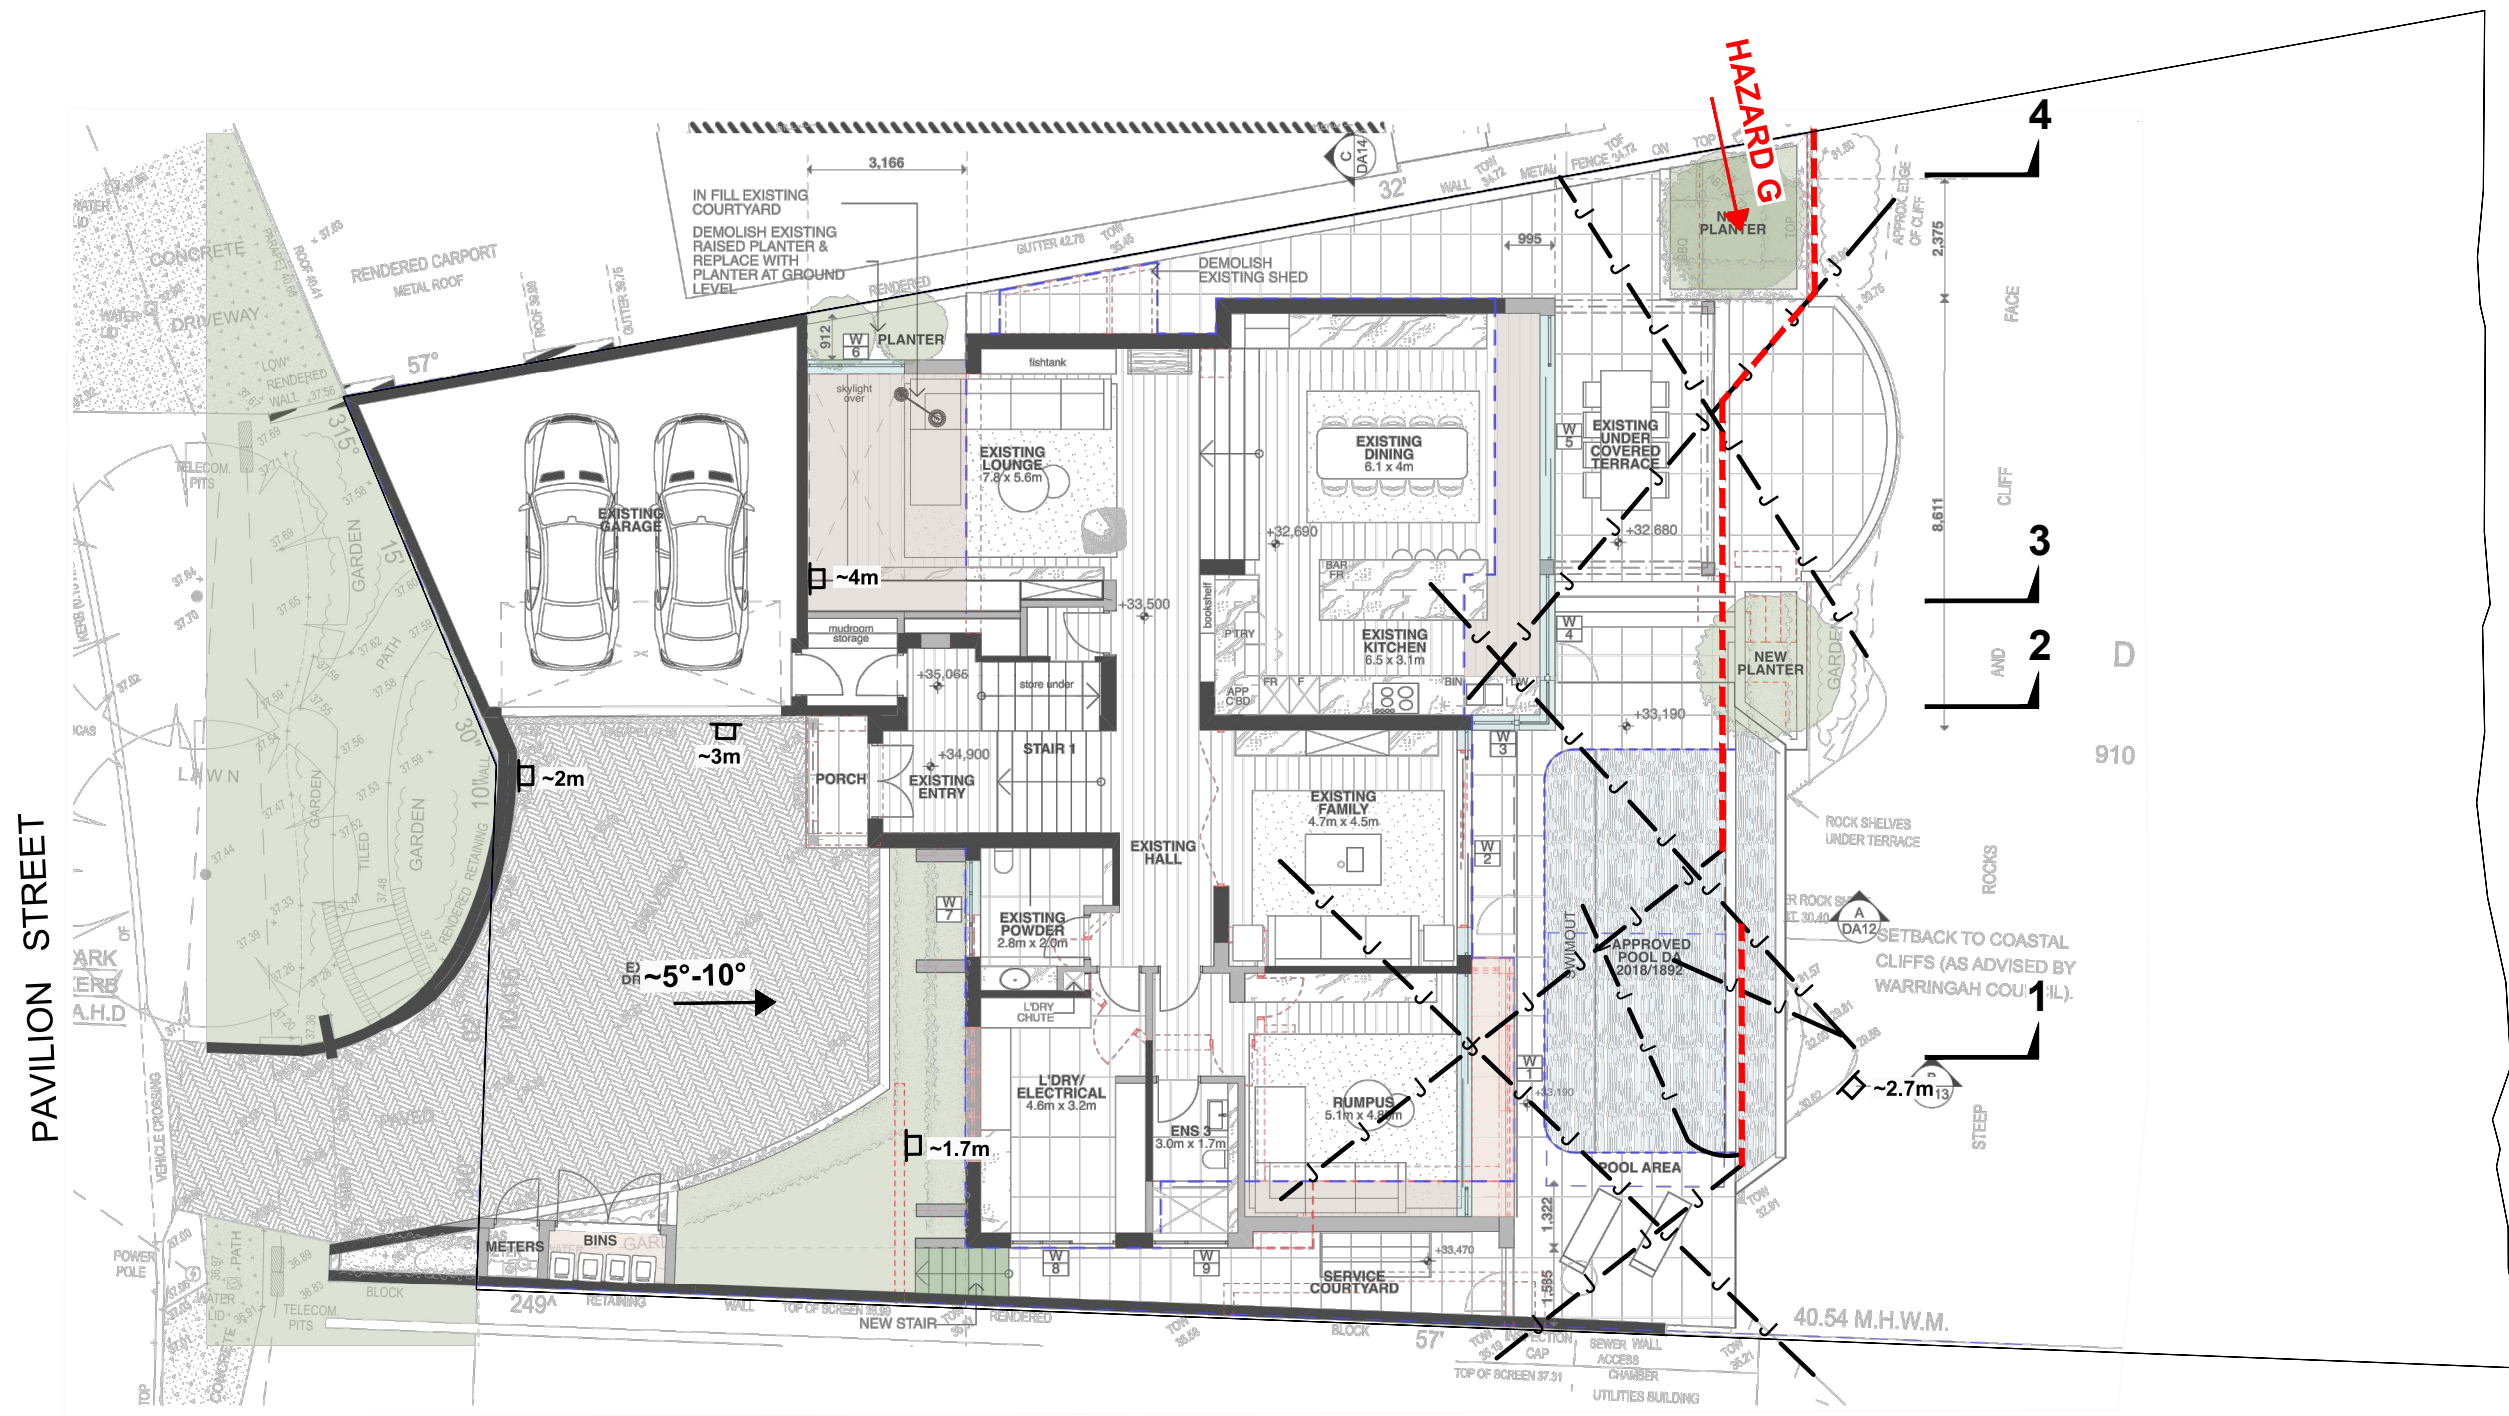
**FIGURE 1: GEOLOGICAL SITE PLAN**

During our earlier investigation a plan view of the cliffline geometry was developed. This was then checked against the results of a later survey incorporated in the plans prepared by Corban Architects (Job No: OPQ). The strike of jointing observed in the exposed cliff face and exposed during construction of the pool was recorded and plotted on the proposed development plan. We have also annotated this plan to indicate the features present across the site as a whole. This plan is presented as Figure 1 and attached to the rear of this report.

The hazards identified for this site are shown on Figures 1, 2, 3, 4 and 5 and are as described below:
