# Arboricultural Impact Assessment

8 Surfside Ave, Avalon Beach

# **Prepared by Alex Austin**

### August 2022 V5

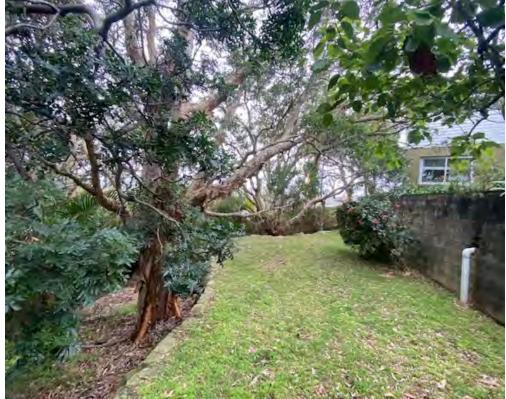
Tree 14 *Melaleuca quinquenervia* (Broad Leafed Paperbark) that has good health and structure with a 25-50 year life expectancy and medium landscape significance. .. The tree has a 7.8m TPZ and 2.9m SRZ, Observations included located 40cm west of sandstone retaining wall. The existing block retaining wall is restricting root growth on the Sothern side of the TPZ.

**Figure 7:** Tree 14 in the landscape showing existing retaining walls (Source: Austin 11<sup>th</sup> of November 2021)

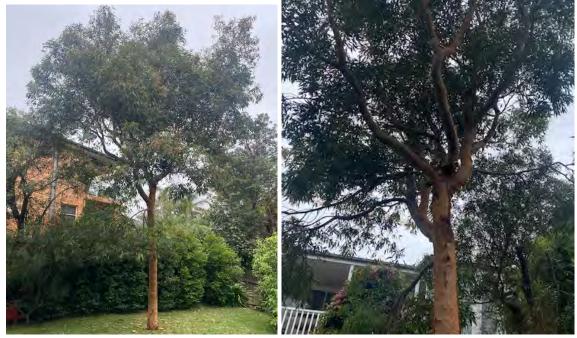
Tree 7 *Angophora costata* (Sydney Red Gum) has good health and poor structure with a 10 -15 year life expectancy.. The tree has a 2.6m TPZ and 1.9m SRZ, Observations included; Previously lopped at 4m, poor structure from lopping points, minor rubbing branches. It appears this tree was lopped for a view prune 3 -5 years ago. This tree is considered to be easily replaceable in the short term due to its small size an should not be considered a constrain on development.

**Figures 8 & 9**: Tree 7 in the landscape (Left) and the poorly attached regrowth originating at the lopping points. (Right). (Source: Austin 11<sup>th</sup> of November 2021)

Six (6) C Retention Value Trees numbered 4, 7, 16, 19, 20 & 21 required for removal from the site to facilitate to the project.

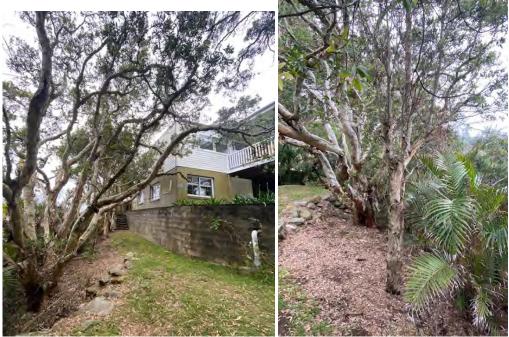
Tree 18 *Melaleuca quinquenervia* (Broad Leafed Paperbark) that has fair health and structure with a 10 -15 year life expectancy and medium landscape significance. The tree has 8m TPZ and 2.8m SRZ, Observations included; Thinning canopy, poor pruning stubs site side and neighbours side. The existing block retaining wall is restricting root growth on the Sothern side of the TPZ.

Tree 19 *Melaleuca quinquenervia* (Broad Leafed Paperbark) that has fair health and structure with a 5-10 year life expectancy. Observations included Previously lopped at 2m height, canopy is regrowth.

**Figures 10 & 11**: Tree 18 in the landscape showing existing retaining walls and a thinning canopy (Left) the small size and poor structure of 19(Right). (Source: Austin 11<sup>th</sup> of November 2021)

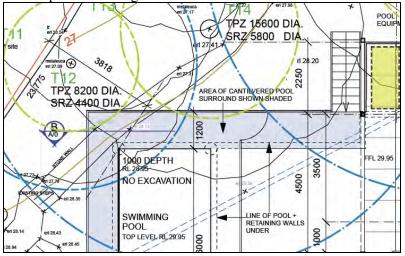
A major >10% encroachment is expected with the pool expansion however, existing retaining walls restrict root growth and result in minor excavation in the TPZ. The works are outside the SRZ and at or above existing grade. The pool surround is suspended reducing the proposed foot print further. No noticeable impact to the health of Trees 12 & 14 is expected and the trees will remain viable during and post construction.

**Figure 14**: The proposed encroachment into the TPZ of Trees 12 & 14 by the pool with cantilevered slabs shown in grey. (Source: Proposed Plans by Atelier Halefeli Architects, dated 18/8/2022)

1 x 30cm mm diameter branch on Tree 14 hanging over the yard requires pruning back to the collar to achieve some pedestrian height clearance from the new levels.

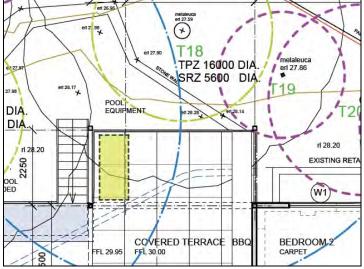
A major >10% encroachment is expected with the proposed covered area however, existing retaining walls restrict root growth and result in minor excavation in the TPZ. The works are outside the SRZ and above existing grade. No noticeable impact to the health of Tree 18 is expected and the trees will remain viable during and post construction.

**Figures 16**: The proposed covered area is with in the TPZ and SRZ Tree 18. (Source: Proposed Plans by Atelier Halefeli Architects, dated 18/08/22)

1 x 30cm mm diameter branch over the yard requires pruning back to the collar to achieve some height clearance from the new levels.

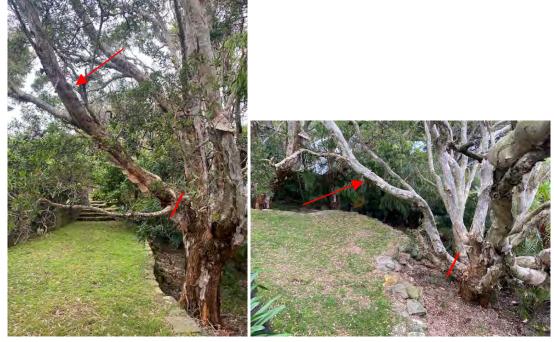
**Figures 18 & 19**: The previous lopping points in Tree 19 and the poor pruning on the neighbours side of tree 21. (Source: Austin 11<sup>th</sup> of November 2021)

Six (6) Trees numbered 4, 7, 16, 19, 20 & 21 are proposed for removal and should be removed at the beginning of the project (STCA). The trees nominated for retention must not be damaged during the tree removal works.
