Preliminary Geotechnical Assessment

For Alterations & Additions at

209 South Creek Road, Wheeler Heights NSW

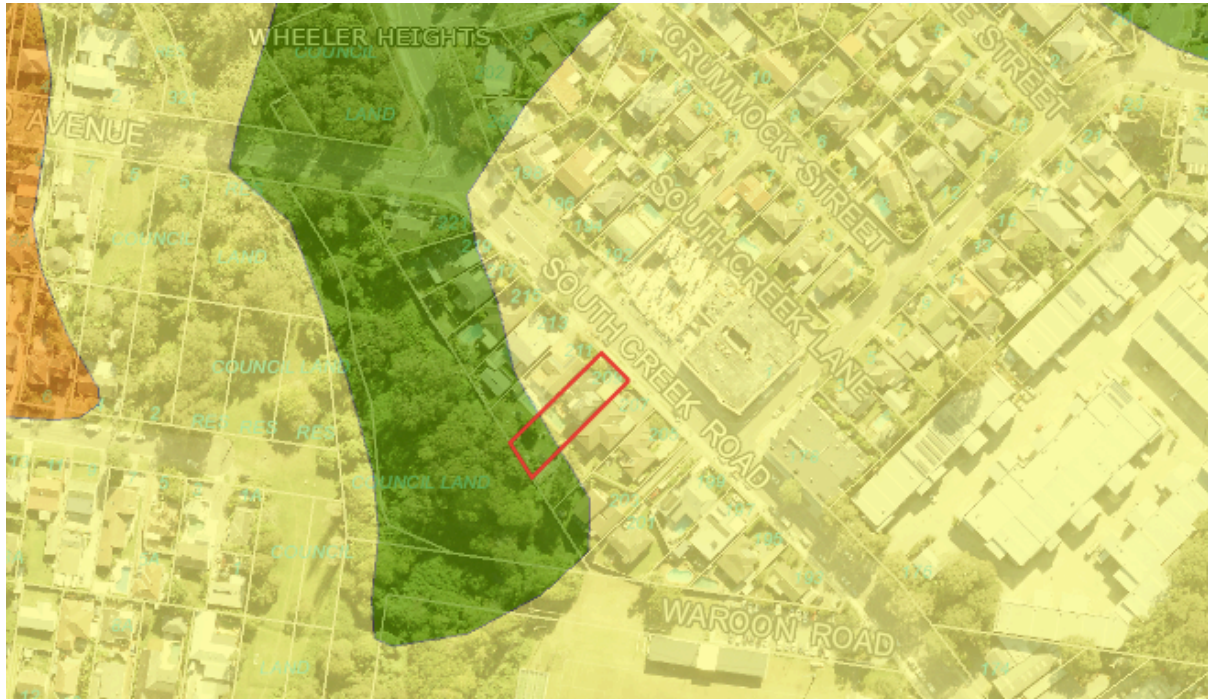
The site is mapped as **Area A & D** on the Landslip Risk Map WLEP 2011 (**Image 1**, below).

WARRINGAH LANDSLIP RISK MAP
