**Mr Vic Micallef**  
**212 Hudson Parade**  
**Clareville NSW 2107**

Project 222043.00  
30 August 2023  
222043.00.R.001.Rev0  
DEM:gl

**Geotechnical Assessment**  
**Proposed New Dwelling**  
**212 Hudson Parade, Clareville**

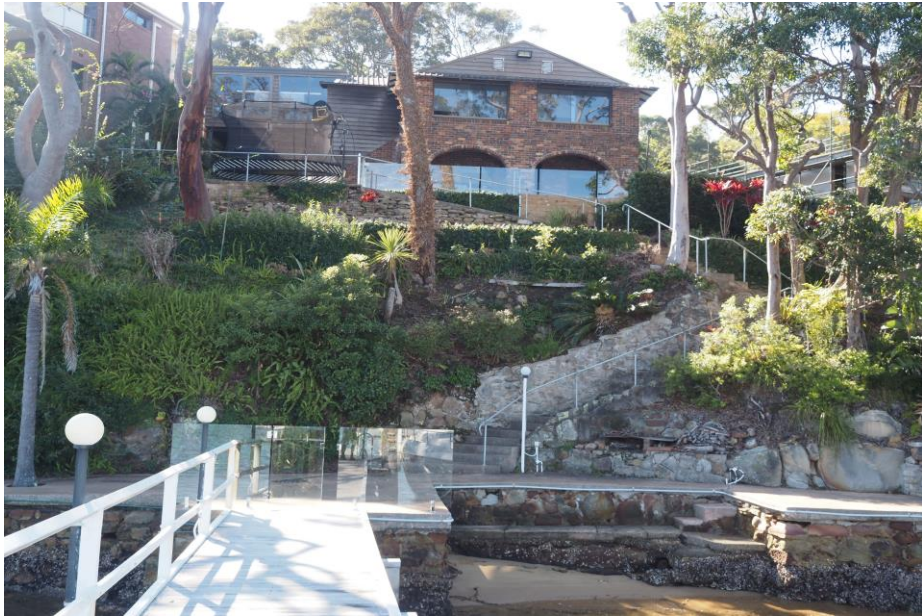
The slope angle over the top (northern) four-fifths of the site (including the existing and proposed building footprints) is in the order of 12°. The lower (southern) fifth of the site comprises a 6 m to 7 m high, vegetated steep slope (slope angle 50° to 60°) above the Pittwater foreshore (refer to Photo 1).

Photo 1: View of site from Pittwater

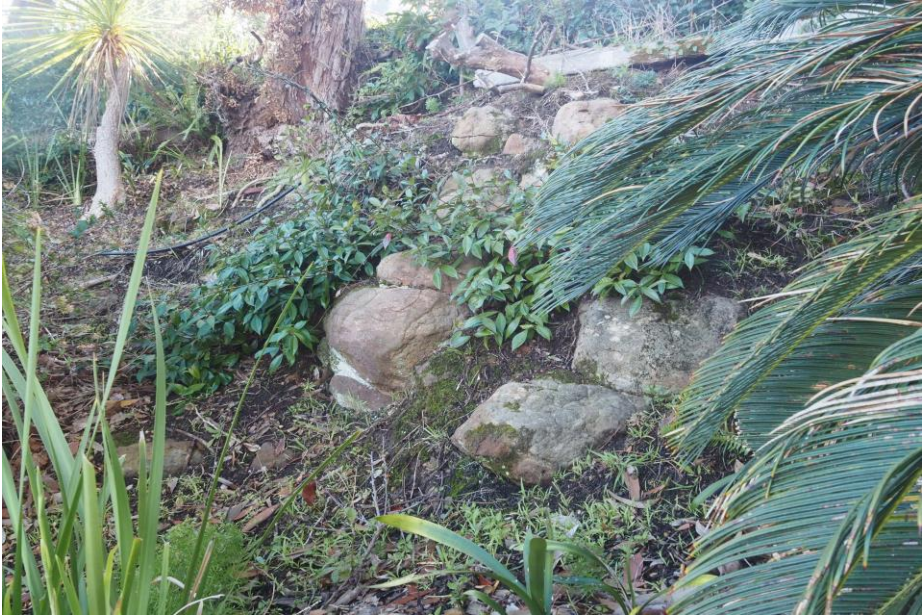
- medium to high strength sandstone bedrock is exposed mid-height and along the toe of the steep slope;
- DCP probing across the top grassed terrace to the south of the residence and within the footprint of the proposed swimming pool reached refusal on apparent bedrock at depths ranging from

Photo 2: Sandstone bedrock exposed on steep slope above Pittwater

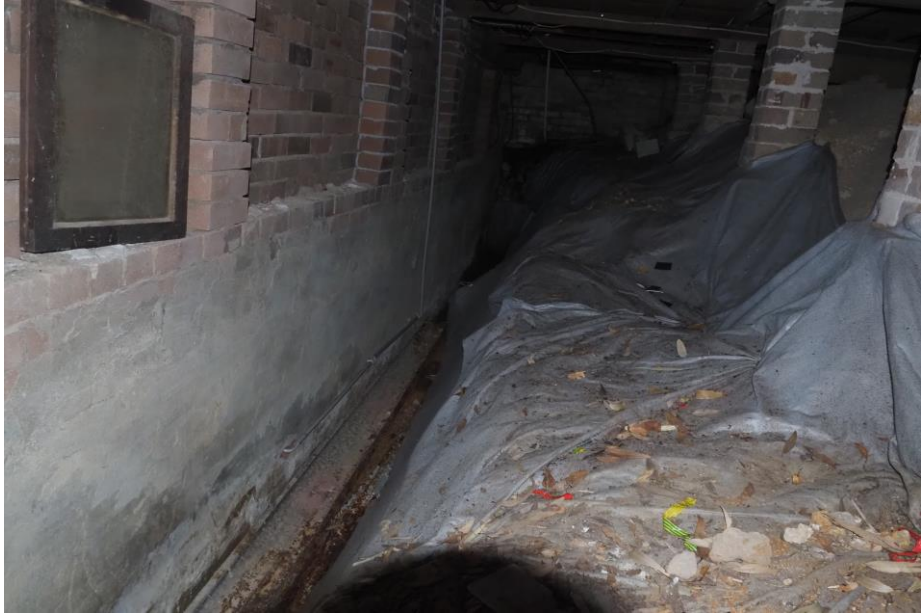
- a 1 m high, excavated soil batter below the residence is covered with geofabric (refer to Photo 3);
- the property owner reports that the sub-floor area of the residence has remained dry during recent wet weather events;

Photo 3: Batter slope below residence covered with geo-fabric

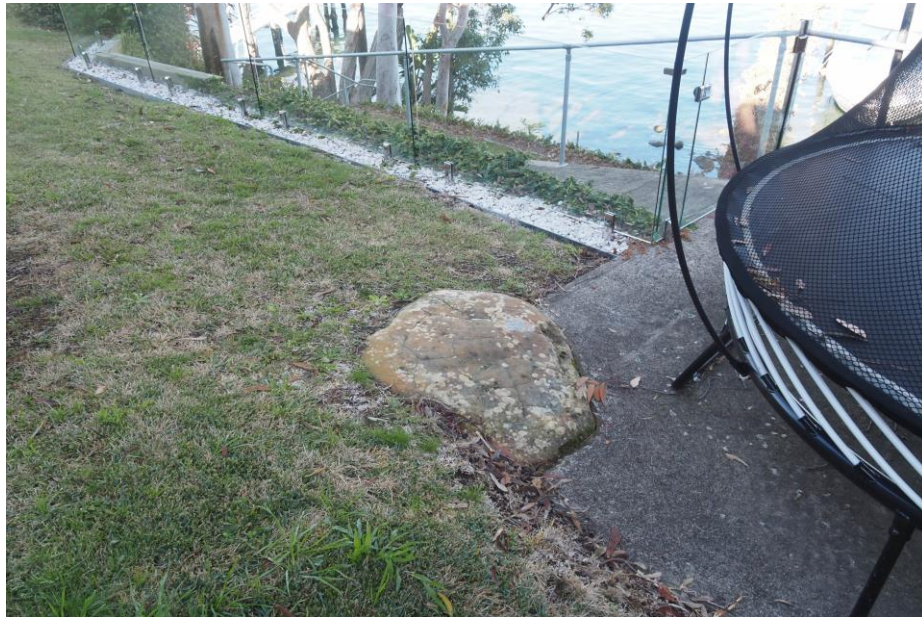
- the cemented sandstone block sea-wall is eroded in places but remains functional;
- there is an apparent small sandstone bedrock outcrop exposed on the grassed terrace to the south-west of the residence (refer to Photo 4);

Photo 4: Possible sandstone bedrock exposed near south-west corner of existing residence

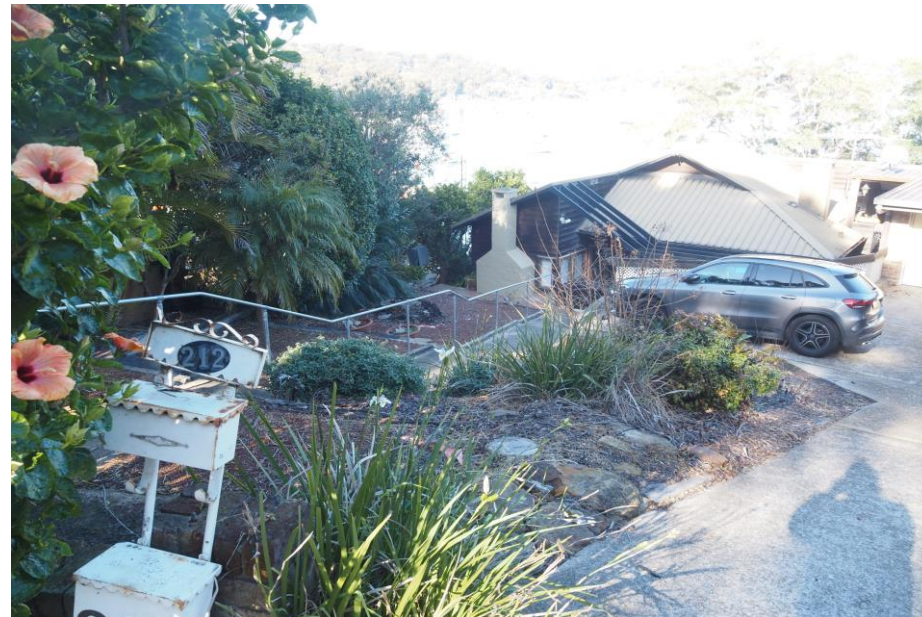
The upper (northern) yard typically comprises tile and gravel or landscaped terraces, separated by 0.5 m to 1 m high, sandstone flagging walls (refer to Photos 5 and 6).

Photo 5: View of site from Hudson Parade

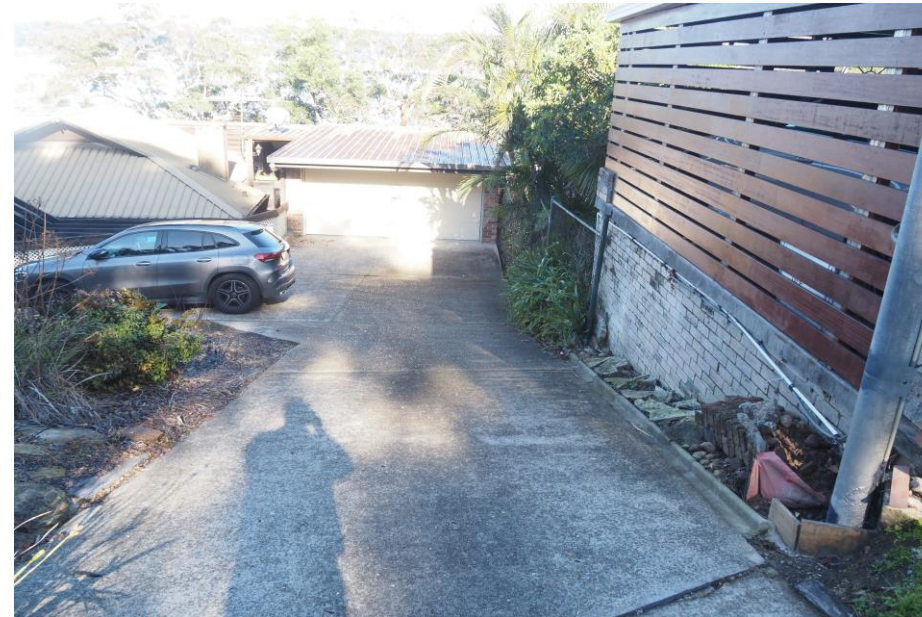
Photo 6: View of site from Hudson Parade
