PRELIMINARY GEOTECHNICAL ASSESSMENT:

86 Ballyshannon Road, Killarney Heights

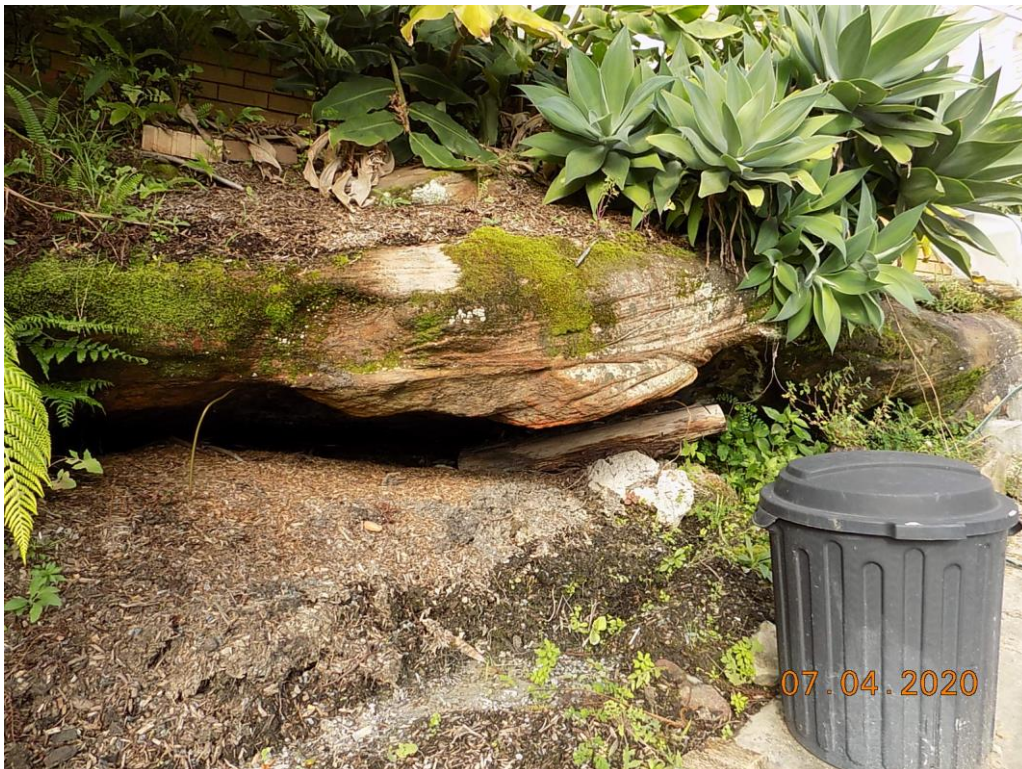
Photo 1

From the road frontage to the upper boundary, the natural slope rises at an average angle of $\sim 17^\circ$. At the road frontage, a concrete driveway runs to a garage on the lower ground floor of the house. The fill for the driveway is supported by a stable $\sim 3.5\text{m}$ high stack rock retaining wall. Below this wall, a pool has been cut into the slope. The water level of the pool indicates no ground movement has occurred in the shell of the pool since its construction. Filling has been placed around the pool for a level area. The fill is supported by a $\sim 1.8\text{m}$ high stable mortared stack rock retaining wall that lines the road frontage. Between the pool and the house is a $\sim 1.0\text{m}$ high rock face. The rock is undercut to $\sim 1.0\text{m}$ (Photo 1). The undercut joint block has a relatively thick cantilever arm in relation to its overhang length, is bridged at its SE side, and does not show any jointing or cracking through the supporting cantilever arm as viewed from above or below. As such, we consider it to be currently stable. The two-storey brick house is supported on brick walls. The supporting brick walls of the house display no significant signs of movement. A gently sloping lawn extends off the uphill side of the house to the upper common boundary. The area surrounding the house is mostly paved or lawn covered. No signs of movement associated with slope instability were observed on the grounds. The adjoining neighbouring properties were observed to be in good order as seen from the road and the subject property.

Provided good engineering and building practice are followed, no further Geotechnical assessment is recommended for the proposed development.
