Report Title: Geotechnical Report 31 Marine Parade, Avalon Beach
Report Date: 9/6/21

GEOTECHNICAL INVESTIGATION:

New House and Garage at **31 Marine Parade, Avalon Beach**

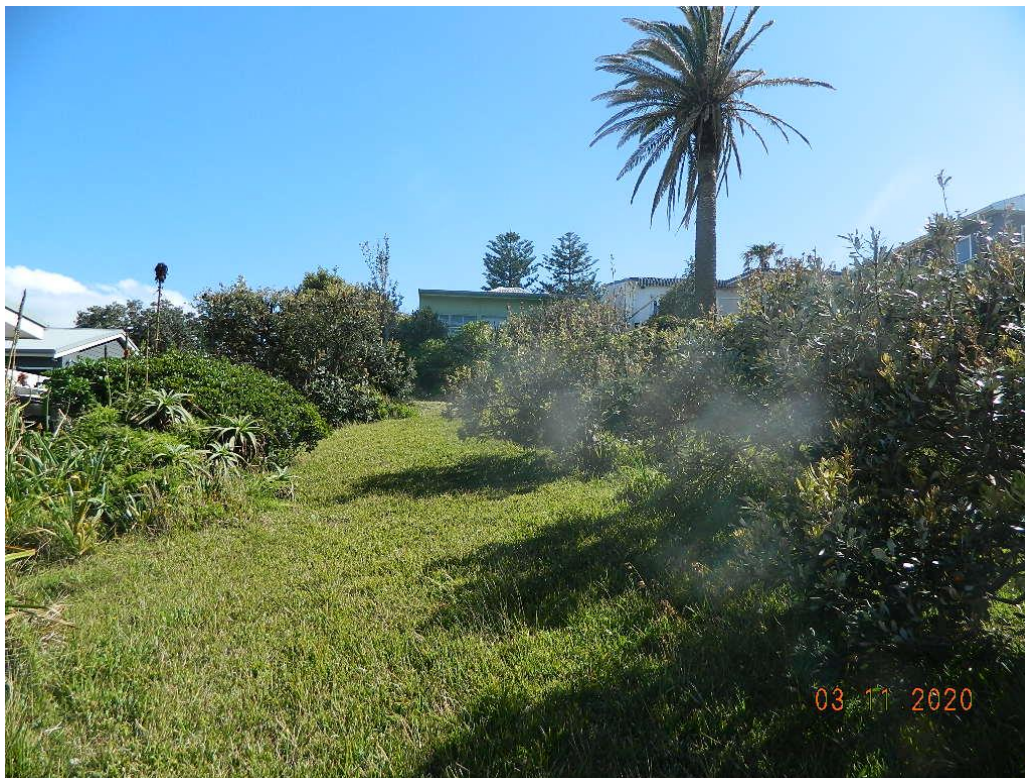
Photo 7

- 2.1** The site was inspected on the 26th May 2021, and previously on the 3rd November, 2020.
- 2.2** This waterfront residential property is near level with the road and encompasses the crest and gentle to steeply graded slope that falls to the waterfront. The ground surface is near level from the road frontage to the downhill side of the house before the slope falls from the downhill side of the house at an angle of ~8° and increases in grade markedly before dropping away at near vertical angles at the coastal bluff.
- 2.3** At the road frontage, a concrete driveway runs to a brick garage beside the house (Photos 1 & 2). Between the road frontage and the house is a near level lawn. The single storey brick, rendered brick and fibro house will be demolished as part of the proposed works. A gentle to moderately graded lawn and garden area extends off

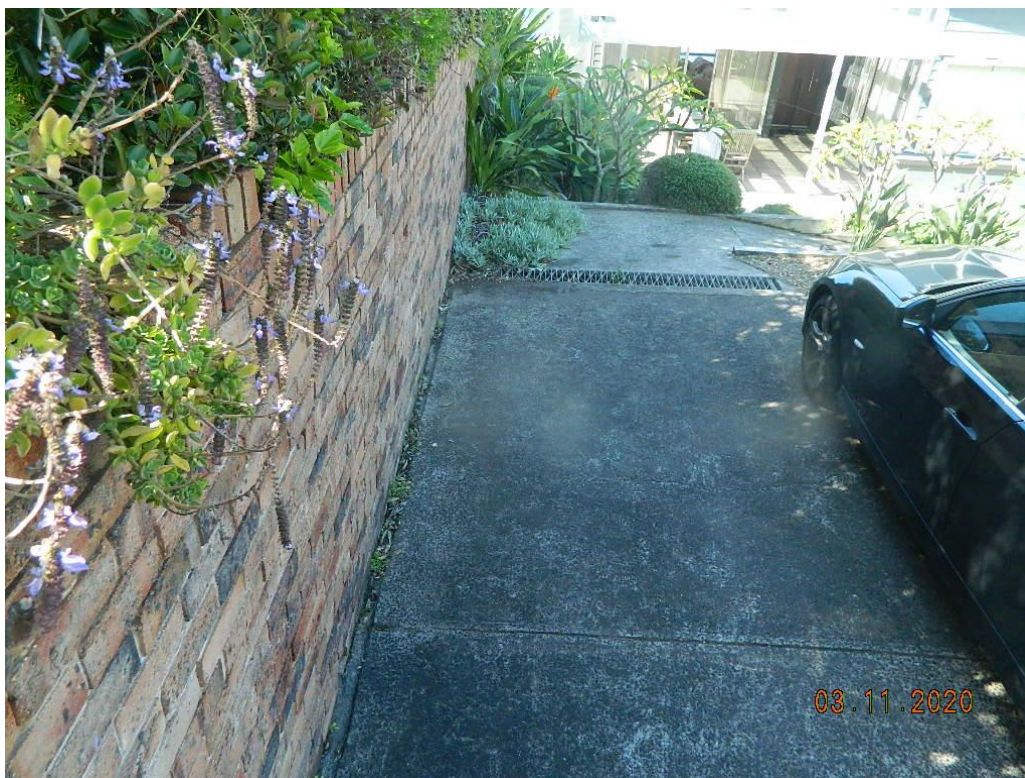
Photo 8

the downhill side of the house (Photo 7). A stable brick retaining wall up to ~2.0m high along the W common boundary supports a cut on the W neighbouring property (Photo 8). The steep coastal bluff that falls to the waterfront is densely vegetated (Photos 9 & 10). A cliff face consisting of various sedimentary layers including laminate, shale and sandstone marks the beachfront. The cliff face shows some evidence of recent rock falls but these are limited in extent by the structure of the rock and are considered part of the normal ongoing weathering process.

No geotechnical hazards were observed below or beside the property. The gentle to steep slope that falls across the property and continues above is a potential hazard (**Hazard One**). The vibrations produced during the proposed excavation impacting on the neighbouring properties is a potential hazard (**Hazard Two**). The proposed excavations are a potential hazard until retaining walls are in place (**Hazard Three**). The additional surcharge loads from the proposed house & garage structures are a potential hazard to the existing brick retaining wall along the W common boundary (Photo 8) (**Hazard Four**). Note: The coastal engineering

As there is an existing brick retaining wall along the W common boundary supporting the cut for the neighbouring property, the excavation along the W common boundary will not require any temporary shoring and will stand unsupported provided care is taken during the excavation so as to not damage the existing wall.

Dilapidation reporting carried out on the W neighbouring property is recommended prior to the excavation works commencing.

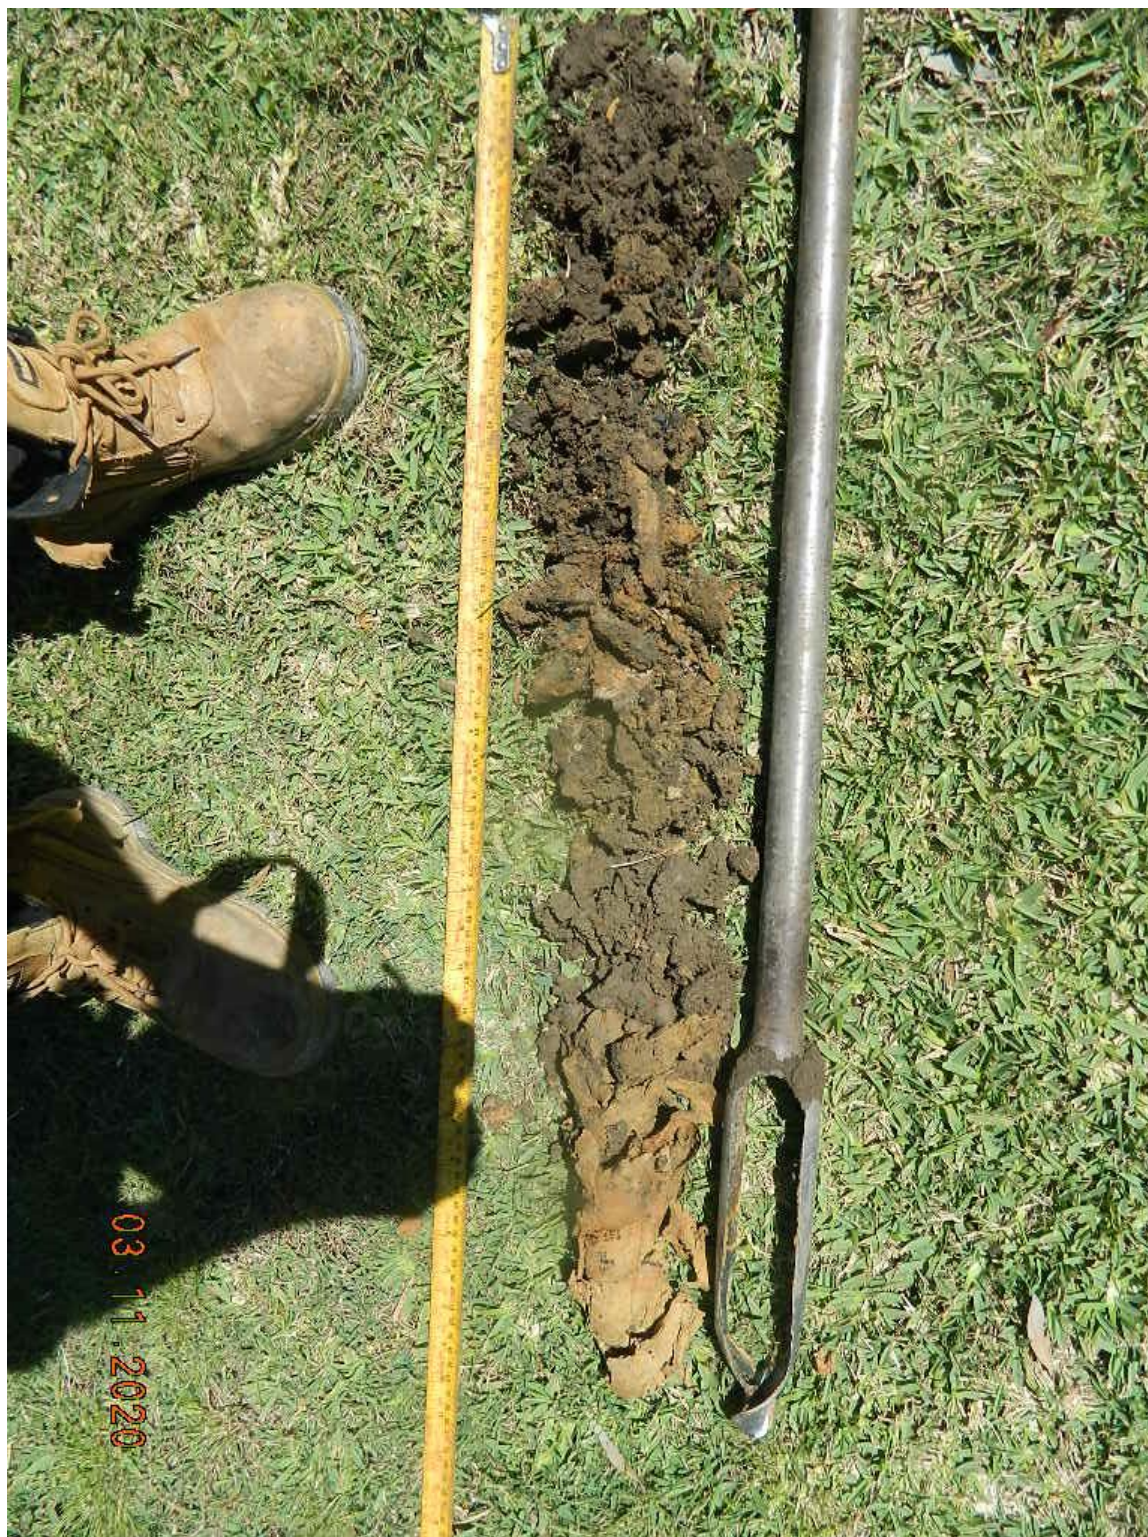
AUGER HOLE 1 (~RL22.4) – AH1 (Photo 11)

Depth (m)	Material Encountered
0 to 0.4	FILL , sandy soil and clay, dark brown and orange brown, fine to medium grained, damp.
0.4 to 0.6	SANDY SOIL , dark brown/grey, fine to medium grained, damp.
0.6 to 0.8	CLAY , light brown/orange, firm, moist.

End of hole @ 0.8m in firm clay. No watertable encountered.

Photo 11: AH1 – Downhole is from top to bottom.

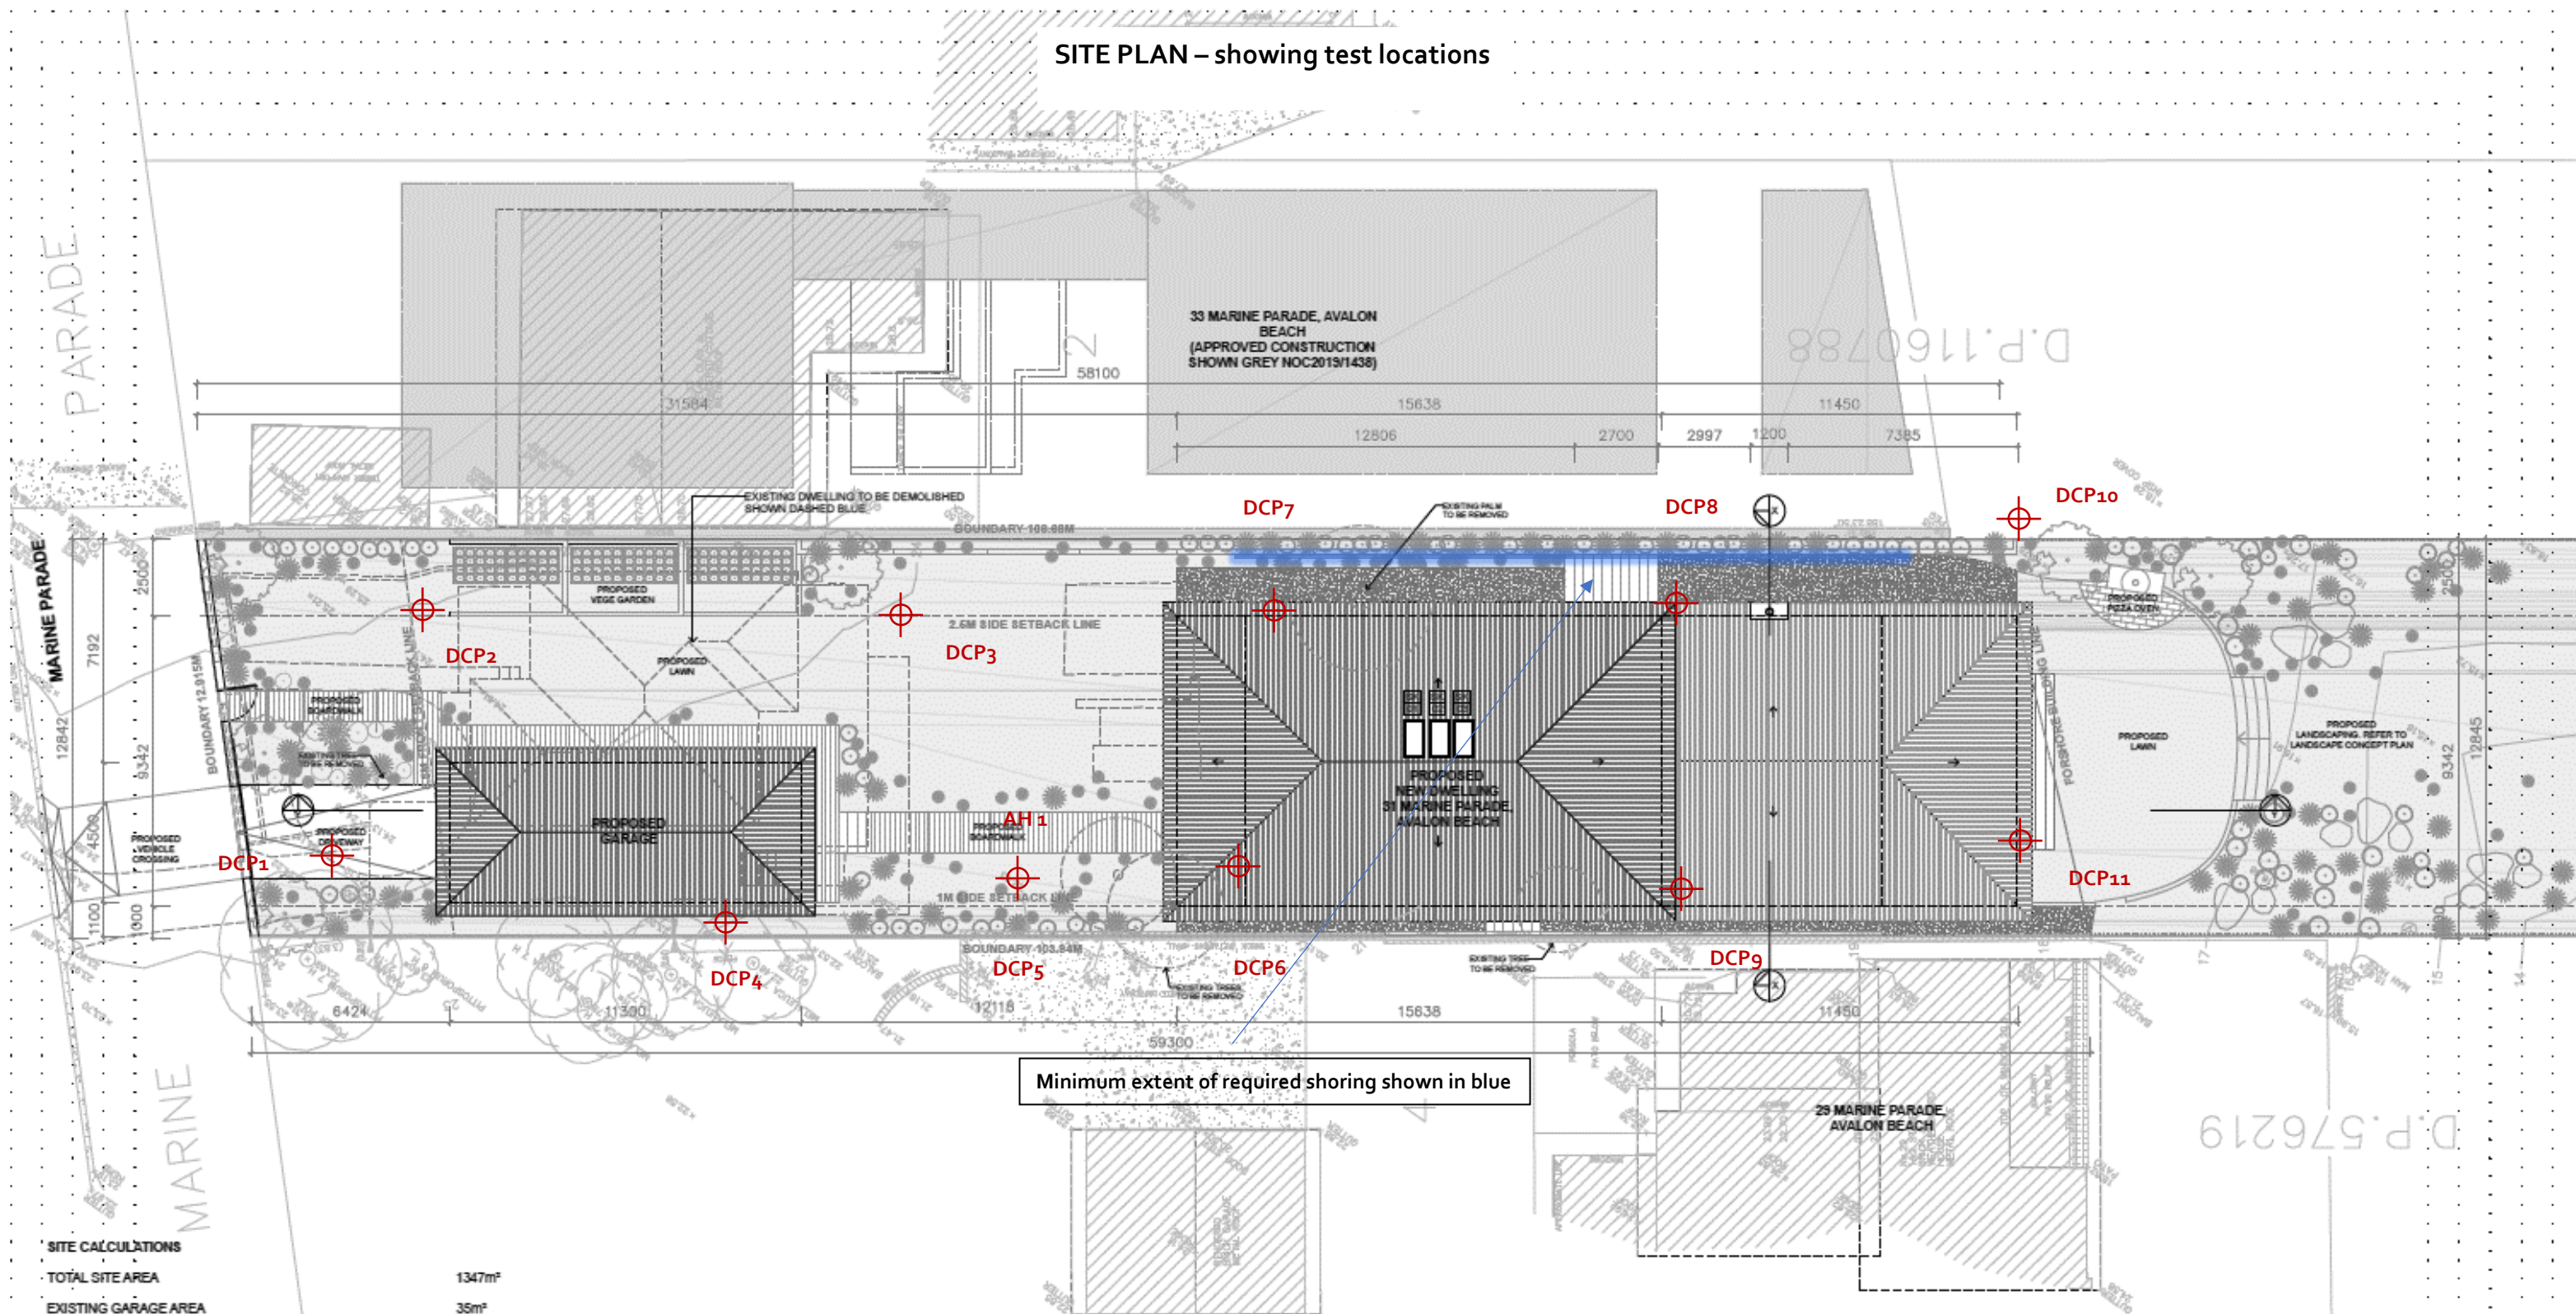
SITE PLAN – showing test locations

Minimum extent of required shoring shown in blue

Where the E common boundary falls within the zone of influence of the excavation, the cut faces will require shoring so the cut face is not left unsupported. One suitable form of shoring is to install a soldier post wall whereby the holes for the soldier posts are drilled and the posts installed before any excavation commences. The gaps between the posts are excavated out one at a time before the supporting walers are installed to form the wall. The support is to be designed by the structural engineer. The temporary support is to remain in place until the retaining walls are built. See site plan attached for extent of minimum required shoring.
