WARRINGAH COUNCIL HAZARDOUS BUILDING MATERIALS SURVEY

NORTH MANLY BOWLING CLUB KENTWELL ROAD, MANLY VALE NSW 2093

REFERENCE No. S8654-BUI00137

NOVEMBER 2015

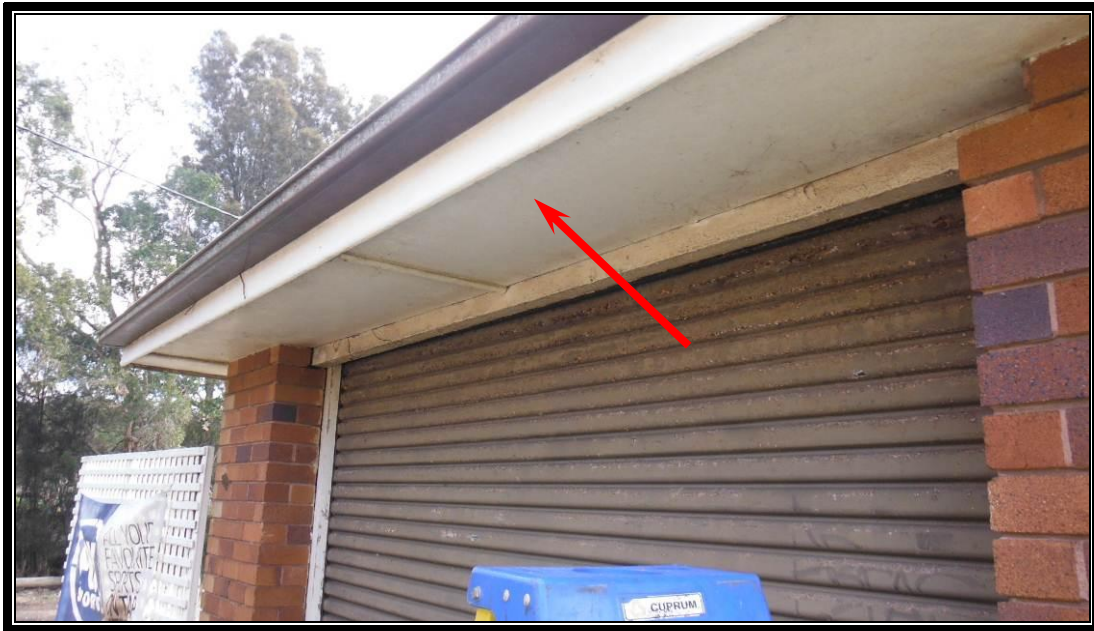
Photograph 01

- Site: North Manly Bowling Club.
- Location: Amenities\Store Building, eaves lining all sides.
- Description: The red arrow points to flat asbestos cement sheet.
- Recommendation: Leave and maintain in good condition.

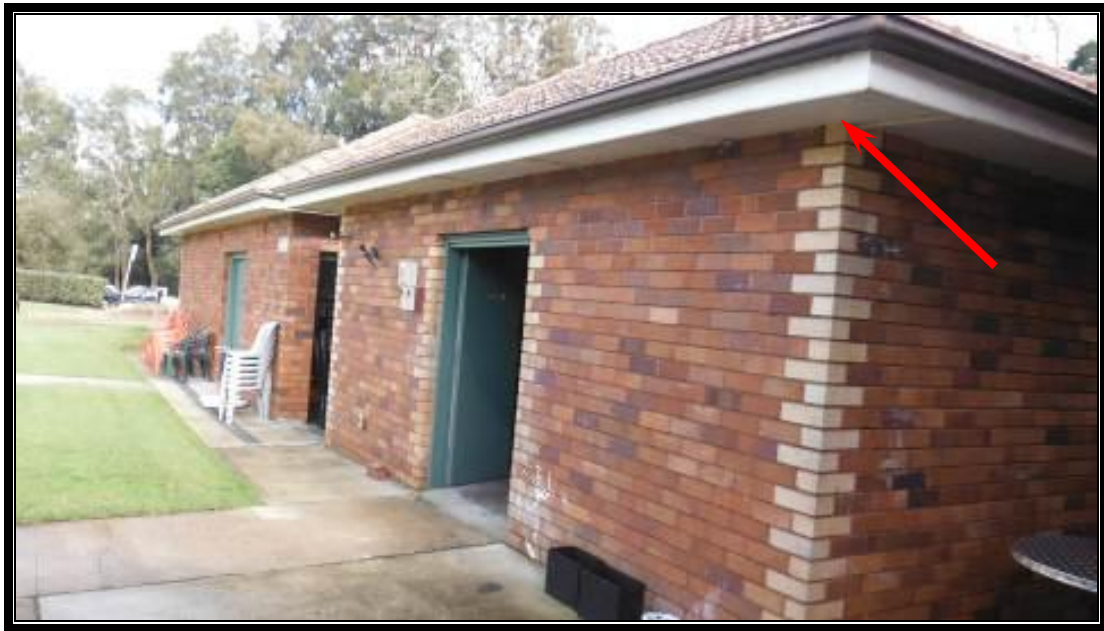
Photograph 02

- Site: North Manly Bowling Club.
- Location: Workshop Building, eaves lining all sides.
- Description: The red arrow points to flat asbestos cement sheet.
- Recommendation: Leave and maintain in good condition.

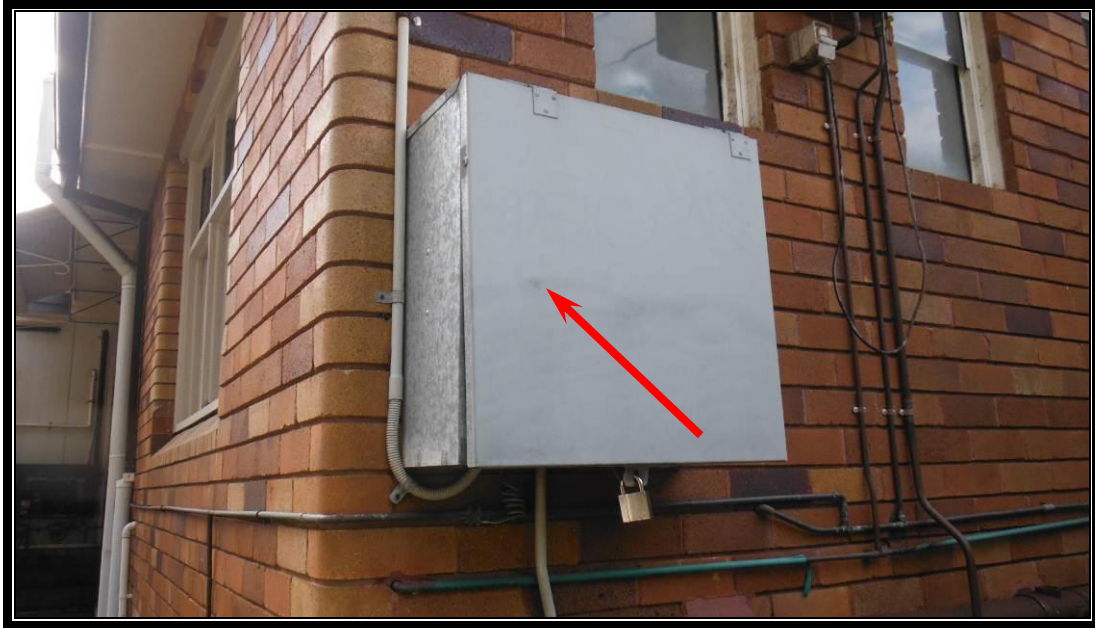
Photograph 03

NORTH MANLY BOWLING CLUB INACCESSIBLE AREAS		
LOCATION	MATERIAL	COMMENT
External, Club, rear wall	Electrical cabinet may contain an asbestos electrical backing board	The electrical cabinet was locked with no key access. Inspect upon next scheduled maintenance

- Site: North Manly Bowling Club.
- Location: External, electrical box on rear wall
- Description: The red arrow points to locked electrical box.
- Recommendation: Leave and maintain in good condition.
