Date: 23rd April 2021

Project No.: 2021-089

Preliminary Landslip Assessment for 7 Hill Street, Queenscliff

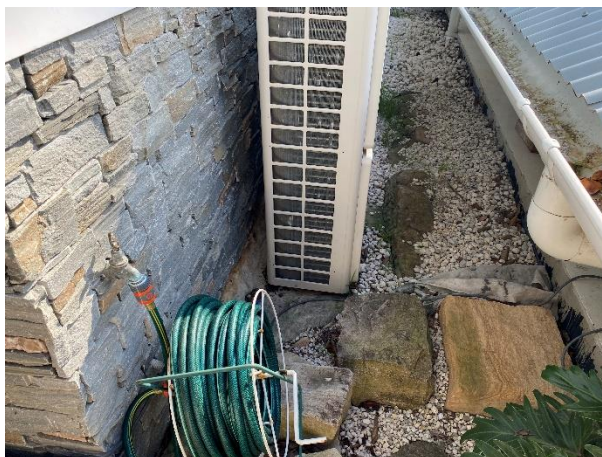
The front carport appears to be excavated into the slope and contains a masonry retaining wall (≤ 1.50 m high) along the southern side. Rock outcrop is located directly to the rear of the carport masonry retaining wall (Photograph-1), which appears to be sandstone bedrock.

*Photograph-1: Potential sandstone bedrock is located directly to the rear of the carport.
View looking down west.*
