Arboriculture Assessment & Hazard Management Statement

January 2020

Site: Lot 33 in DP 12186
37 Parkes Street
MANLY VALE, NSW

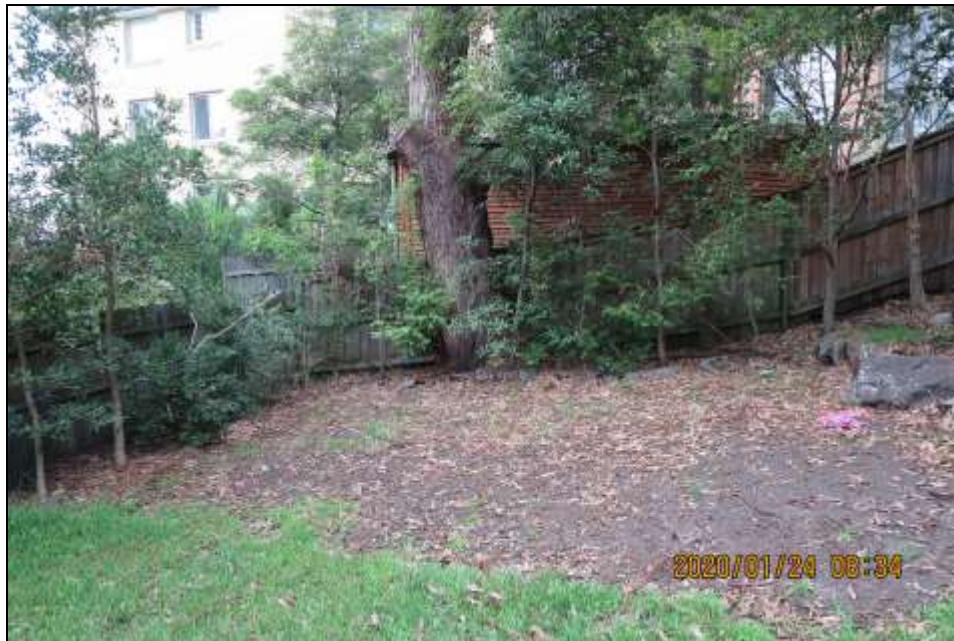
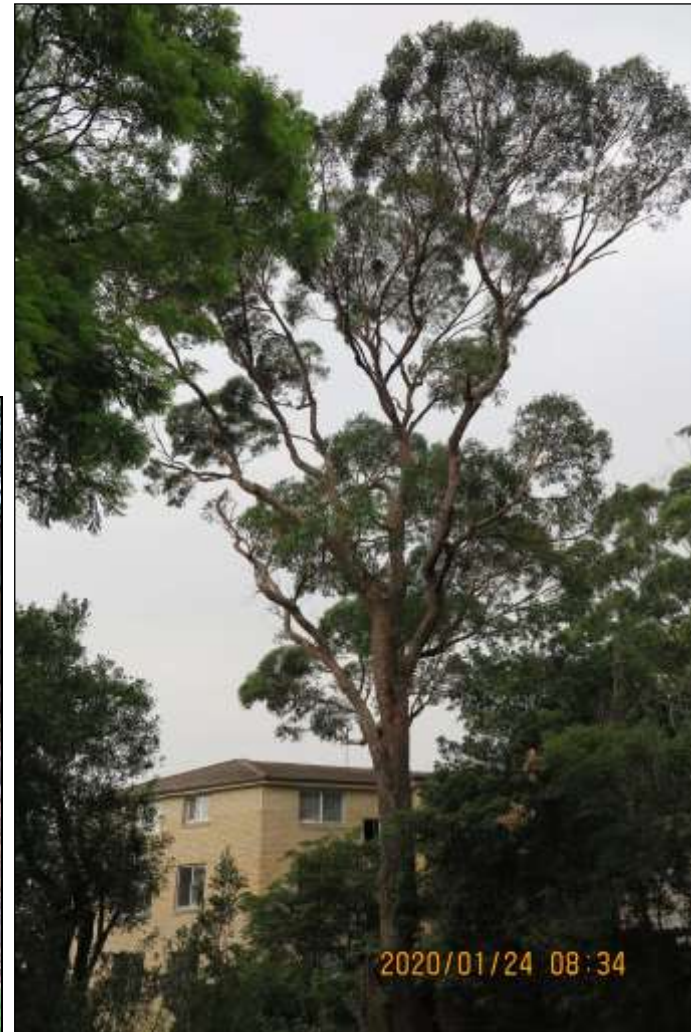
Figure 3: Illustrates tree location & canopy outline.

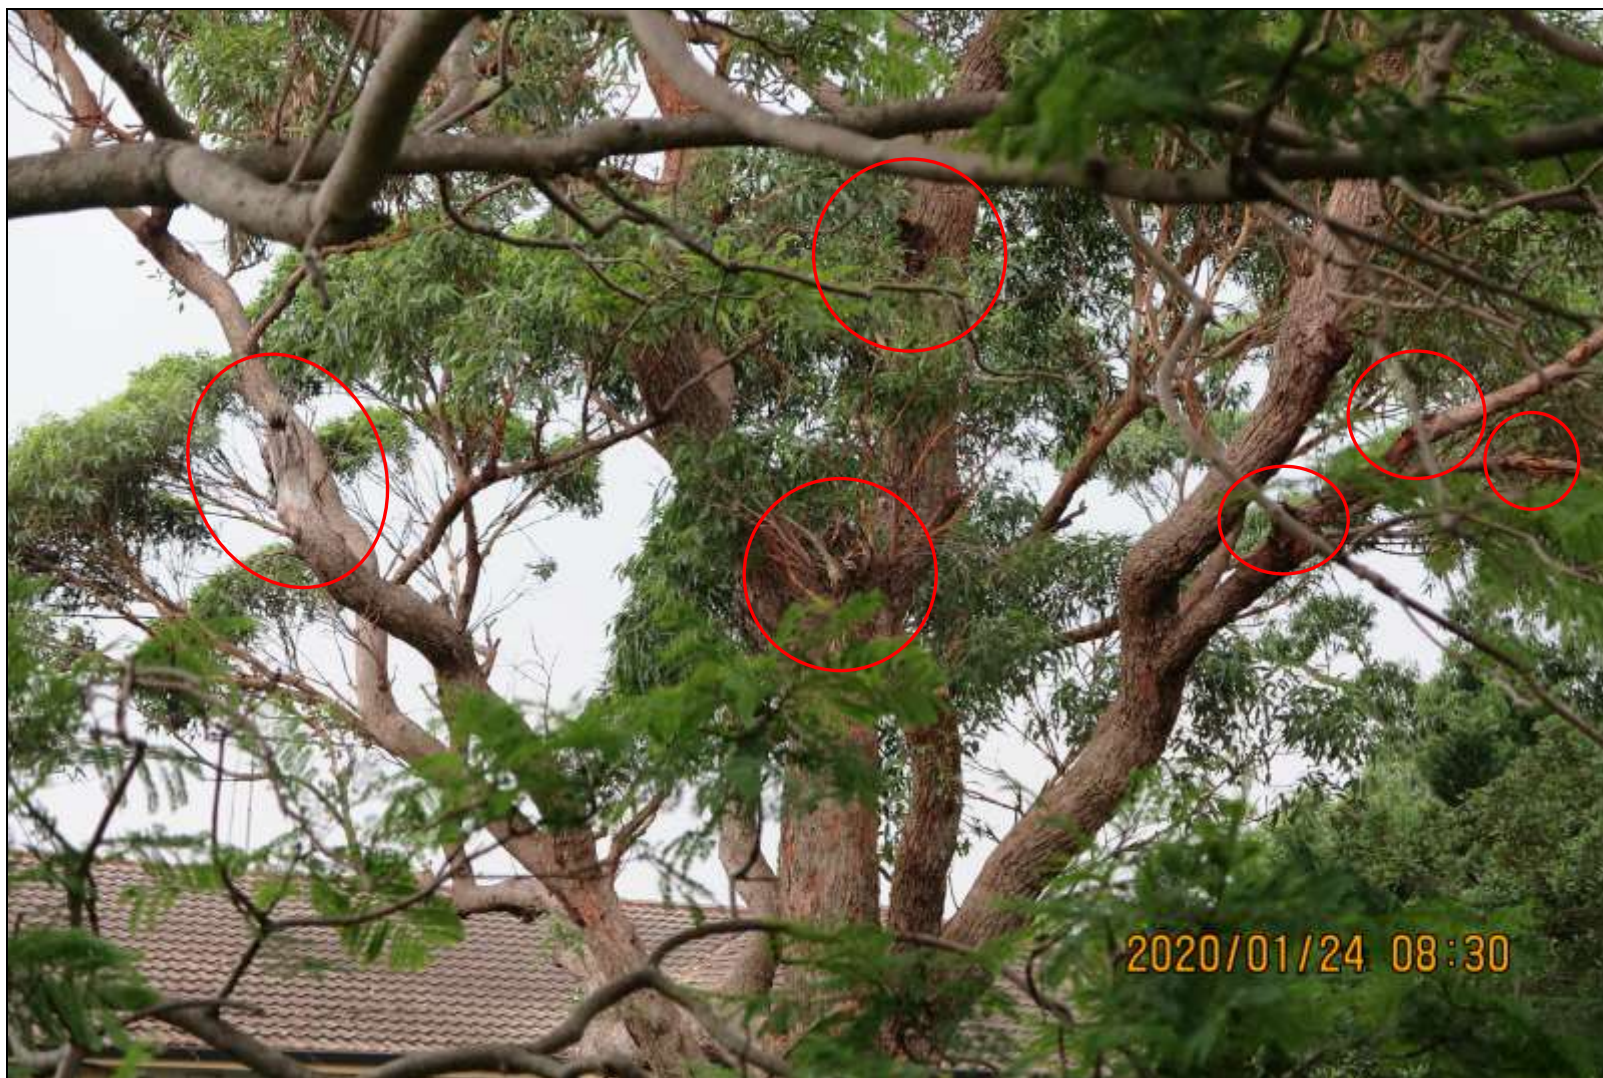
Figure 4: Illustrates some of the confirmed 'live branch' failure sites.

The discussed tree has been assessed & classified to be an unacceptable 'risk' on the basis of many recent years 'live branch' failure incidents of a significant diameter. Eight (8) sites have been identified by VTA stage 1 & stage 2 criteria.

By virtue of the subject site property owners having four (4) young, active children & the fact most 'live branch' failure incidents appear to be consistent with 'sudden branch drop syndrome' (which occurs mostly during calm weather with nil wind).

- *Prune to remove dead/dying/broken branches as well as branches where 'live branch failure sites have left stubs as identified & discussed. Pruning must be compliant with the Australian Standard (AS4373-2007 Pruning of amenity trees, see Chapter 7, Sections 7.1, 7.2 & 7.3.)*

Lodge immediately an application for total tree removal & replacement with the NBC on the grounds of the tree presenting an unacceptable risk to persons & a lesser degree property.

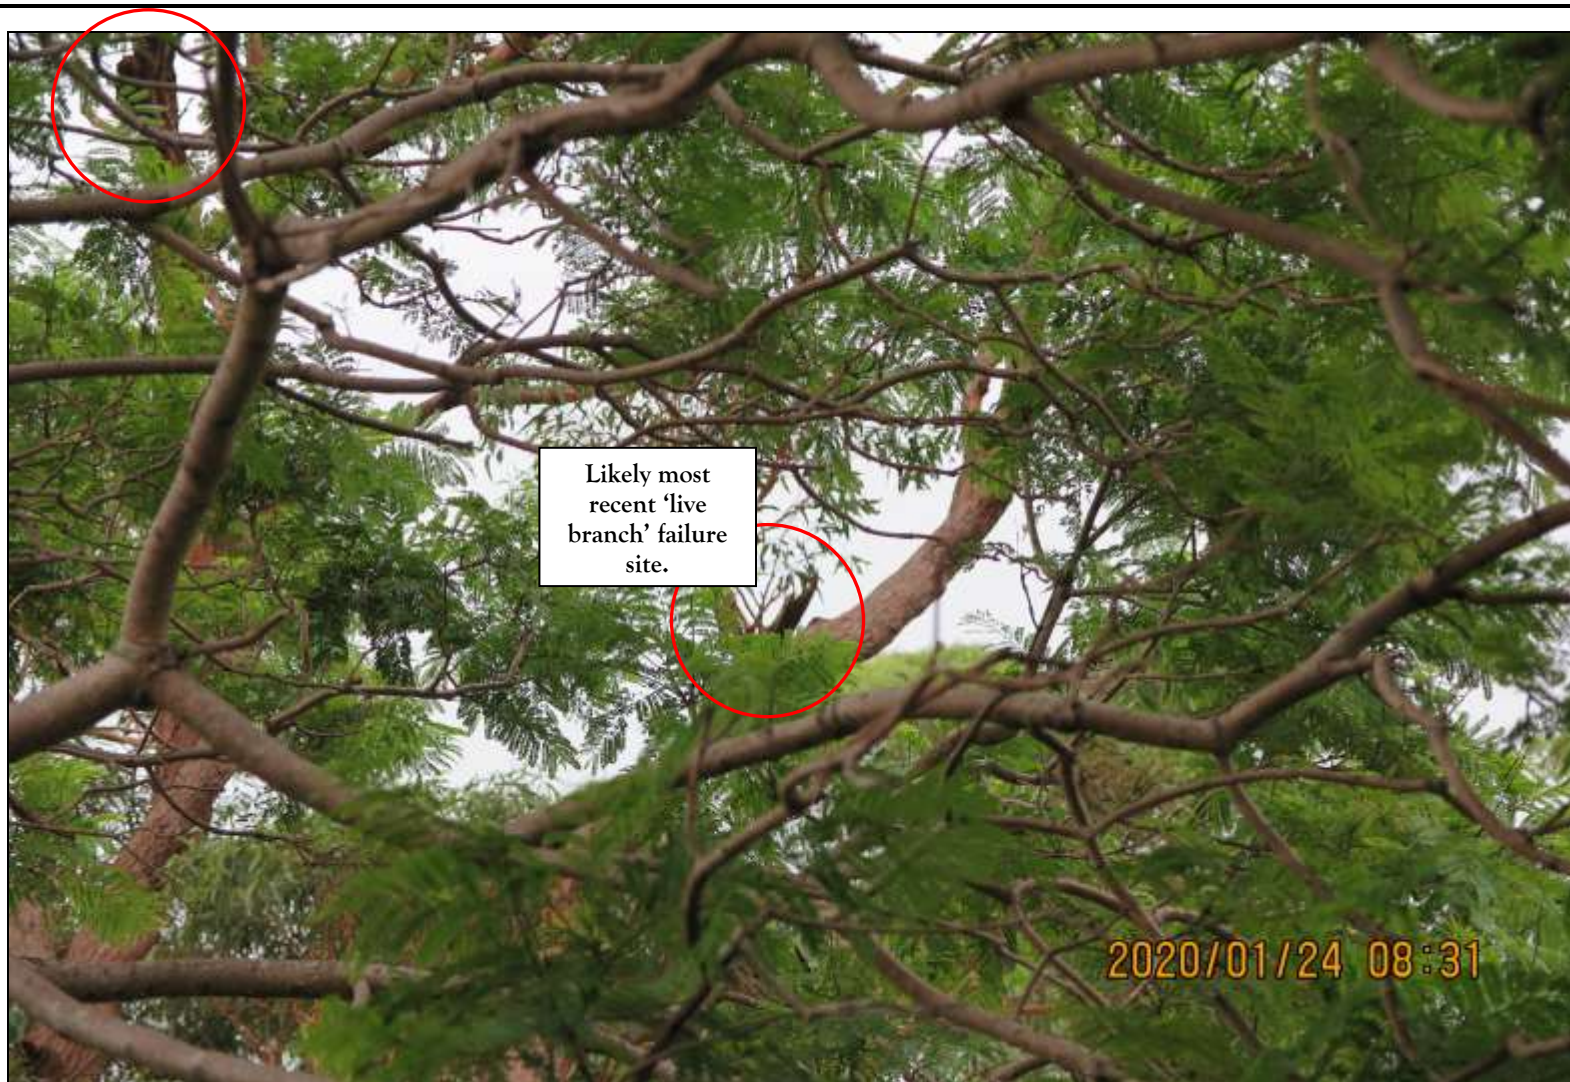
Figure 5: Illustrates more 'live branch' failure sites, including the site likely to have been the most recent.

It is unusual for a tree that has so many 'live branch' failure incidents to be as orientated in any single direction as observed at this site. Most 'live branch' failure incidents face the north. The reason for this is not known. The tree appears to be more exposed to winds from a Northerly direction. It is possible a tree from within one of the adjoining to the subject site common boundary properties has had a large tree removed that has exposed the discussed tree.
