REPORT ON GEOTECHNICAL SITE INVESTIGATION

PROPOSED ALTERATIONS AND ADDITIONS

552 PITTWATER ROAD, NORTH MANLY, NSW

Project No.: 2020-236

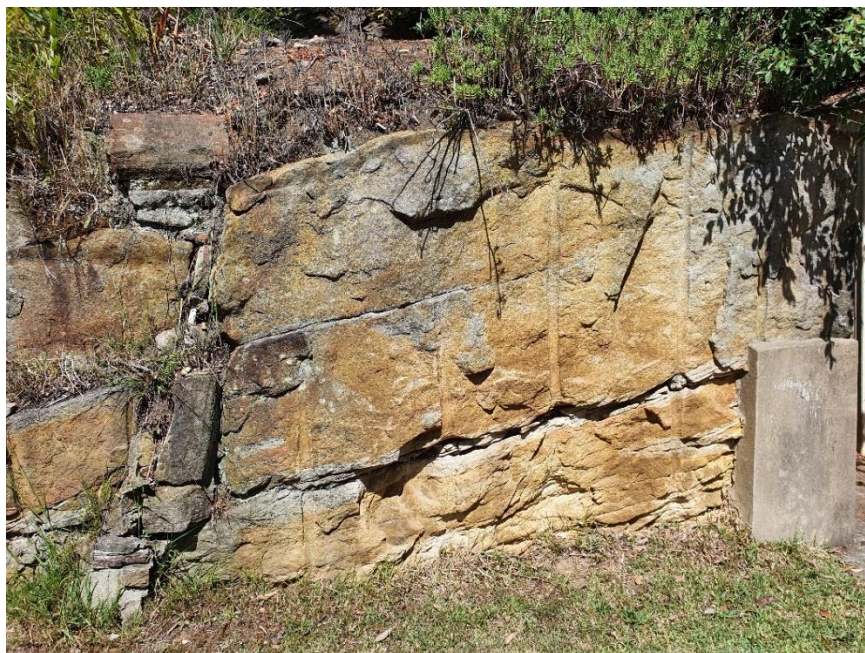
The site is located on the high east side of Pittwater Road within moderate to steep west dipping topography. Pittwater Road is formed with a bitumen pavement with concrete gutter and kerb and is gently (-1°) south dipping where it passes the site. A concrete footpath and sandstone bedrock/outcrop lie between the road and site boundary. There were no signs of excessive cracking or deformation within the road pavement and footpath to suggest any movement or underlying geotechnical issues. The sandstone bedrock was excavated vertically on the western side to accommodate the footpath and also towards the east to accommodate the existing garage of the site and concrete steps accessing to the house. The sandstone bedrock comprises sandstone of medium to high strength with subhorizontal (-20°) north dipping bedding defect and very low strength to low strength siltstone band, see Photograph 2. The southern side of the rock face appears to be underpinned by brick walls due to weathering of the siltstone band, see Photograph 3.

Photograph 2. Rock face at the front of the site, facing east

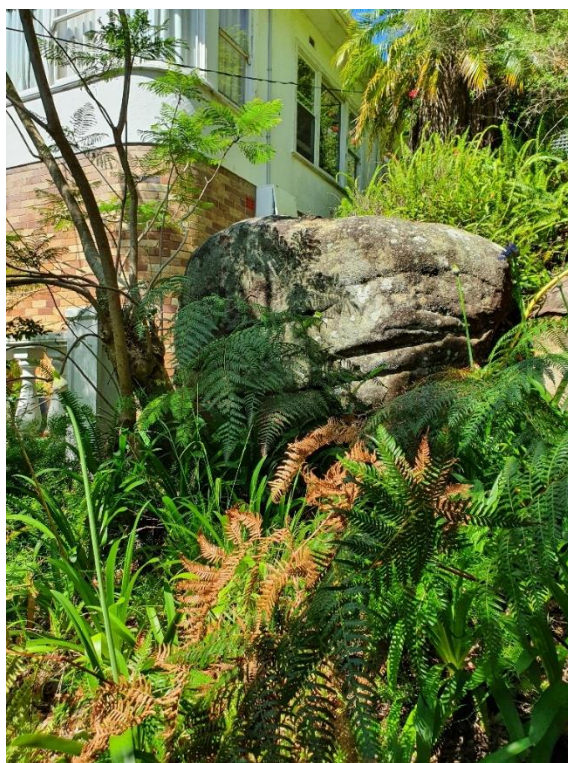
The concrete steps lead up to the site house through a steep (-20°) soil slope on both sides. Detached sections/boulders directly overlie the bedrock within the northern portion of the soil slope, which appear stable at present, see Photograph 4. The soil slope is covered by heavy vegetation and contains several large trees (up to 15m high).

*Photograph 4. Boulder along north boundary
buried in soil slope, facing east*

Detached sections/boulders were identified directly overlying the bedrock within the northern portion of the soil slope and adjacent to the north boundary. They are considered stable at present. However, the proposed excavation will extend adjacent to and even into the boulders and could/will cause instability. Therefore, stabilizing measures or the removal of these boulders is recommended.

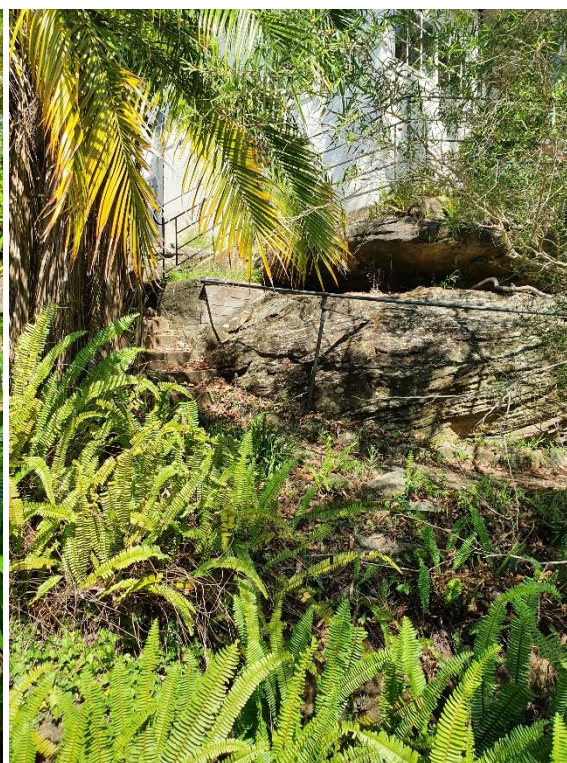
The front of the site house contains a north-south striking sandstone cliff up to 2.5m high. The cliff comprises sandstone of low to medium strength with subhorizontal (-10°) north dipping bedding defects and an upper massive unit of $<0.5\text{m}$ thickness that is undercut approximately 1.0m laterally and 0.50m high by weathering of weak sandstone unit, see Photograph 5. The existing house is a single storey fibrous and rendered brick house situated on the top of the cliff within a terraced area. The structure appears in reasonable condition with no signs of significant cracking or deformation on its external walls.

*Photograph 5. Sandstone cliff at the western
front of the house with undercut*

It is recommended to undertake additional cored boreholes to confirm rock strength and quality, including defects adjacent to the front of the existing house to below the main excavation base level (RL6.45m), to allow machinery selection and assessment of excavation stability.
