STANDFAST TREE SERVICES
ESTABLISHED 1979

Re T21 at 78 Hudson Pde, Clareville, DA 2019/0152

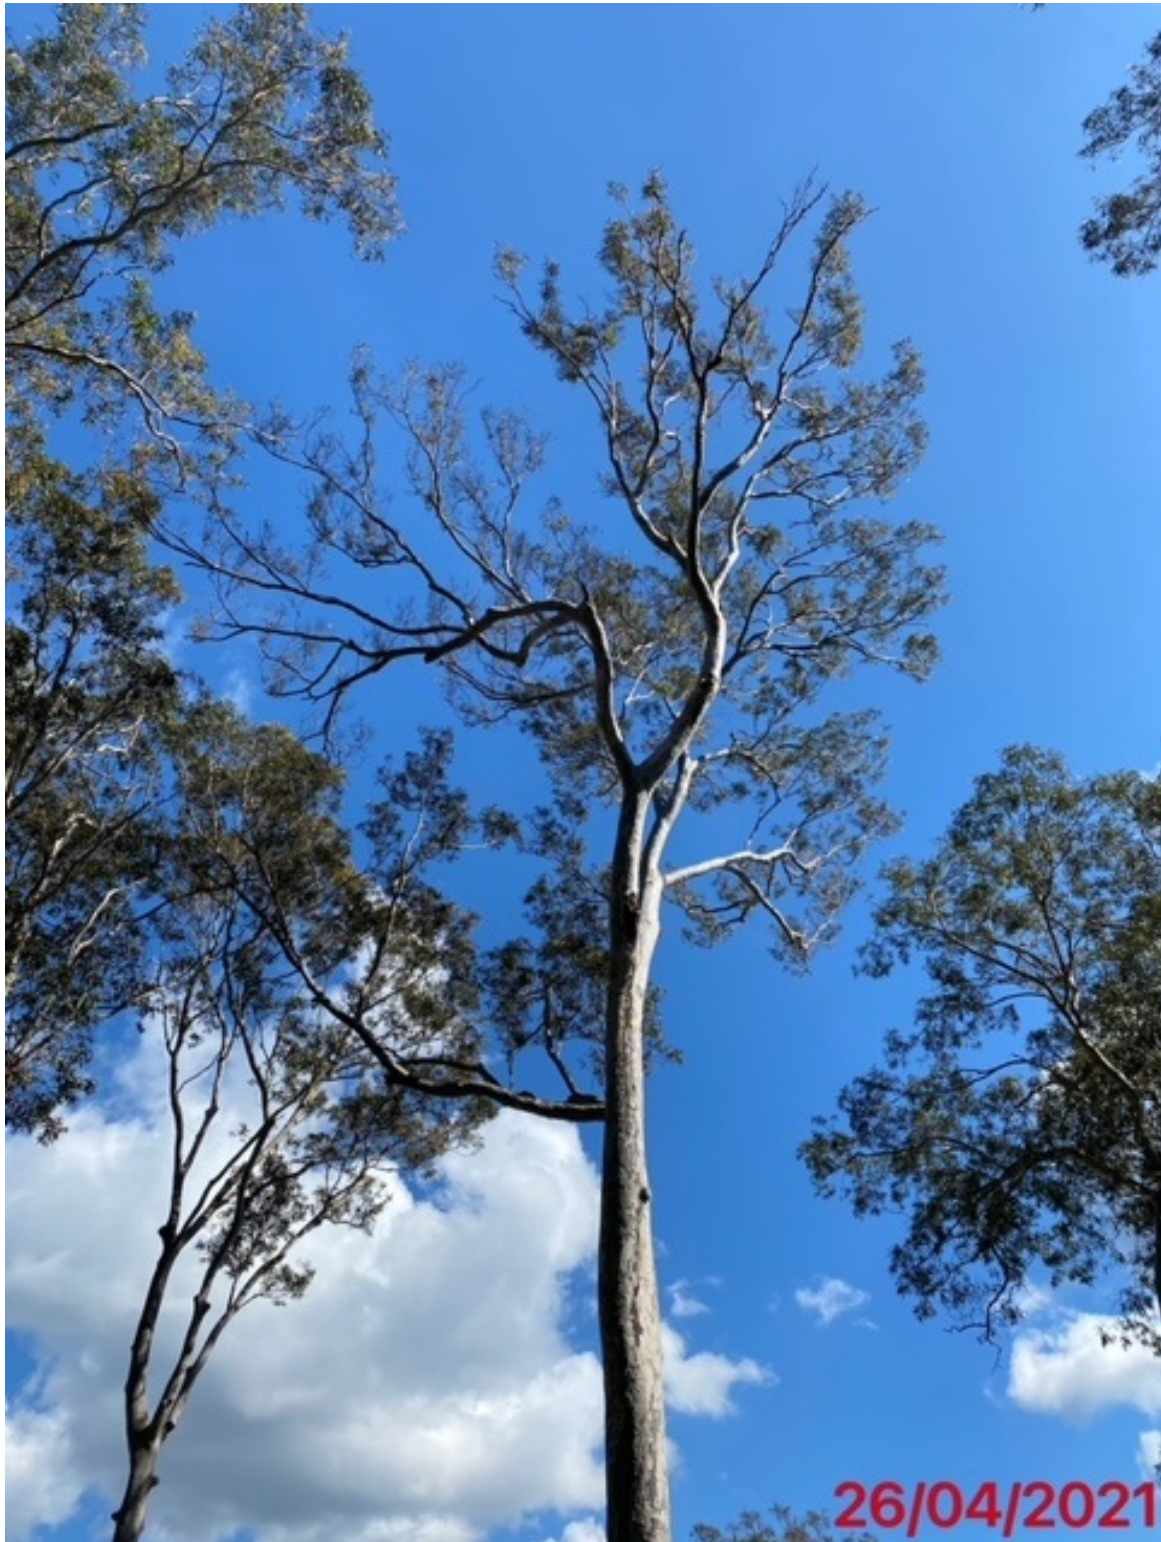
Prior to development at the site T21 was in poor health and condition,² *'Deadwood >40mm, epicormic shoots, sparse canopy, included fork at 15m above ground and cross branch approx. 17m above ground ... Overmature.'*

T21 is in decline and will not survive.

Half the canopy is dead and the other half is sparse and dieing, please refer to figure 1.

Figure 1, T21, *Corymbia maculata*, in decline

With construction well underway and work due to begin around T21 it would be advisable to remove the tree while it is in an open position and before it is incorporated into a new built environment.

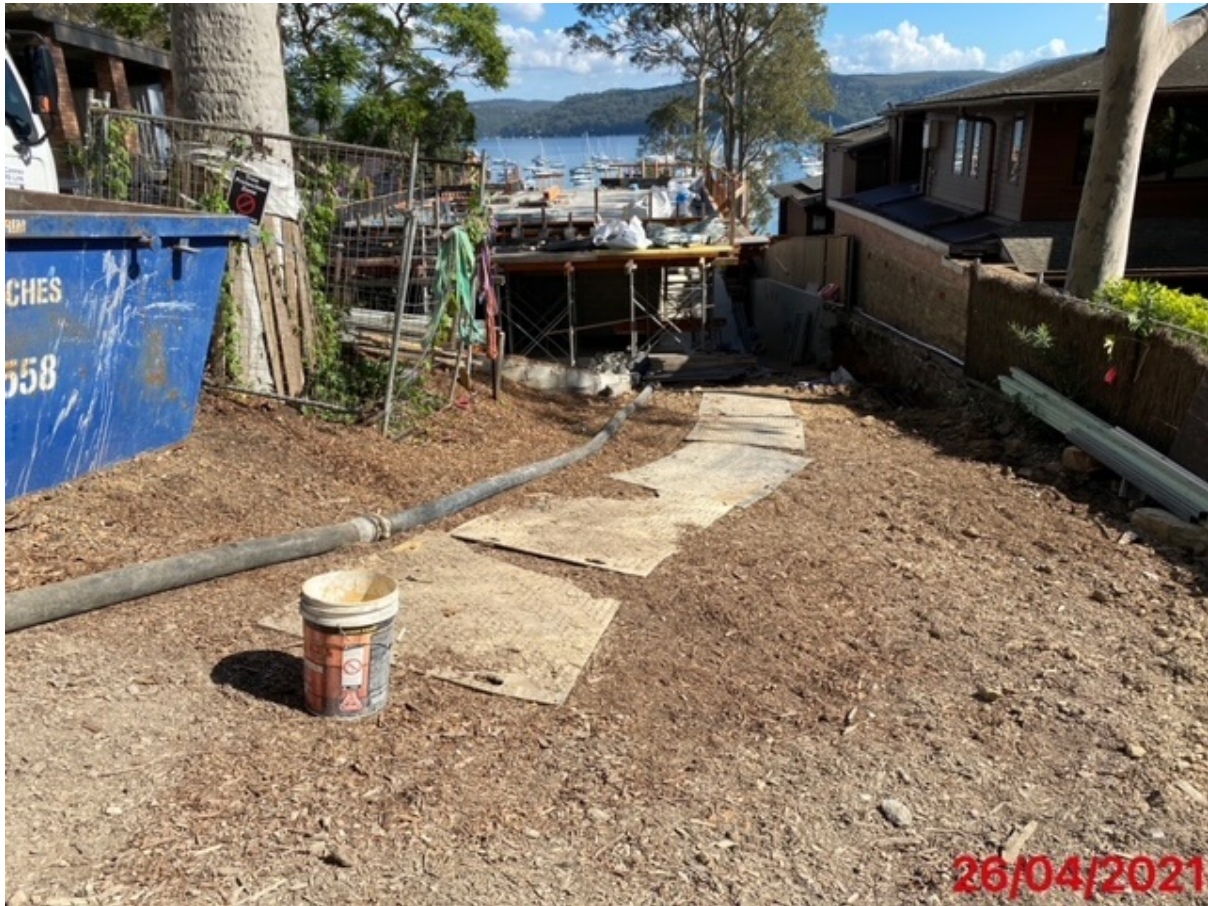
Figure 2, T21 front left, Tree protection in place as it has been maintained throughout construction
