Report Title: Geotechnical Report 87 Wallumatta Road, Newport

Report Date: 25/6/20

GEOTECHNICAL INVESTIGATION:

Alterations and Additions at 87 Wallumatta Road, Newport

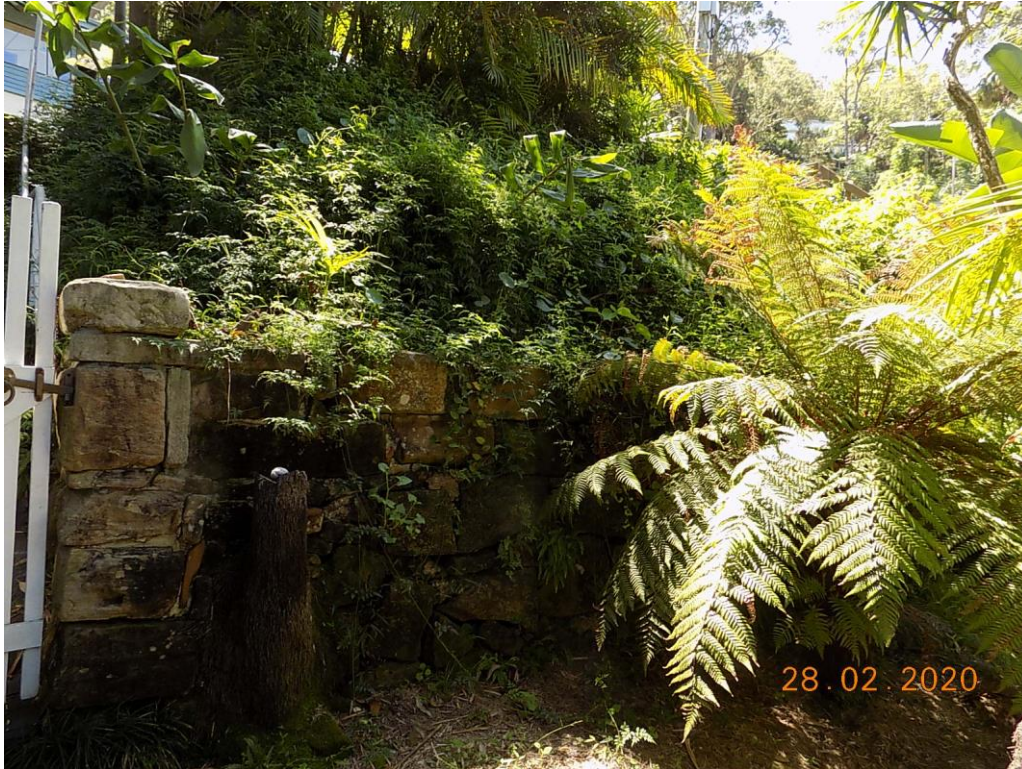
Photo 1

- 2.3** A small gravel parking area extends off the road frontage. The fill for the road and parking area is battered to stable angles (Photo 1). The fill batter is well-vegetated and falls to the top of a ~1.2m high stable sandstone block retaining wall that approximates the upper boundary (Photo 2). Between this wall and the house is stepped stable brick retaining wall ~1.0m high (Photo 3). The part two-storey brick house is supported on brick walls (Photo 4). No significant signs of movement were observed in the supporting brick walls. Some of the supporting walls were observed to be supported directly off outcropping competent Medium Strength Sandstone. A stormwater pipe discharges immediately below the house into a creek channel that runs down the centre of the downhill side of the property to and beyond the lower

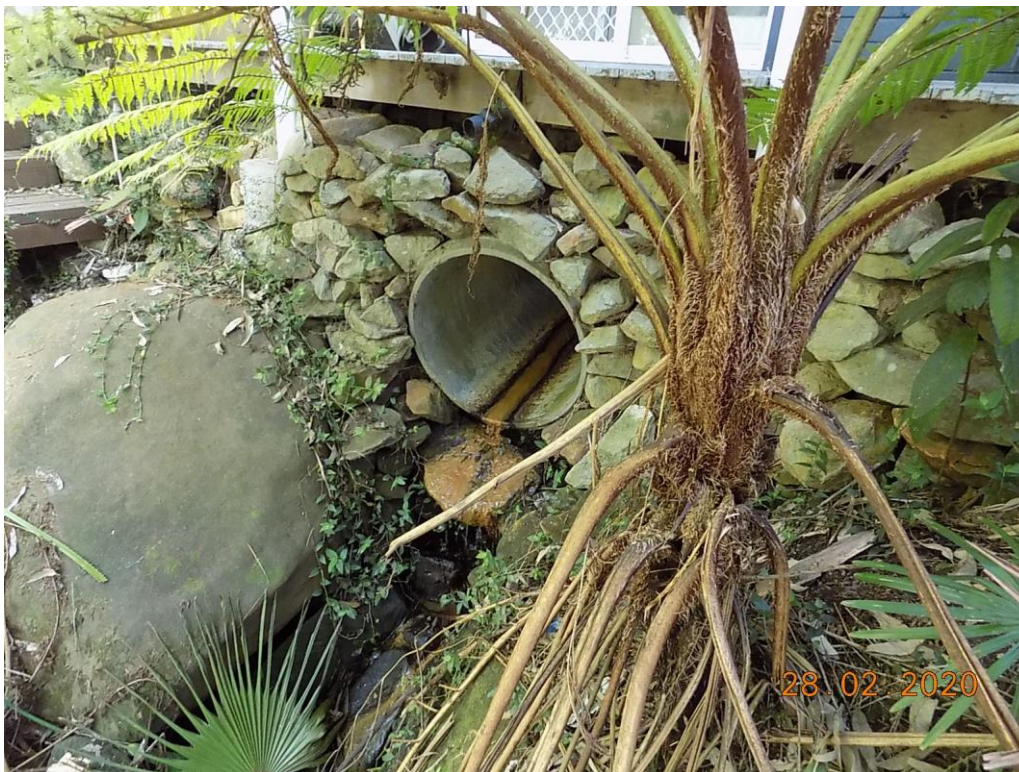
Photo 5

boundary (Photos 5 & 6). Medium Strength Sandstone bedrock was observed to be outcropping within the creek bed. Some sandstone boulders were also observed in the creek bed. The slope has been terraced on the E side of the creek with two stable sandstone block retaining walls reaching ~1.5m high (Photo 7). The slope around the creek is well-vegetated (Photo 8).

Ground water seepage is expected to move over the buried surface of the rock and through the cracks. As a creek flows down the centre of the block (Photos 5 & 6), we expect groundwater seepage to be slightly higher across the block as slope seepage will move toward the creek. Due to the slope and elevation of the block, the water table is expected to be many metres below the base of the proposed works.

A creek is piped down the centre of the site and under the house where it flows into a natural channel immediately below the deck on the downhill side of the house. This will have design implications for the proposed deck in terms of positioning of the supporting posts.

There is fall to the creek that runs down the property (Photos 5 & 6). Roof water from the development is to be piped to the creek through any tanks that may be required by the regulating authorities. A diffuser is to be installed at the outlet of any new stormwater pipes that divert stormwater to the creek channel.

The proposed deck is to be supported on piers taken into the underlying Medium Strength Sandstone. The supporting deck posts are to be positioned beyond either side of the creek channel. The sandstone is expected at depths of 0.2 and 1.3m below the current surface on either side of the creek channel. The piers are to be potted 0.3m into rock or attached to the rock with suitable bar (reo) grouted into the rock. A maximum allowable bearing pressure of 1000kPa can be assumed for footings on Medium Strength Sandstone.

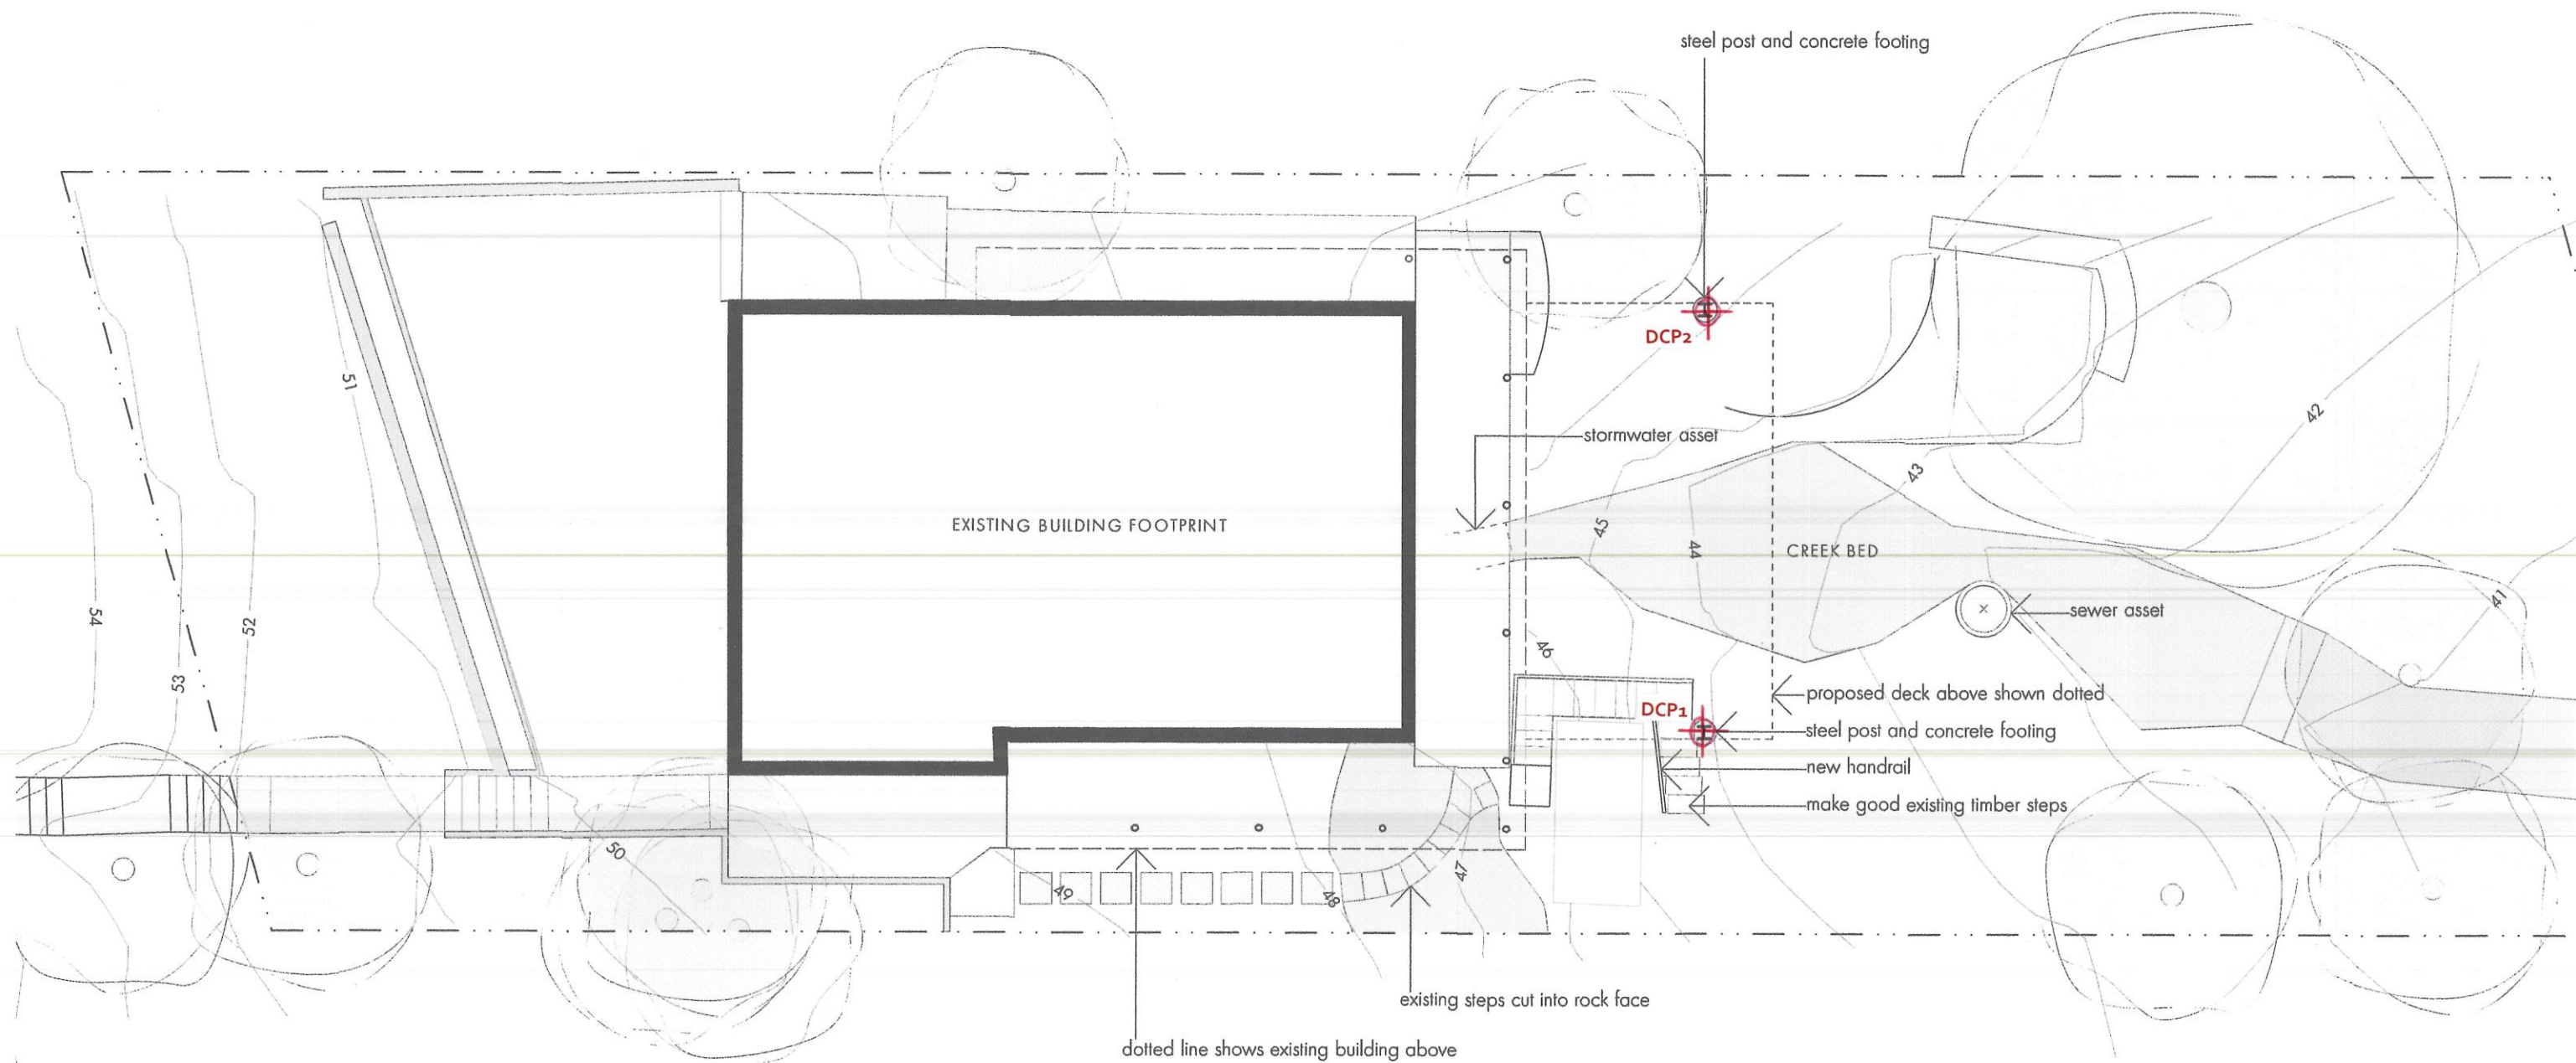
SITE PLAN – showing test locations

Two Dynamic Cone Penetrometer (DCP) tests were put down to determine the relative density of the overlying soil and the depth to bedrock. The locations of the tests are shown on the site plan. It should be noted that a level of caution should be applied when interpreting DCP test results. The test will not pass through hard buried objects so in some instances it can be difficult to determine whether refusal has occurred on an obstruction in the profile or on the natural rock surface. This is not expected to be an issue for the testing on this site and the results are as follows:

DCP1 – Refusal on rock @ 0.2m, DCP bouncing off rock surface, white impact dust on dry tip.

DCP2 – Refusal on rock @ 1.3m, DCP bouncing off rock surface, white impact dust on dry tip.

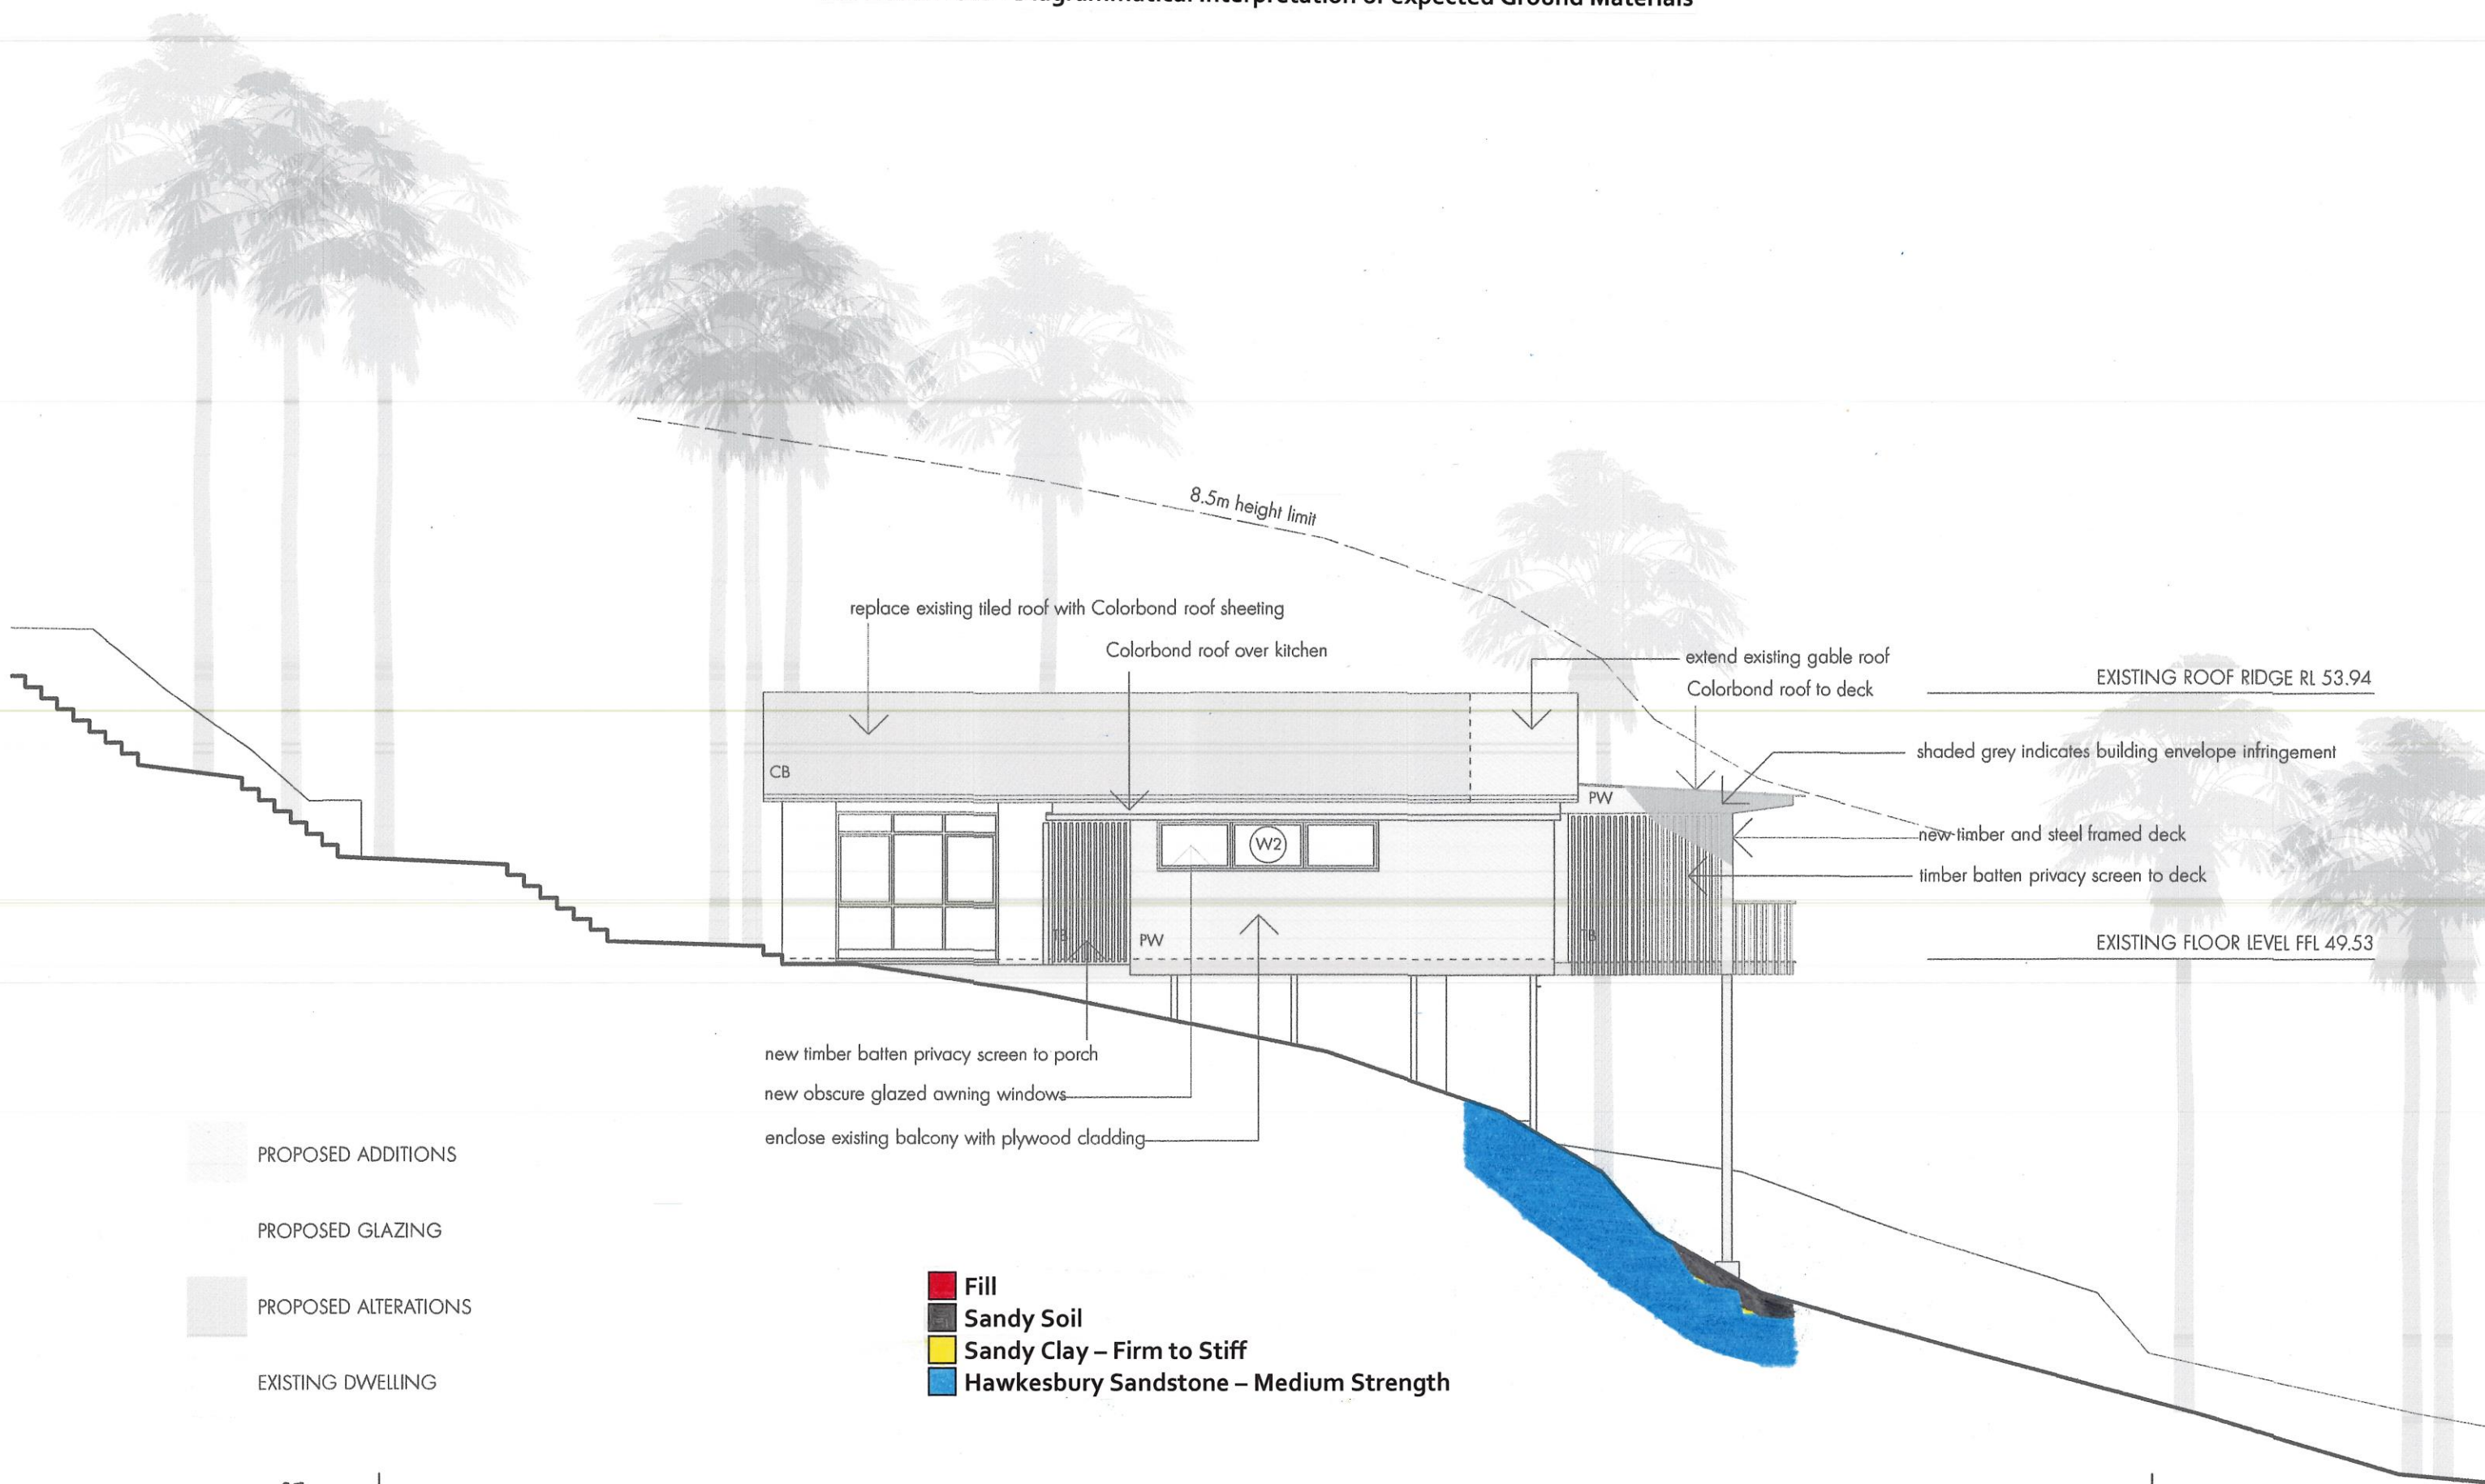
TYPE SECTION – Diagrammatical Interpretation of expected Ground Materials

The surface features of the block are controlled by the underlying sandstone bedrock that steps down the property forming sub-horizontal benches between the steps. Where the grade is steeper, the steps are larger and the benches narrower. Where the slope eases, the opposite is true. The rock is overlain by a thin sandy topsoil over firm to stiff sandy clays that fill the bench step formation. Filling has been placed on the E side of the creek channel for terracing. In the test locations, rock was encountered at depths of 0.2 and 1.3m below the current surface on either side of the creek channel. The deeper test (DCP2) was taken through the fill on the E side of the channel. The sandstone underlying the property is estimated to be medium strength or better as the DCP bounced at the end of every test and similar strength rock is expected to underlie the entire site. See Type Section attached for a diagrammatical representation of the expected ground materials.
