GEOTECHNICAL INVESTIGATION REPORT

ALTERATIONS AND ADDITIONS TO A DWELLING
21A GREYCLIFFE STREET, SEAFORTH NSW

PREPARED FOR GREG RITCHIE
REPORT ID: G25023QUE-R01F

Date: 7th April 2025

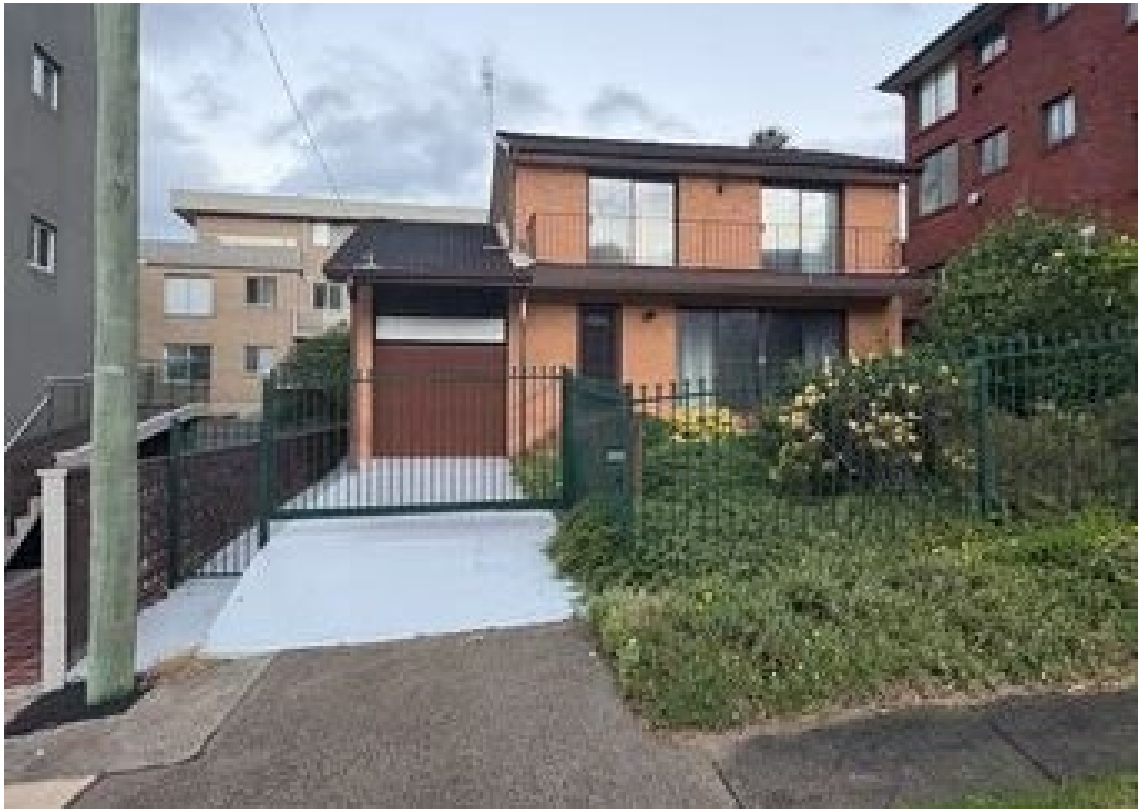
Plate 1: Front of the dwelling viewed to the west.

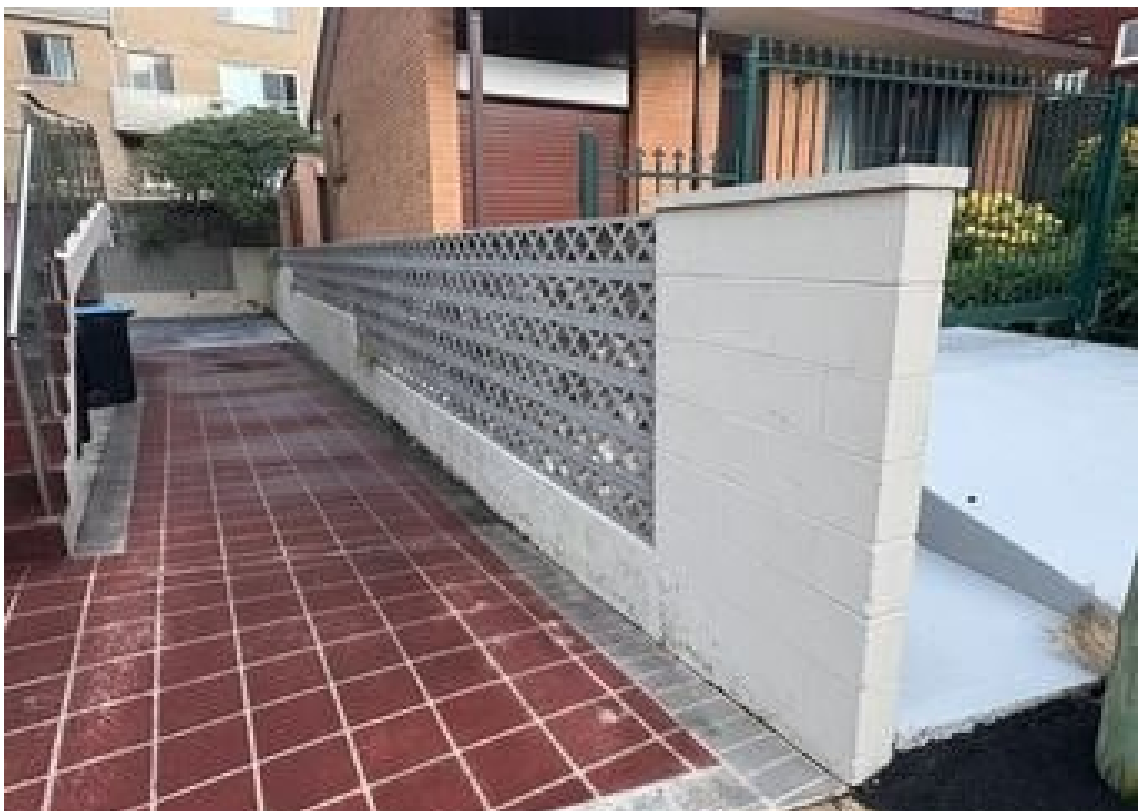
The southern boundary is retained by a concrete block retaining wall up to 1.70m in height, **Plates 2, 3 and 4** with the northern boundary being retained by a brick wall and a separate concreted wall, **Plates 5 and 6**. A garage has been constructed into the southern side of the ground floor level which is accessed by a concrete driveway from Greycliffe Street, **Plate 1**.

Plate 2: Southern boundary of the site viewed to the west.

- ◇ Retaining walls along the lower southern boundary and upper northern site boundaries to be assessed by a qualified structural engineer to ensure their current condition is adequate and meet the requirements of AS4678-2002: Australian Standard, 2002: Earth Retaining Structures (reference 5).
- ◇ Site drainage should be assessed to make sure surface water flows are not directly impacting retaining structures and natural slopes below.

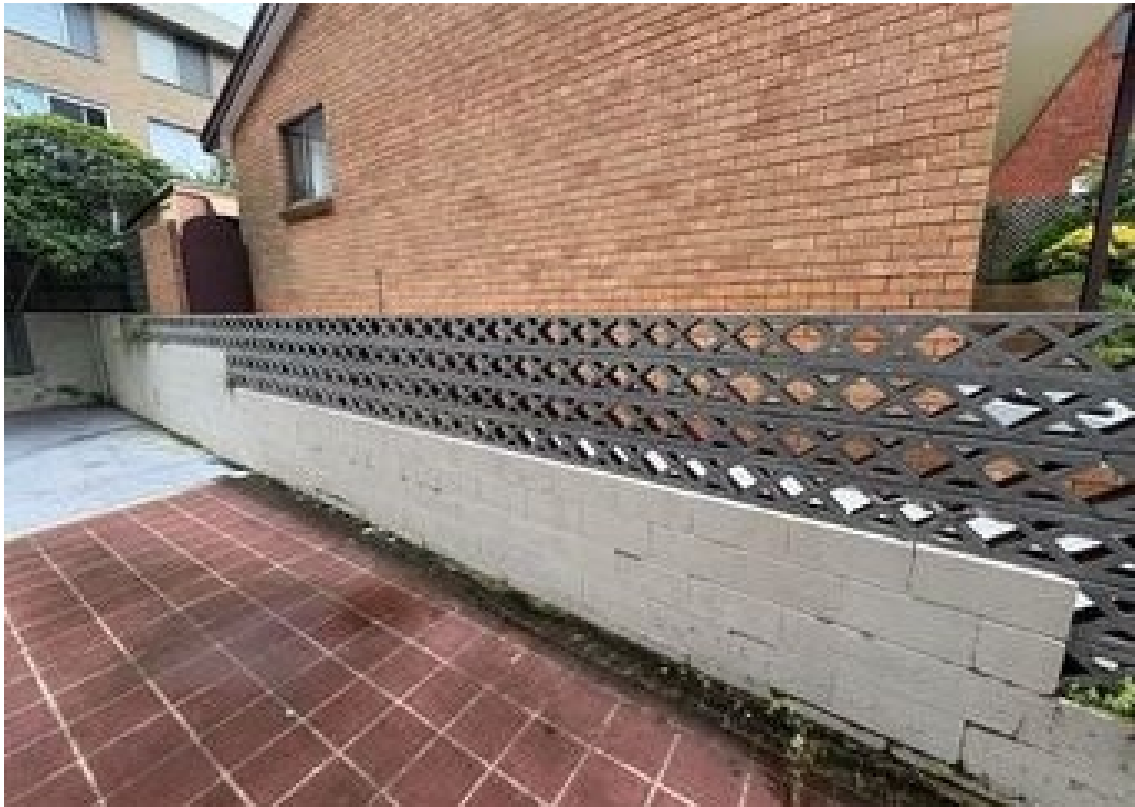
Plate 3: Southern site boundary viewed to the west.

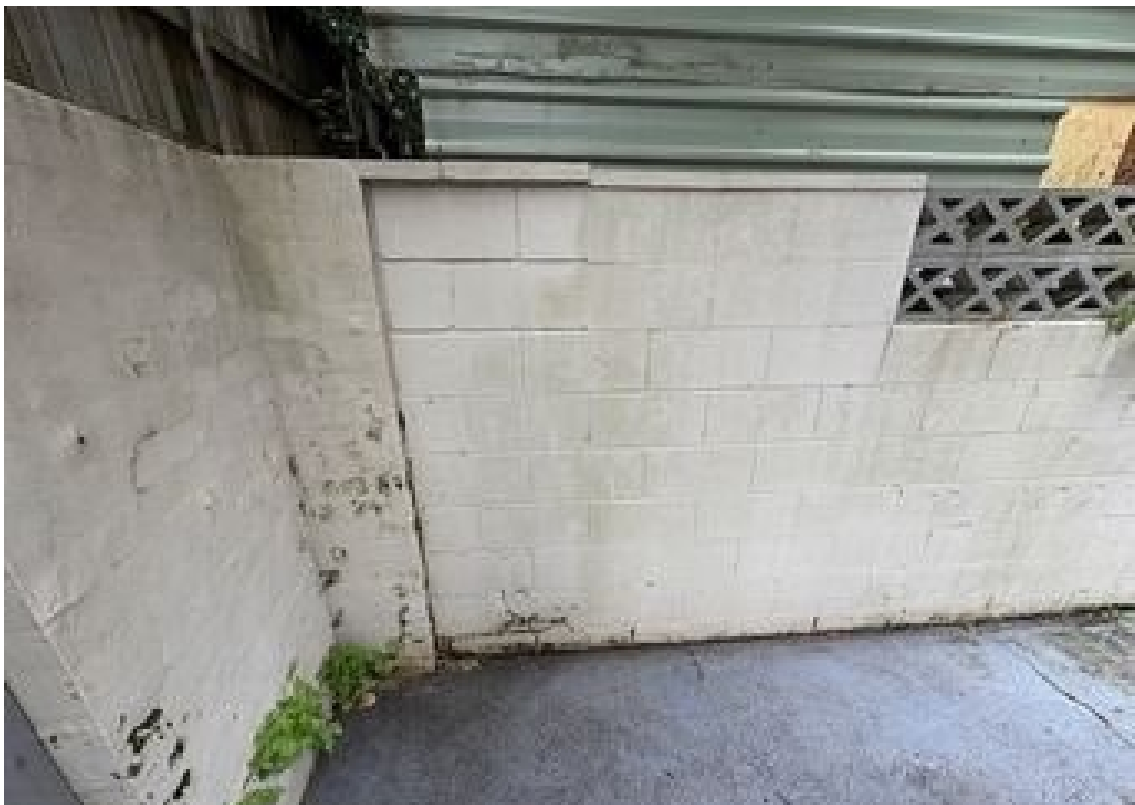
Plate 4: Southern site boundary viewed to the north.

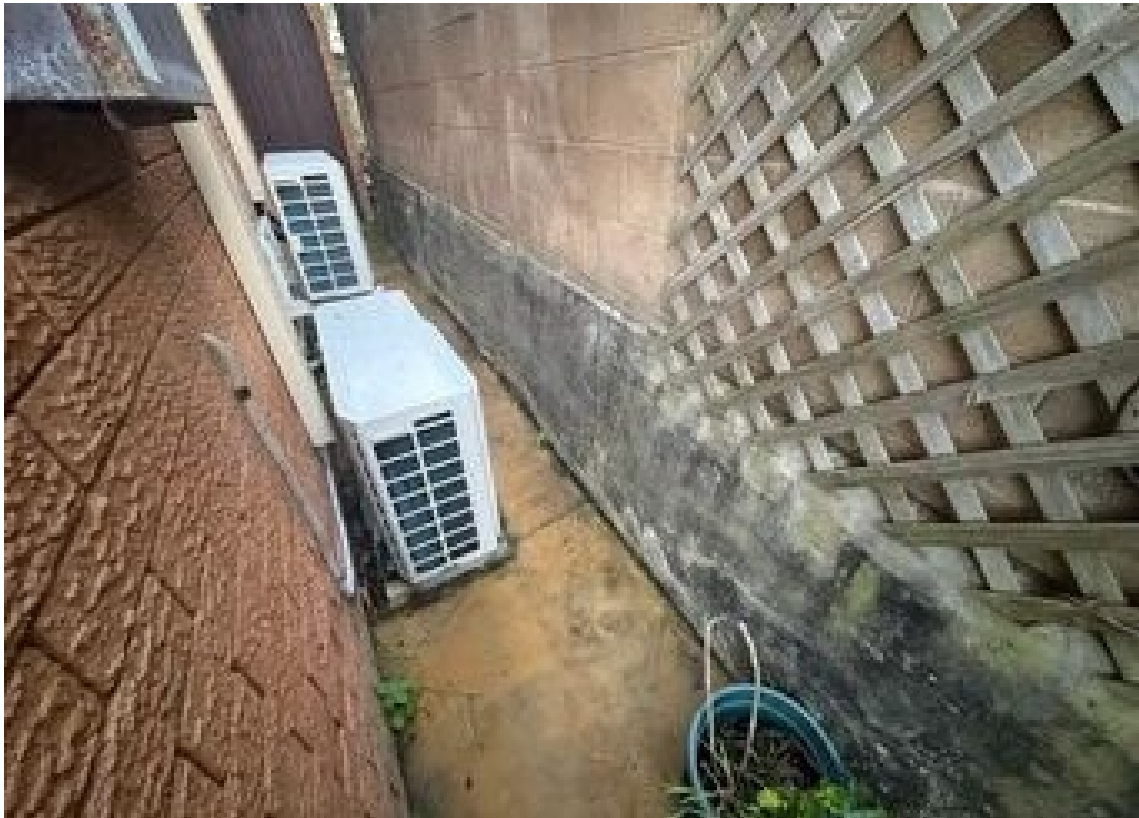
Plate 5: Low concrete retaining wall along northern site boundary viewed to west.

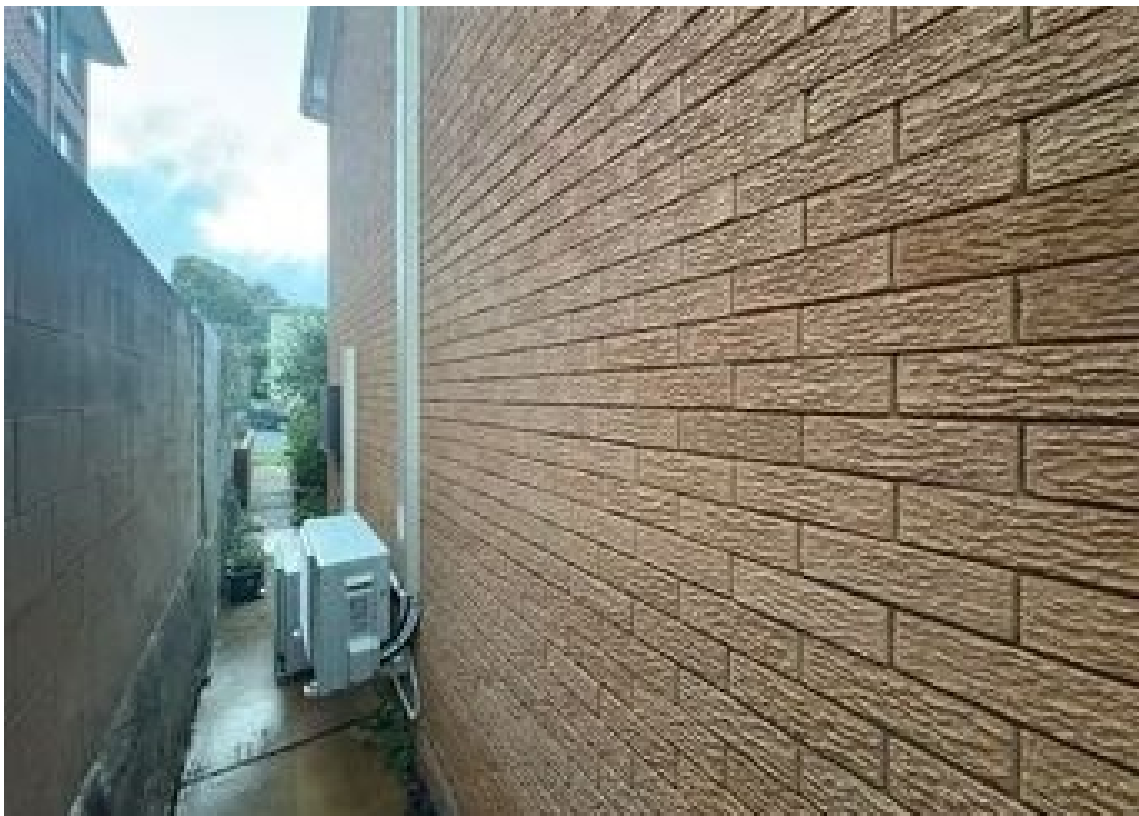
Plate 6: Low concrete retaining wall along northern site boundary viewed to east.

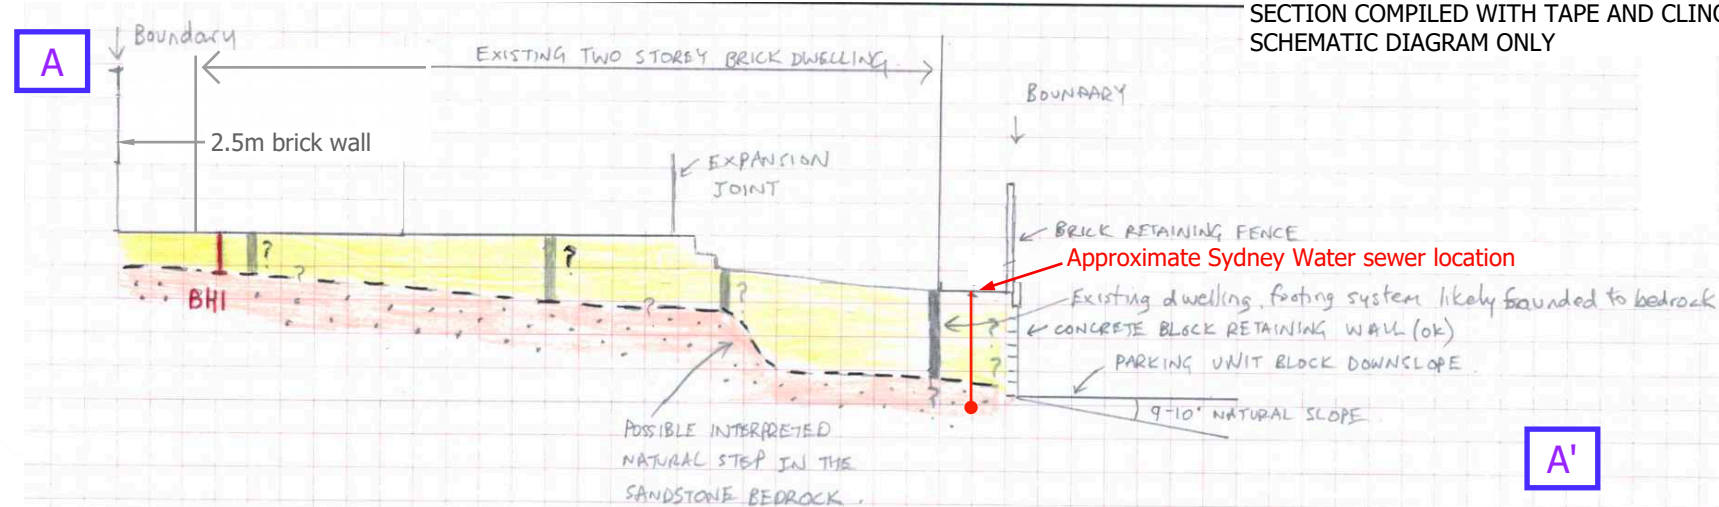
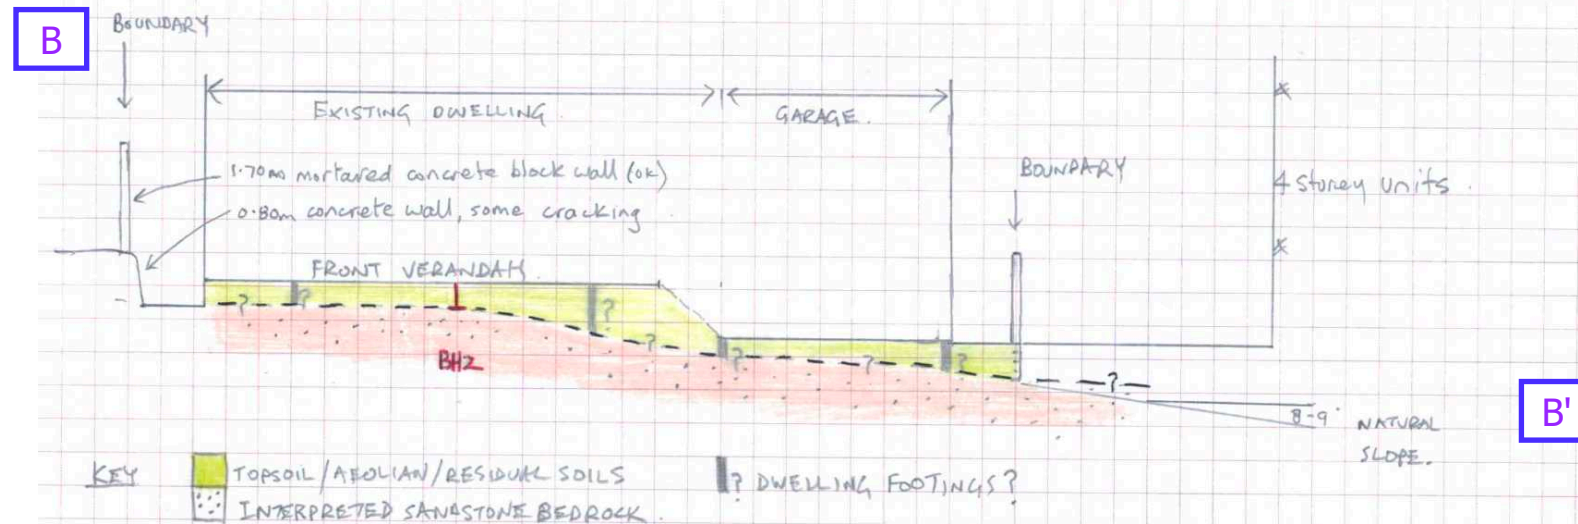
- NOTES:
- SHALLOW SANDSTONE BEDROCK IN BOREHOLES UPSLOPE SIDE SITE
 - NO ACCESS TO DO BOREHOLES LOWER SIDE SITE DUE TO CONCRETE SLABS
 - SOIL PROFILES WERE SATURATED DOWNSLOPE SEEPAGES
 - 2 STOREY BRICK DWELLING, EXTERNAL INSPECTION APPEARS IN GOOD CONDITION, LIKELY FOUNDED ON BEDROCK
 - NATURAL SANDSTONE CLIFFLINES OBSERVABLE 35-40m DOWNSLOPE TO SOUTH OF GREYCLIFF STREET
 - SOME CONCRETE BRICK STRUCTURES, CONCRETE SLABS ARE CRACKED, LIKELY DUE TO DIFFERENTIAL SETTLEMENTS POOR FOUNDATION TO ADJACENT BEDROCK
