# Geotechnical Assessment

**Project:** Alterations & Additions  
122 Hudson Parade, Clareville NSW

**Ref:** AG 25110  
17 March 2025

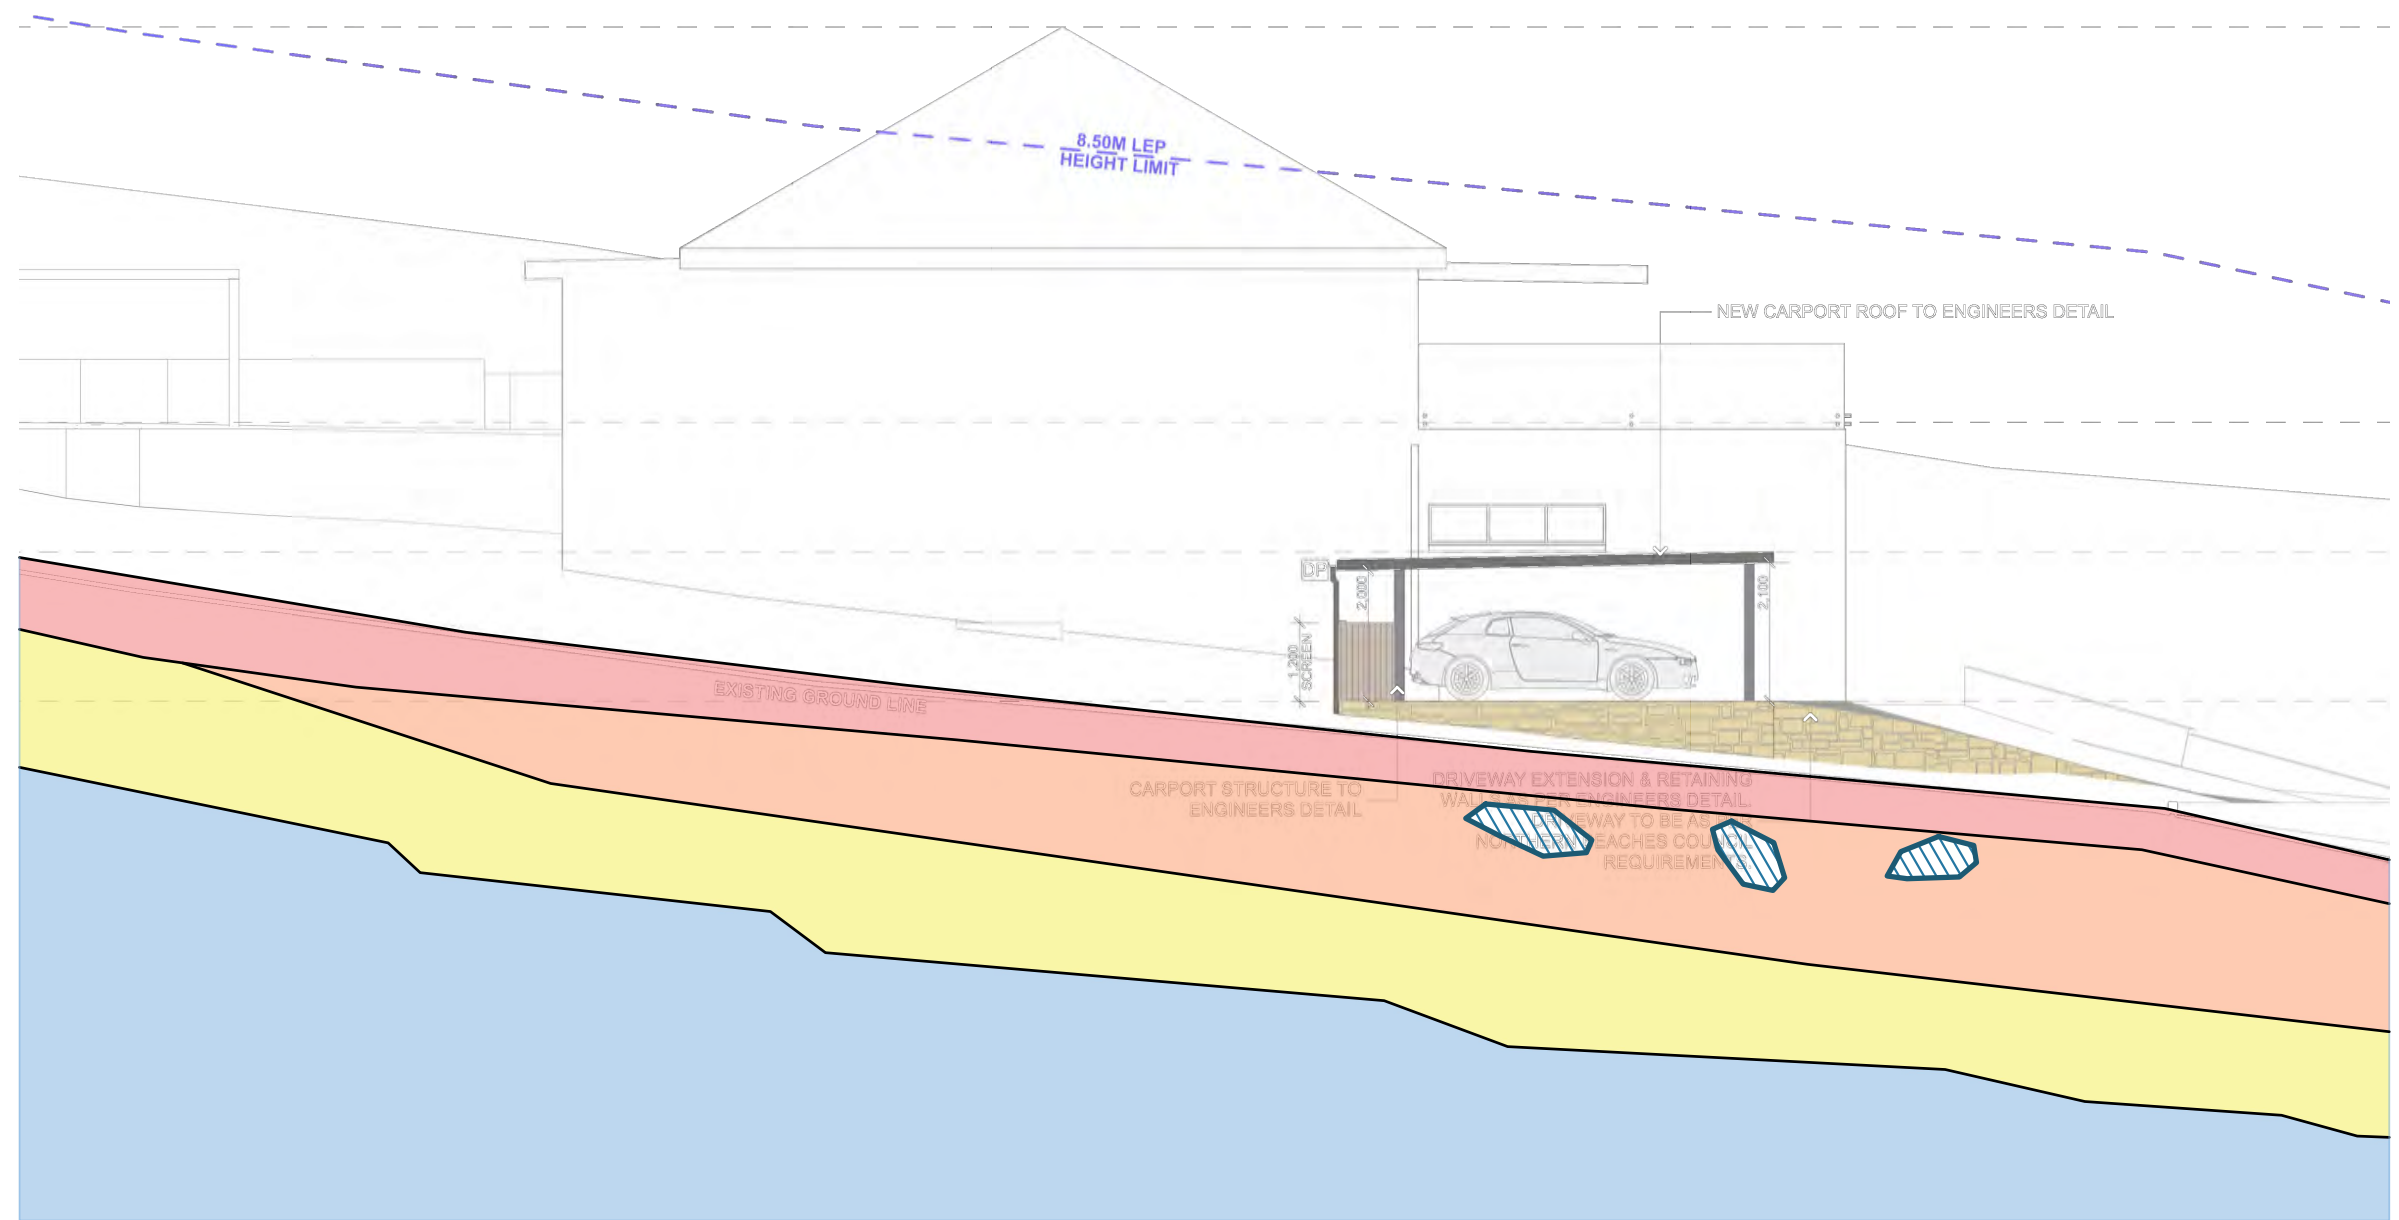
**INFERRED GEOLOGICAL SECTION**  
SCALE NTS

The soil profile is interpreted to consist of silty fill, silty topsoil, estuarine silty sand with occasional sandstone boulders (O & A Horizons), clay (B Horizon) and weathered low strength bedrock (C Horizon). Based on our observations and the results of testing on site, we would expect weathered low strength weathered bedrock to be found at approximately 2 metres below current surface levels across the area of the proposed works and potentially deeper where filling has been carried out.

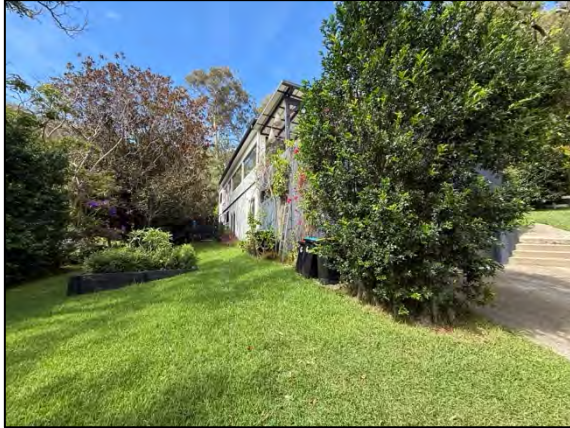
**Photo 1:** Location of proposed carport.

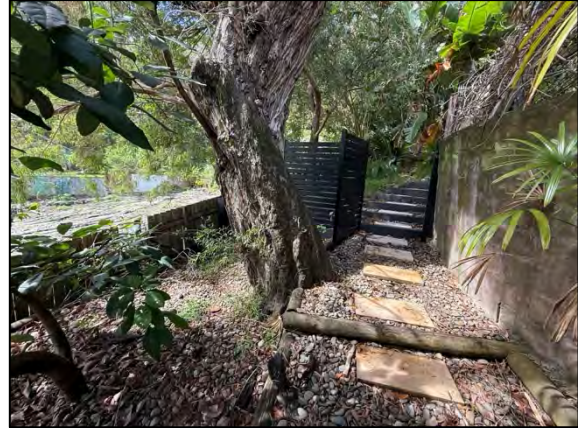
In the southeast of the site, a breeze/hollow block retaining wall, measuring approximately 2.5m high, supports the rear decking (above). The wall, at the time of the investigation, appeared to be in a good condition.

**Photo 2:** Breeze-block retaining wall in the south of the site.

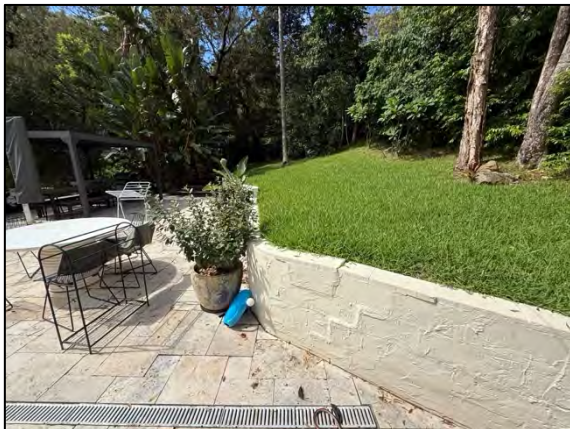
In the southwest of the site, a breeze/ hollow block retaining wall, measuring approximately 1m high, supports the rear garden (above). The wall at the time of the investigation was noted to be leaning at approximately 80 degrees to the northeast with some evidence of block dislodgement.

**Photo 3:** Failing breeze-block retaining wall in the rear of the garden.

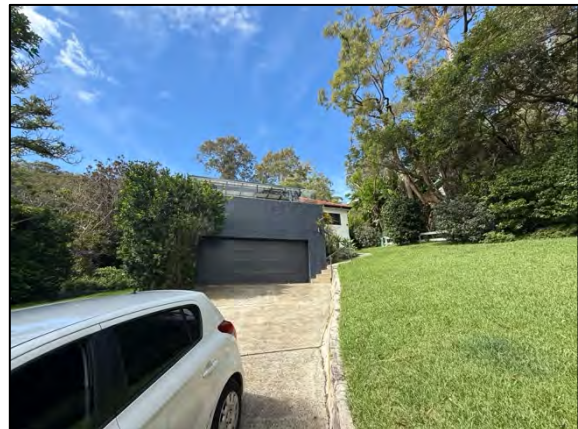
**Photo 4:** Front of residence.
