Report Title: Geotechnical report <b>63 MARINE PARADE, AVALON</b>
Report Date: 10/5/14
Author : BEN WHITE
Author's Company/Organisation : WHITE GEOTECHNICAL GROUP PTY LTD

## **GEOTECHNICAL INVESTIGATION:**

### **Alterations & Additions at 63 Marine Parade, Avalon**

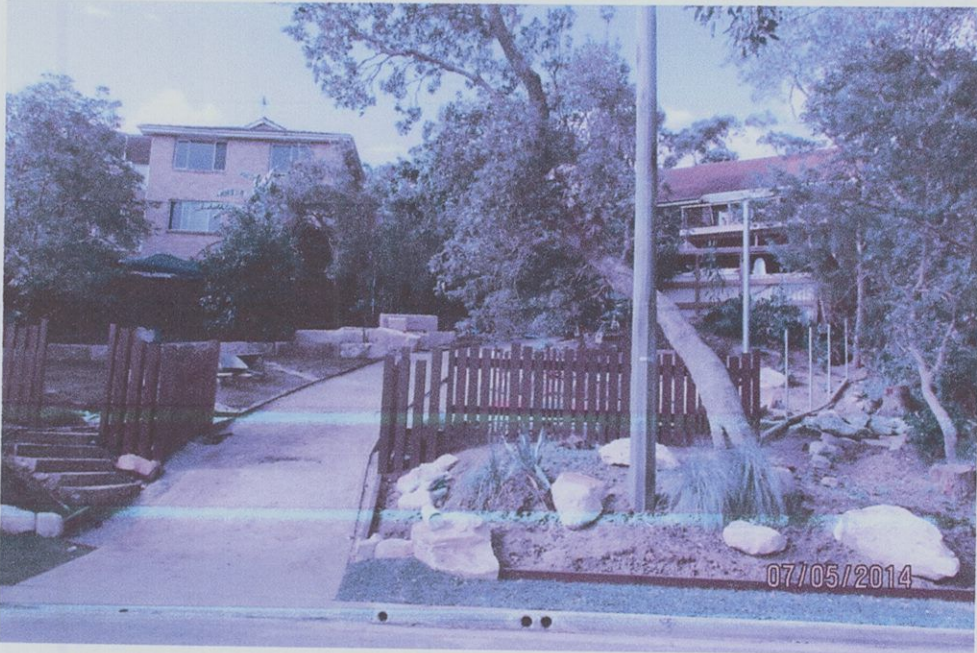
Photo 1

- 2.3 At the road frontage a concrete paved driveway climbs the slope to a brick carport below the house (Photo 1 & 2). The carport is constructed over a cut and fill in the slope. The cut is supported by a brick wall. The fill merges into the natural slope. The house is a two storey brick structure and has also been supported on a cut and fill. At the higher northern side sandstone bedrock is exposed in the cut. At the southern downhill corner some settlement is evident in the exterior supporting wall, where it is likely supported on the fill (Photo 3). On the uphill side of the house a cut has been made in the slope to provide a lawn area. The cut is supported by a brick wall that has cracked and tilted (Photo 4). This wall will be replaced as part of the works. Above the wall sandstone bedrock that caps the cliff outcrops and rises to the crest of the slope. At the crest the surface is level for ~10m before the cliff drops to the ocean (Photo 5). The top half of the face is horizontally bedded sandstone with shale beds forming the lower half (Photo 6). Some minor undercutting was observed through the upper sandstone beds but the majority of the face within the property contained no undercutting and is considered stable. The base of the cliff is protected from the erosive forces of wave action by the rock platform and boulders that have accumulated at the base of the cliff as part of the normal weathering process.

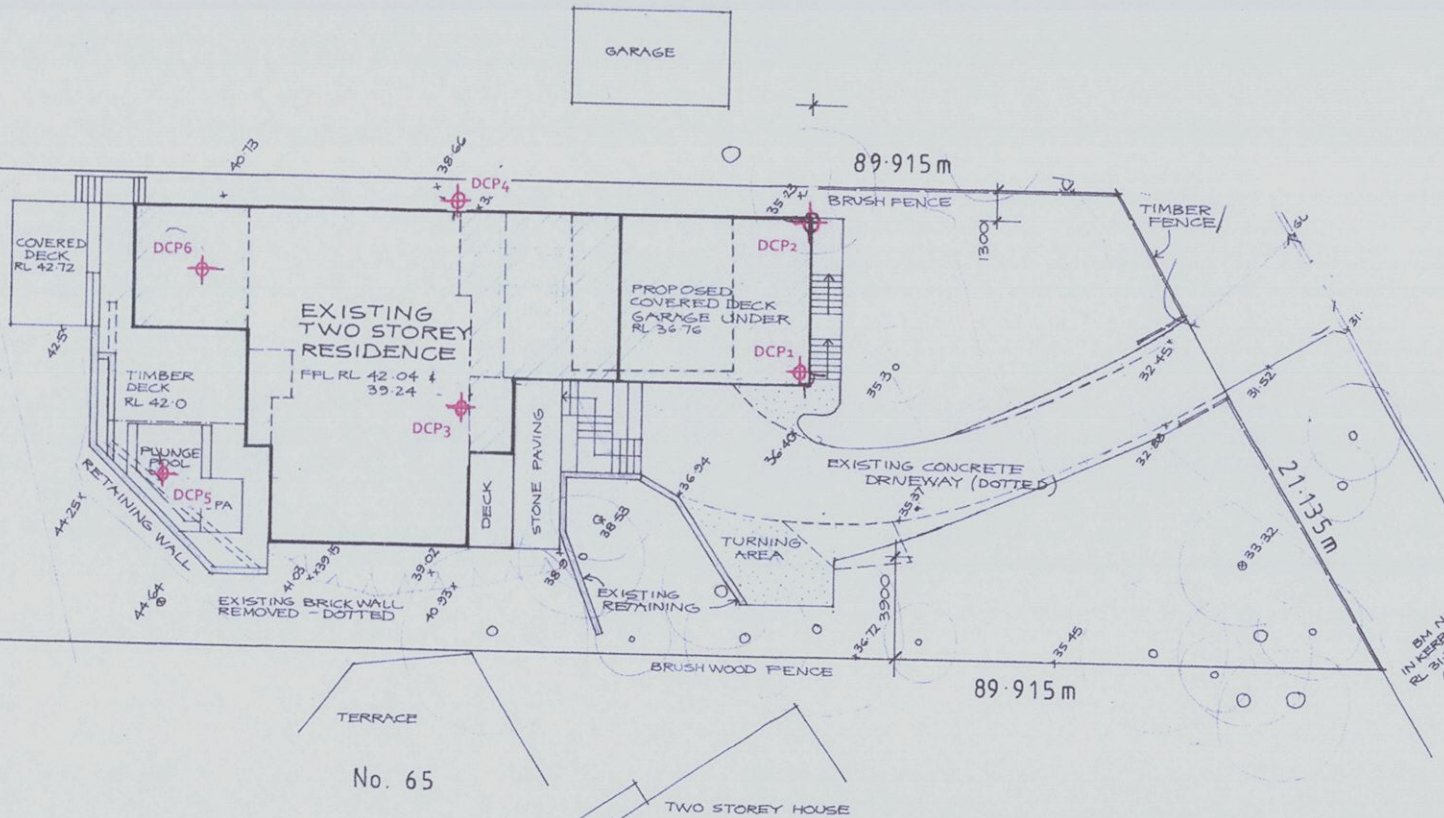
SITE PLAN – showing test locations

Five DCP (Dynamic Cone Penetrometer) tests were put down to determine the relative density of the overlying soil and the depth to bedrock. The location of the tests are shown on the site plan and the results are as follows:

- DCP1 – end of test @ 1.2m, nothing on dry tip.
- DCP2 – end of test @ 0.9m, nothing on dry tip.
- DCP3 – end of test @ 0.6m, nothing on dry tip.
- DCP4 – end of test @ 0.1.8m, nothing on dry tip.
- DCP5 – refusal @ 0.6m on rock, orange impact dust on dry tip.
- DCP6 – end of test @ 0.9m, light brown impact dust on dry tip.

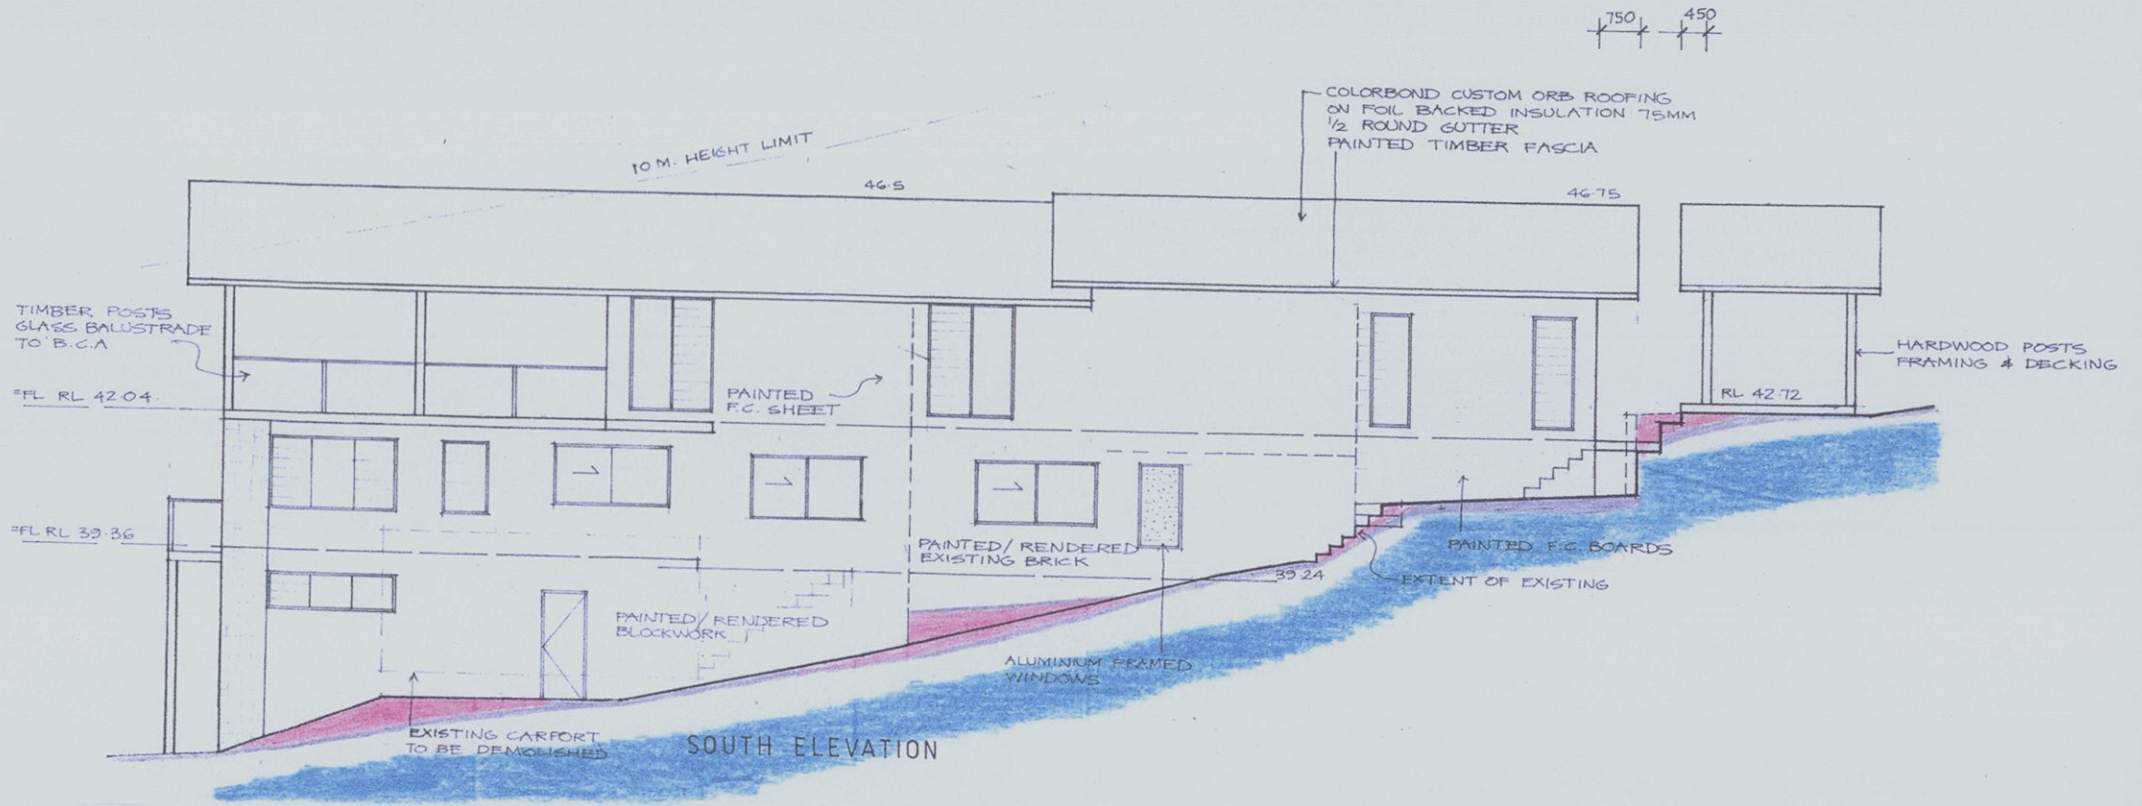
TYPE SECTION

The slope materials are colluvial at the near surface and residual at depth. They consist of sandy clays and clays with rock fragments throughout the profile. The sandy clays and clays merge into the weathered zone of the underlying rocks at depths expected to be in the range 0.6 to 1.5m. The weathered shale can appear as a mottled maroon to light grey stiff clay when it is cut up by excavation equipment. Fill is expected at the southern downhill corner of the house, behind the brick retaining wall on the downhill side of the house and below the downhill side of the garage.

- Fill
- Topsoil
- Sandy Clay
- Narrabeen Group Rocks – sandstone beds expected above the house, shale beds expected below - on encounter after excavation can resemble a stiff to hard clay
