J3065. 11<sup>th</sup> November, 2020. Page 1.

# **GEOTECHNICAL INVESTIGATION:**

New Secondary Dwelling at 36 Weeroona Avenue, Elanora Heights

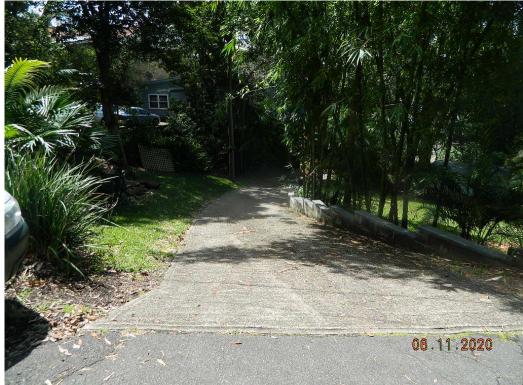
Photo 1

**2.3** At the road frontage a concrete driveway runs to down the slope to a gravel parking area (Photos 1 & 2). Beside the driveway is a moderately sloping lawn (Photo 3). The fill for the parking area is supported by a low sandstone block retaining wall (Photo 4). A brick/timber clad shed, timber deck and pool in good condition are located downhill of the parking area (Photos 5). The two storey rendered and steel clad house is supported by rendered walls and a concrete slab (Photos 5 to 7). The external supporting walls display no significant signs of movement. The cut for the house is supported by a low sandstone flagging retaining wall. A portion of the cut has

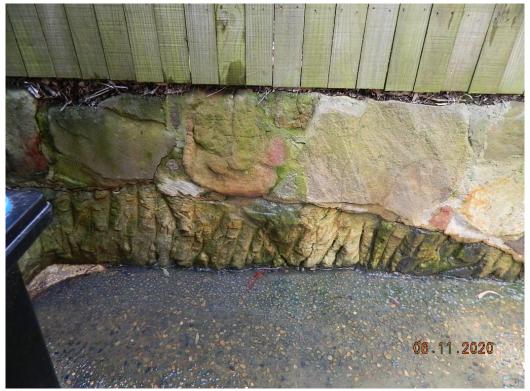
Photo 8

exposed Medium Strength Hawkesbury Sandstone bedrock (Photo 8). No signs of slope instability were observed on the property. The adjoining neighbouring properties were observed to be in good order as seen from the street and subject property.

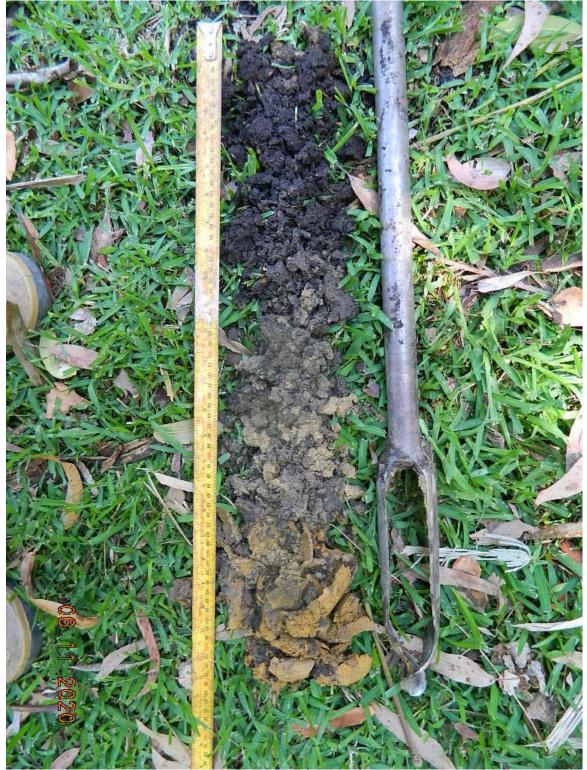
# AUGER HOLE 1 (~RL54.5) - AH1 (photo 9)

Depth (m)	Material Encountered
0.0 to 0.2	<b>TOPSOIL</b> , sandy soil, dark brown, damp, fine to medium grained with fine trace organic matter.
0.2 to 0.5 0.5 to 0.6	SAND, grey and light brown/white, damp, medium grained. SANDY CLAY, light orange/brown, firm, damp.

Refusal @ 0.6m in firm Sandy Clay. No watertable encountered.

Photo 9: AH1 – Downhole is from top to bottom.

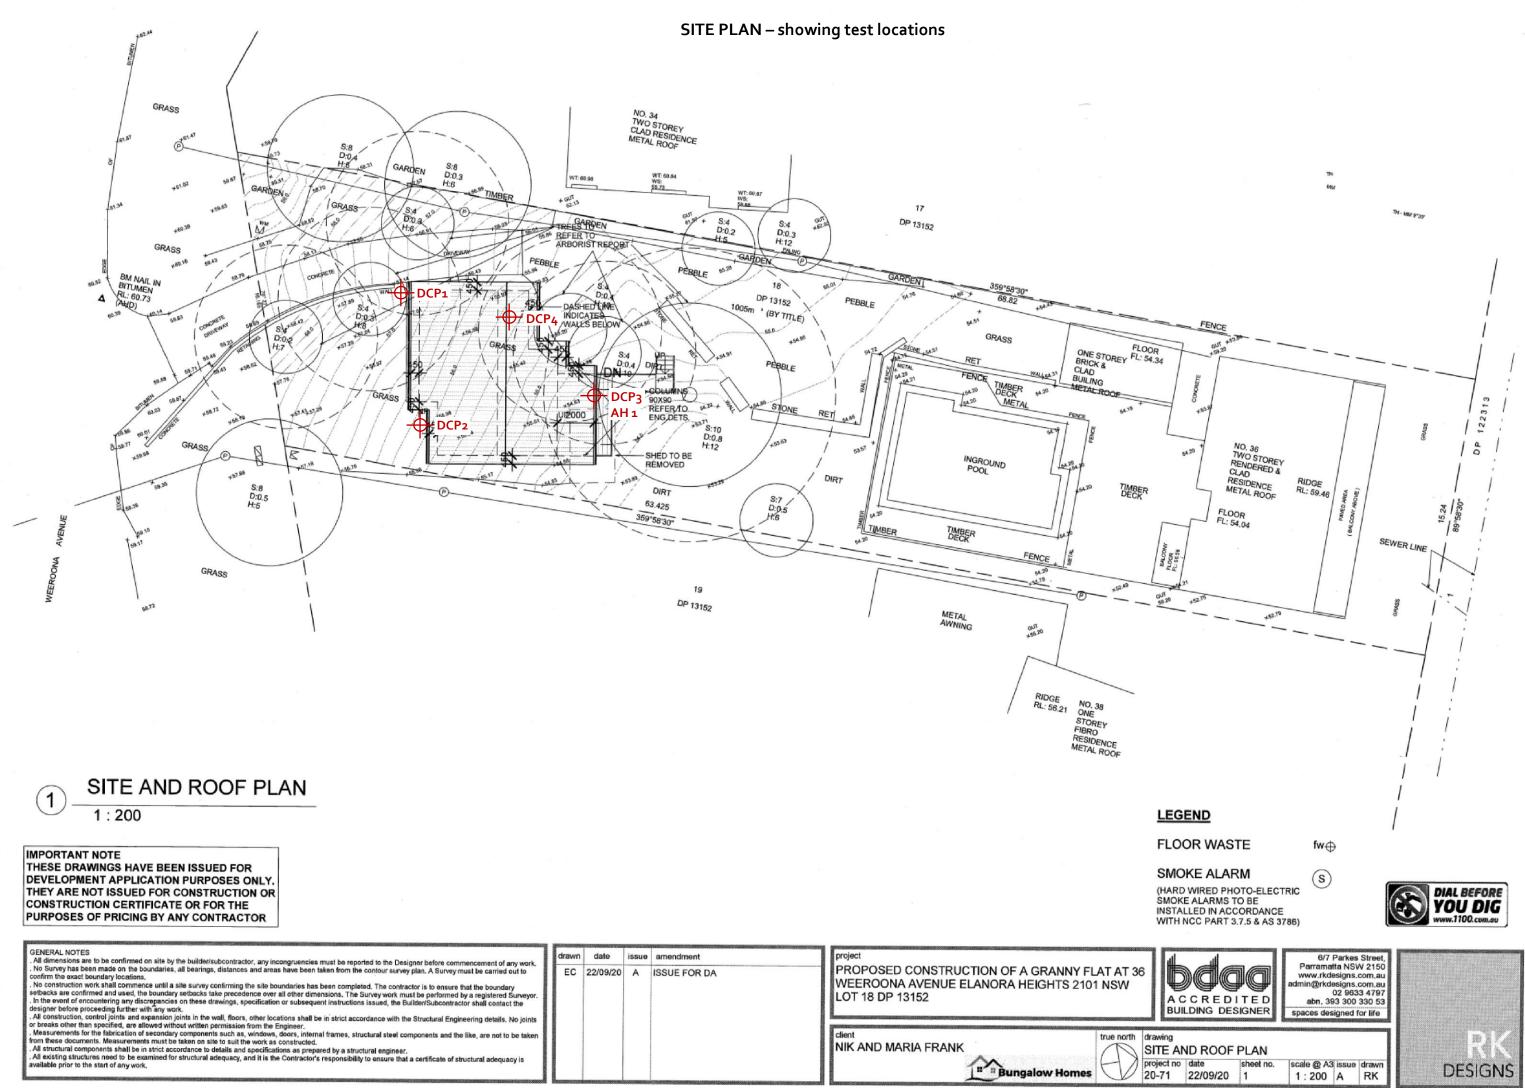
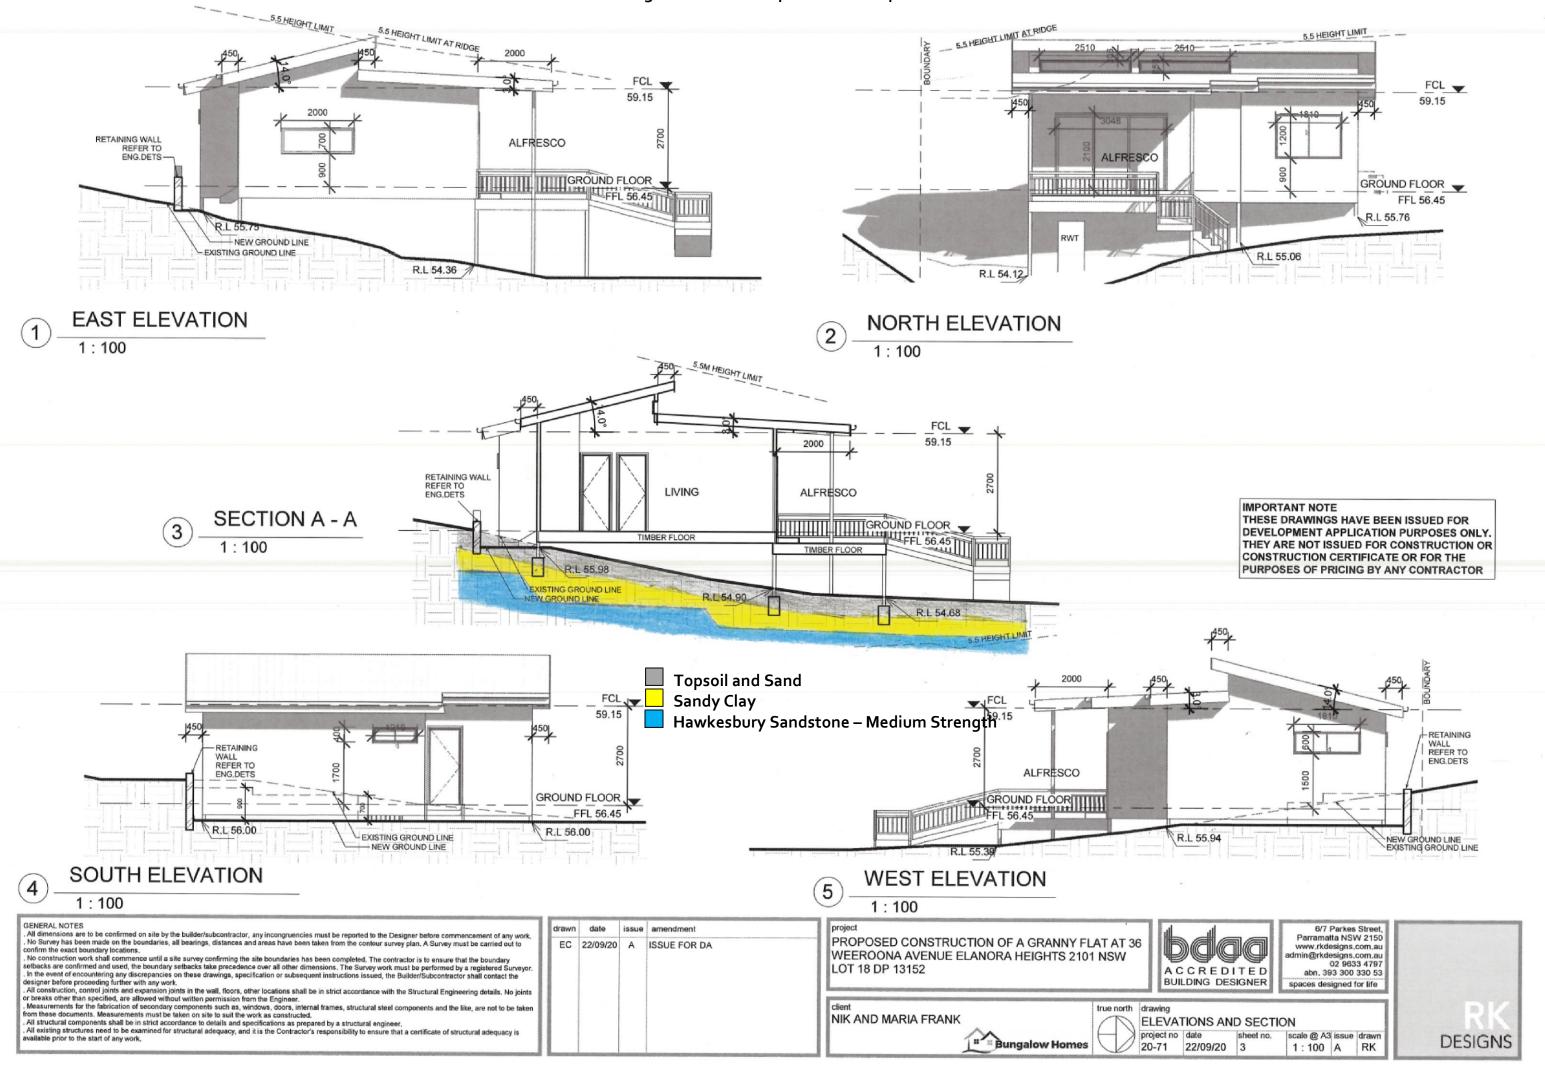
**TYPE SECTION – Diagrammatical Interpretation of expected Ground Materials**

The surface features of the block are controlled by the underlying sandstone bedrock that steps down the property forming sub-horizontal benches between the steps. Where the grade is steeper, the steps are larger and the benches narrower. Where the slope eases, the opposite is true. The rock is overlain by a sandy topsoil, sand and sandy clays that fill the bench step formation. Fill has been placed over the soil profile in the location of the parking area to reduce the slope and form a near level platform. In the test locations, the depth to rock ranged from between 1.0m to 1.4m below the current surface. The sandstone underlying the property is estimated to be Medium Strength or better. See Type Section attached for a diagrammatical representation of the expected ground materials.
