# Jack Hodgson Consultants Pty Limited

MR 30957  
26<sup>th</sup> July, 2017  
Page 1

## GEOTECHNICAL ASSESSMENT REPORT FOR PROPOSED ALTERATIONS AND ADDITIONS AT 9 LOLITA AVENUE FORESTVILLE

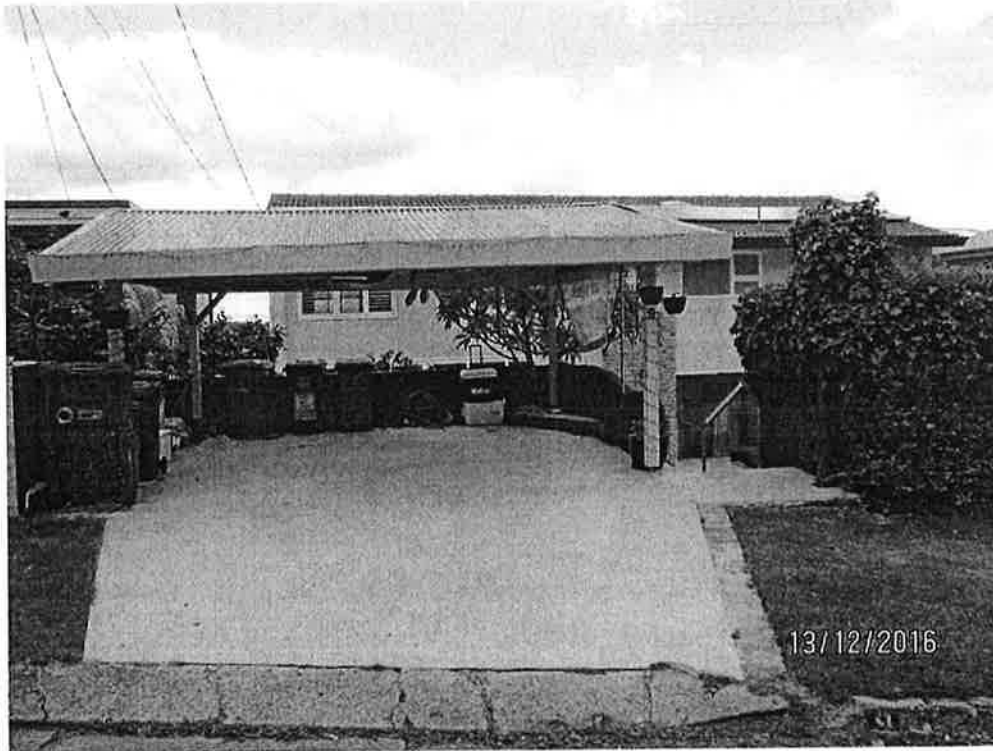
Photo 1

3.3 Vehicular access to the block is via a short concrete vehicle crossing and driveway that provides access to a carport (Photo 1). The road reserve is largely level and lawn covered. A concrete inground swimming pool is situated at the northern corner of the block. The cut for the pool area is supported by a brick wall that extends along the northern boundary of the block (Photo 2). A paved patio and courtyard area extend along the northern side of the residence (Photo 3). Access to the rear of the block is via a corridor that extends along the south-eastern boundary. Timber stairs drop down to the lower yard level (Photo 4). A Hawkesbury Sandstone escarpment extends north-west south-east along the middle of the block (Photo 5). The escarpment is comprised of massive, horizontally bedded quartz sandstone. The escarpment is mildly undercut toward the base, and has a number of well-developed joints (Photo 6). A half tennis court is situated on the lower garden level (Photo 7). The slope below the tennis court is vegetated with native low shrubs.

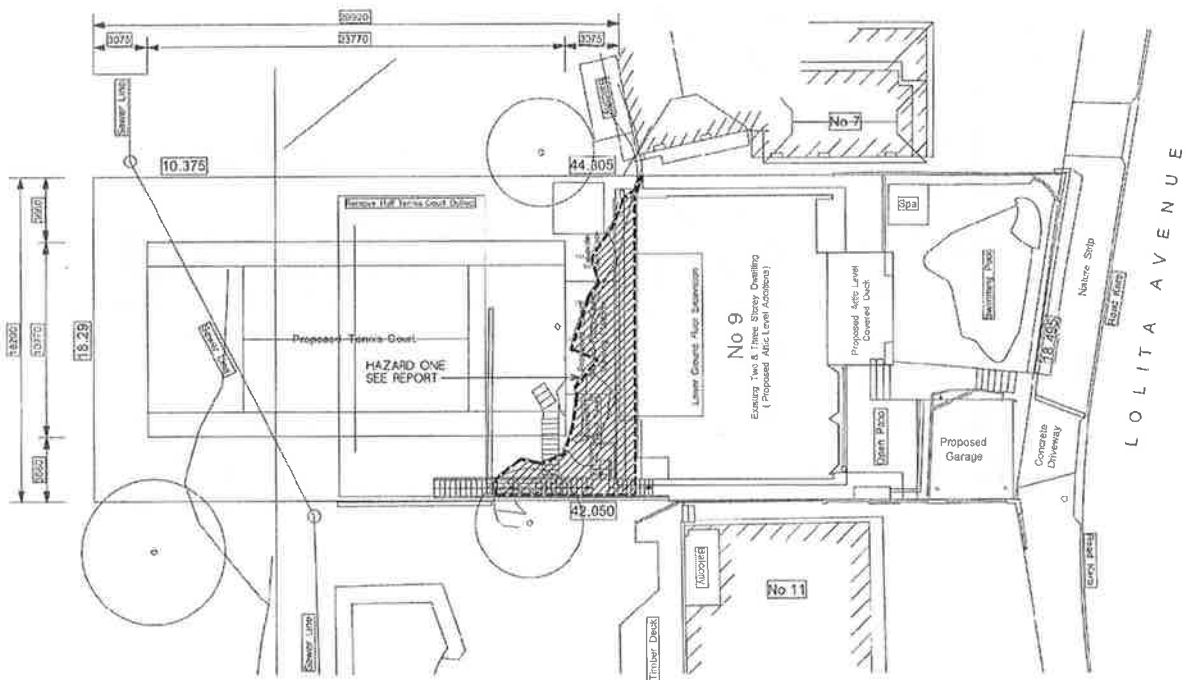
## SITE PLAN - HAZARD LOCATIONS

The excavations required for the proposed development are considered a potential hazard (**HAZARD ONE**).

An excavation to an approximate maximum depth of 2.50m will be required for the proposed development. The bulk of this excavation is expected to be through competent Hawkesbury Sandstone bedrock at the base of the escarpment. Provided the recommendations given in Section 10 are undertaken the likelihood of the cut failing and impacting on the worksite is assessed as 'Unlikely' ( $10^{-4}$ ). The consequences to property of such a failure are assessed as 'Minor' (5%). The risk to property is 'Low' ( $5 \times 10^{-6}$ ).

**10.2.1** The cuts for the proposed tennis court and surrounds and proposed lower ground floor extension will reach maximum depths of approximately 2.50 metres (tennis court) and 1.50 metres (lower ground floor extension). These are expected to be through a superficial layer of topsoil before underlying competent Hawkesbury Sandstone is found at shallow depths.

**10.2.3** Due to the proximity of the escarpment we recommend an onsite meeting be scheduled with the geotechnical engineer and the excavation contractor to approve the excavation methodology and equipment before the commencement of any significant excavations.

**10.2.6** All excavation through rock must be carried out using equipment that results in minimal vibration so as not to impact on the existing structures or neighbouring properties. A Rock Saw is ideally suited for this purpose. If hydraulic picks are to be used the energy input per blow should not exceed 300 Joules. A 300kg Rock Breaker produces 250 to 600 Joules depending on the type (brand) of breaker. This should be confirmed with the manufacturer. Rock breaking should be carried out in short bursts to prevent amplification of vibration.
