Proposed New Pool 1 Norma Road, Palm Beach NSW

Further Geotechnical Assessment and Investigation

Our ref: 6550-1-G1 2 December 2021

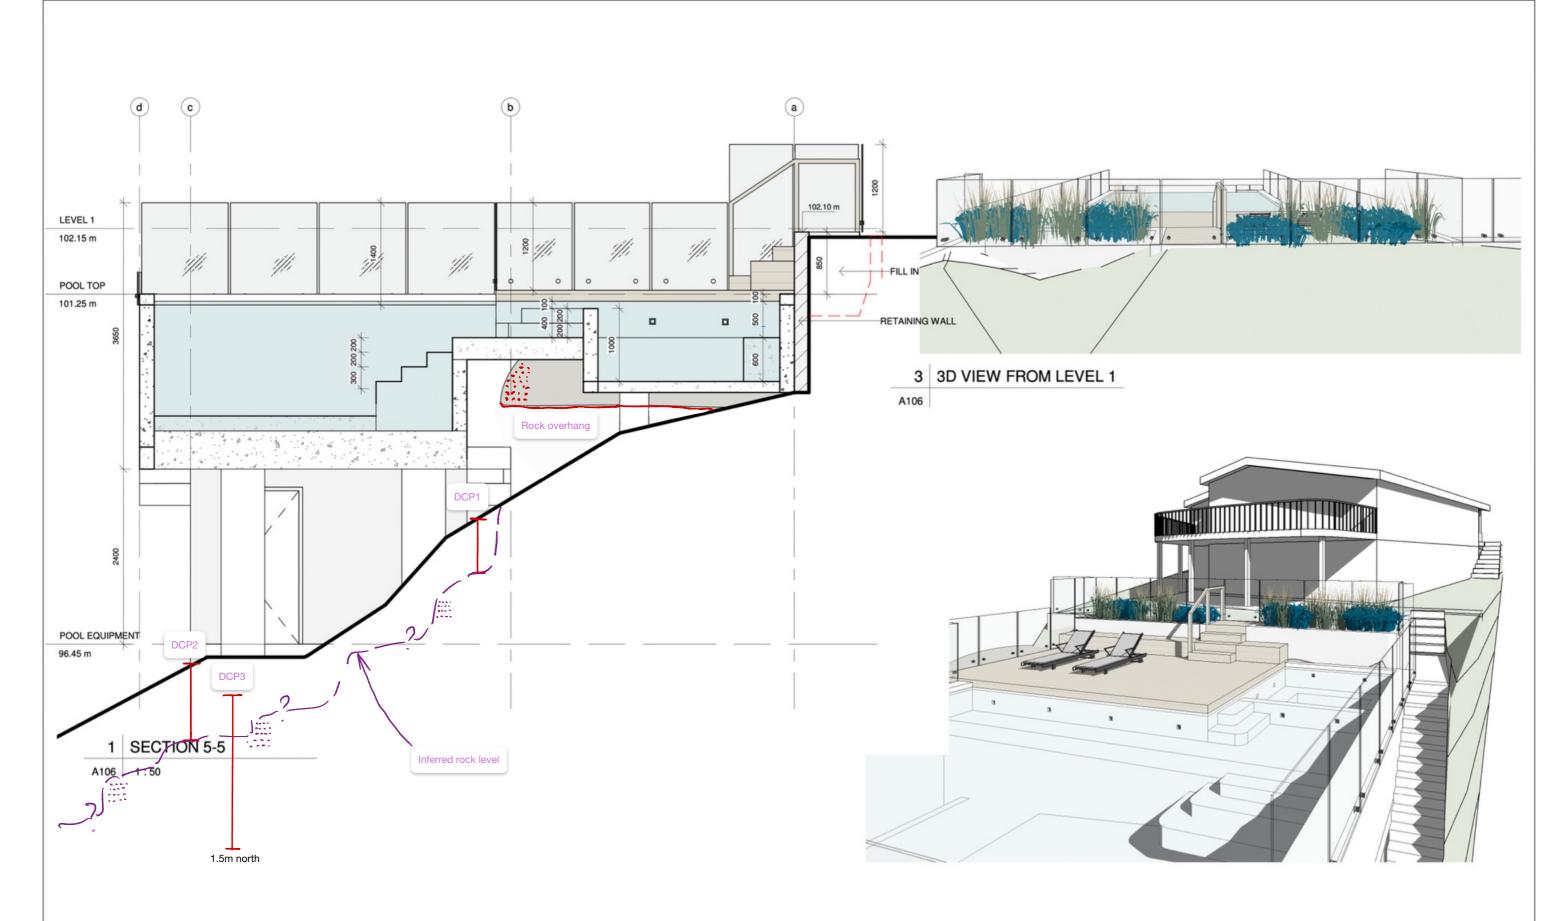
Figure 1 – Site Locality Figure 2 – Test Locations Figure 3 – Interpreted Section

A generalised geotechnical model for the Site has been developed is shown in Table 1. An interpreted section is shown in Figure 3. For a detailed description of the subsurface conditions, refer the attached engineering logs and explanatory notes. For specific design input, reference should be made to the logs and/or the specific test results, in place of the following summary.

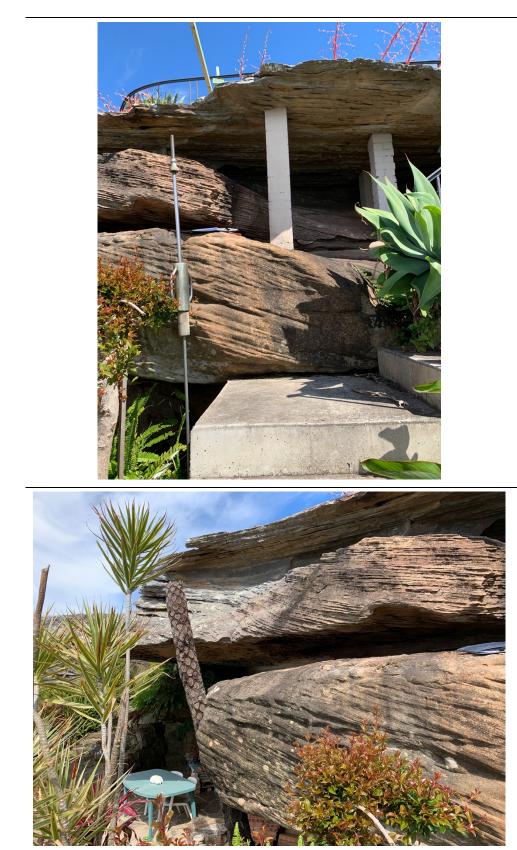
Photo 1

DCP probing (DCP1) within the outcrop area beneath existing terrace.
