GEOTECHNICAL INVESTIGATION:

New Pool at 14 O'Connors Road, Beacon Hill

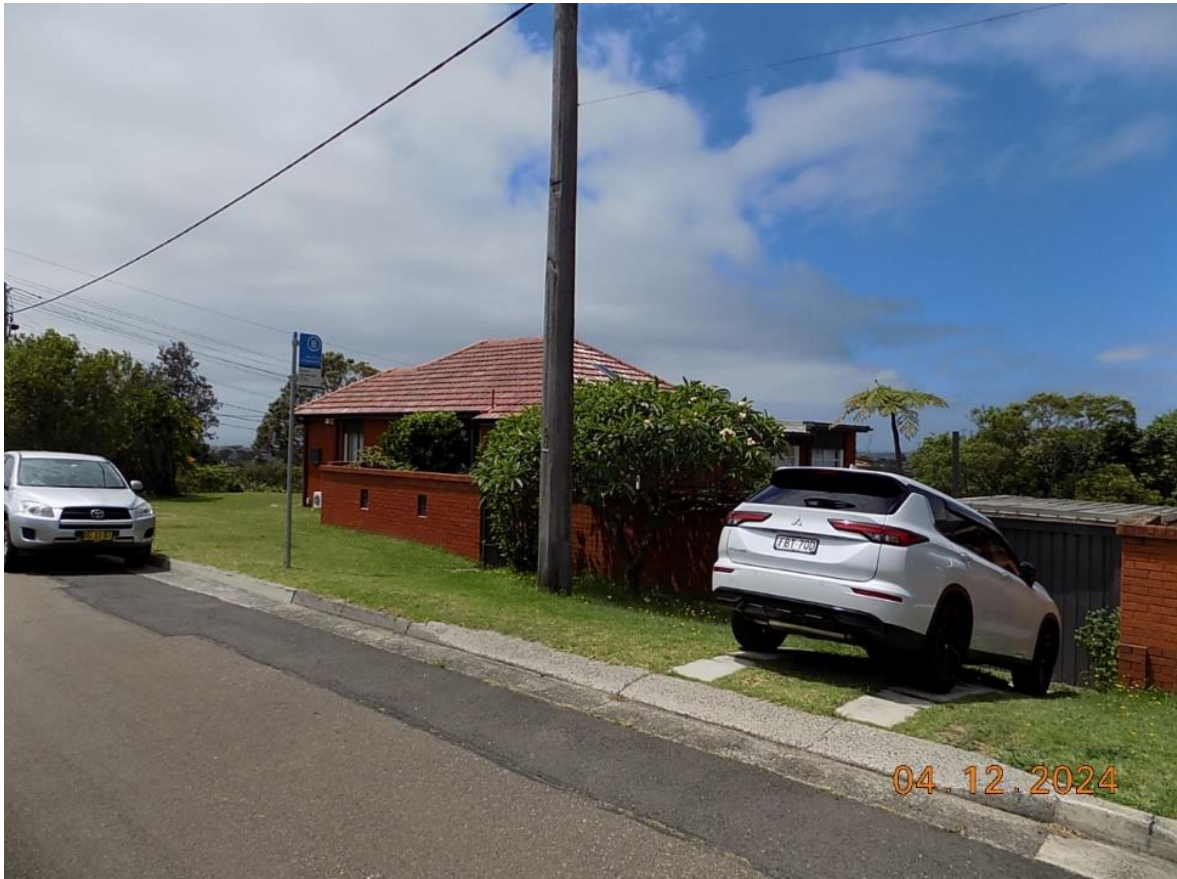
Photo 1

- 2.3** At the Mary Street frontage (Photo 1), a concrete driveway runs to a stable brick garage on the W side of the property (Photo 2). Between the garage and the house is a stable deck. Fill for a level lawn below the deck is supported by a stable low brick retaining wall which approximates the S common boundary (Photo 3). The single-story house is supported on brick and sandstone block walls and brick piers. Some of

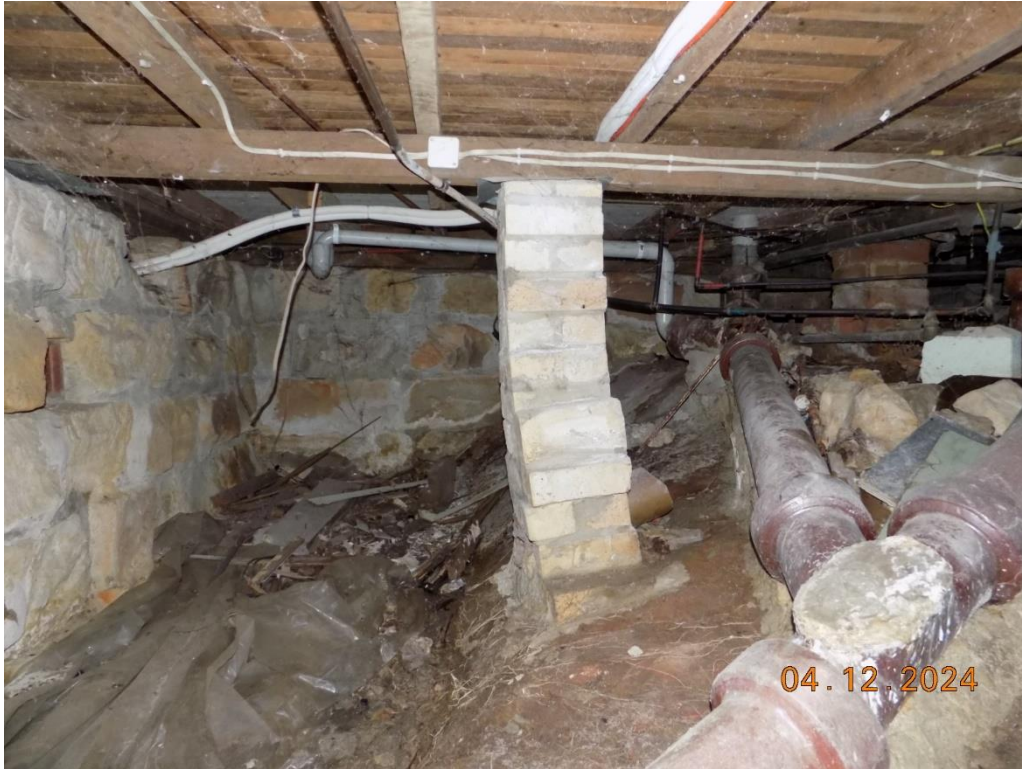
Photo 4

the walls and piers were observed to be supported on outcropping competent Medium Strength Sandstone from within the foundation space of the house. One of the piers supported on rock exhibits tilting (Photo 4). This appears to have been how it was initially constructed. As such, all foundations are considered stable. Between the O'Connors Road frontage and the E side of the house is a gently sloping lawn (Photo 5). A low masonry retaining wall supporting fill in this location was observed to be cracked and tilting towards the house (Photo 6). Due to the wall's low height and location, it is not considered a threat to life or property should further movement occur. This wall will be demolished as part of the proposed works. At the O'Connors Road frontage, a ~2.0m high cut for an electrical box has been taken through Very Low to Medium Strength Sandstone (Photo 7). No significant geological defects were observed in the rock face and it is considered stable.

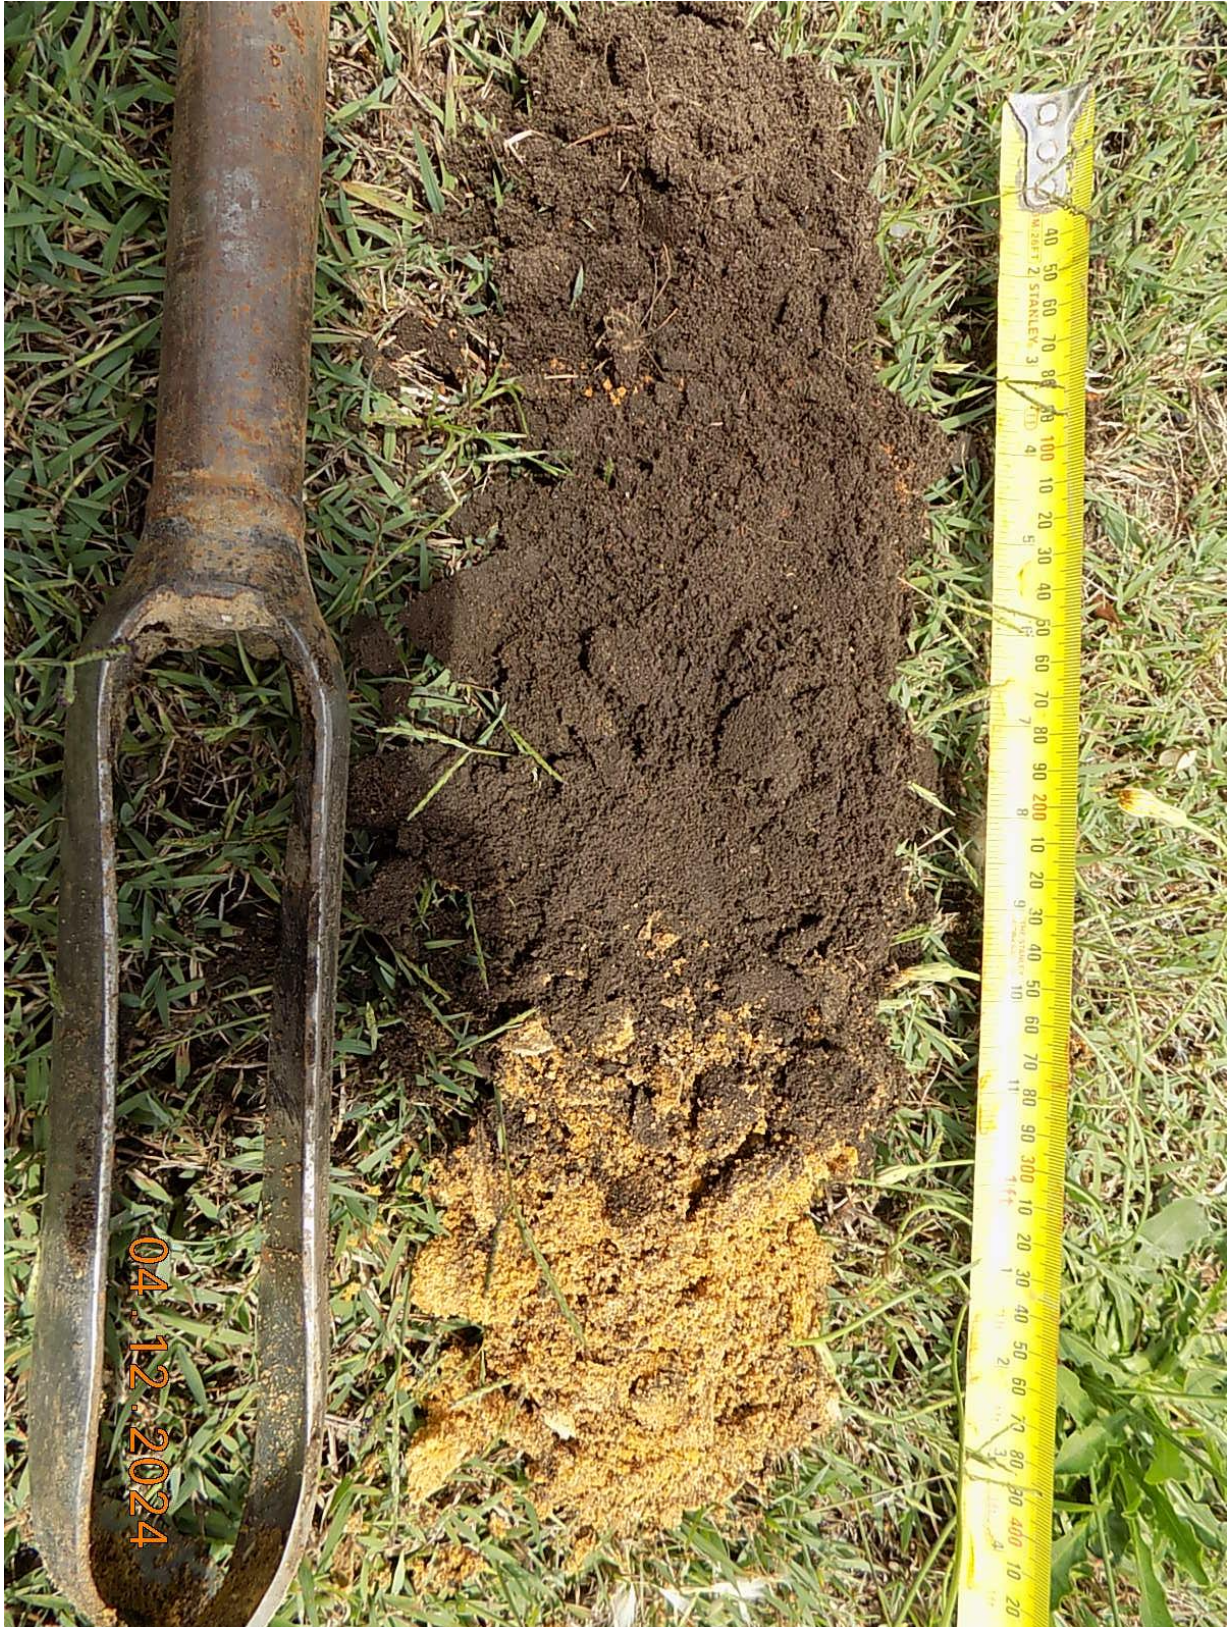
Photo 8 (Top to Bottom)

AUGER HOLE 1 (~RL128.8) – AH1 (Photo 8)

| Depth (m) | Material Encountered |
|---|--|
| 0.0 to 0.3 | TOPSOIL , brown, medium dense, dry, fine to medium grained, weathered sandstone fragments included. |
| 0.3 to 0.4 | WEATHERED SANDSTONE , orange, medium dense to dense, dry, coarse grained, sugary texture. |

Refusal @ 0.4m on rock. Auger grinding. No water table encountered.

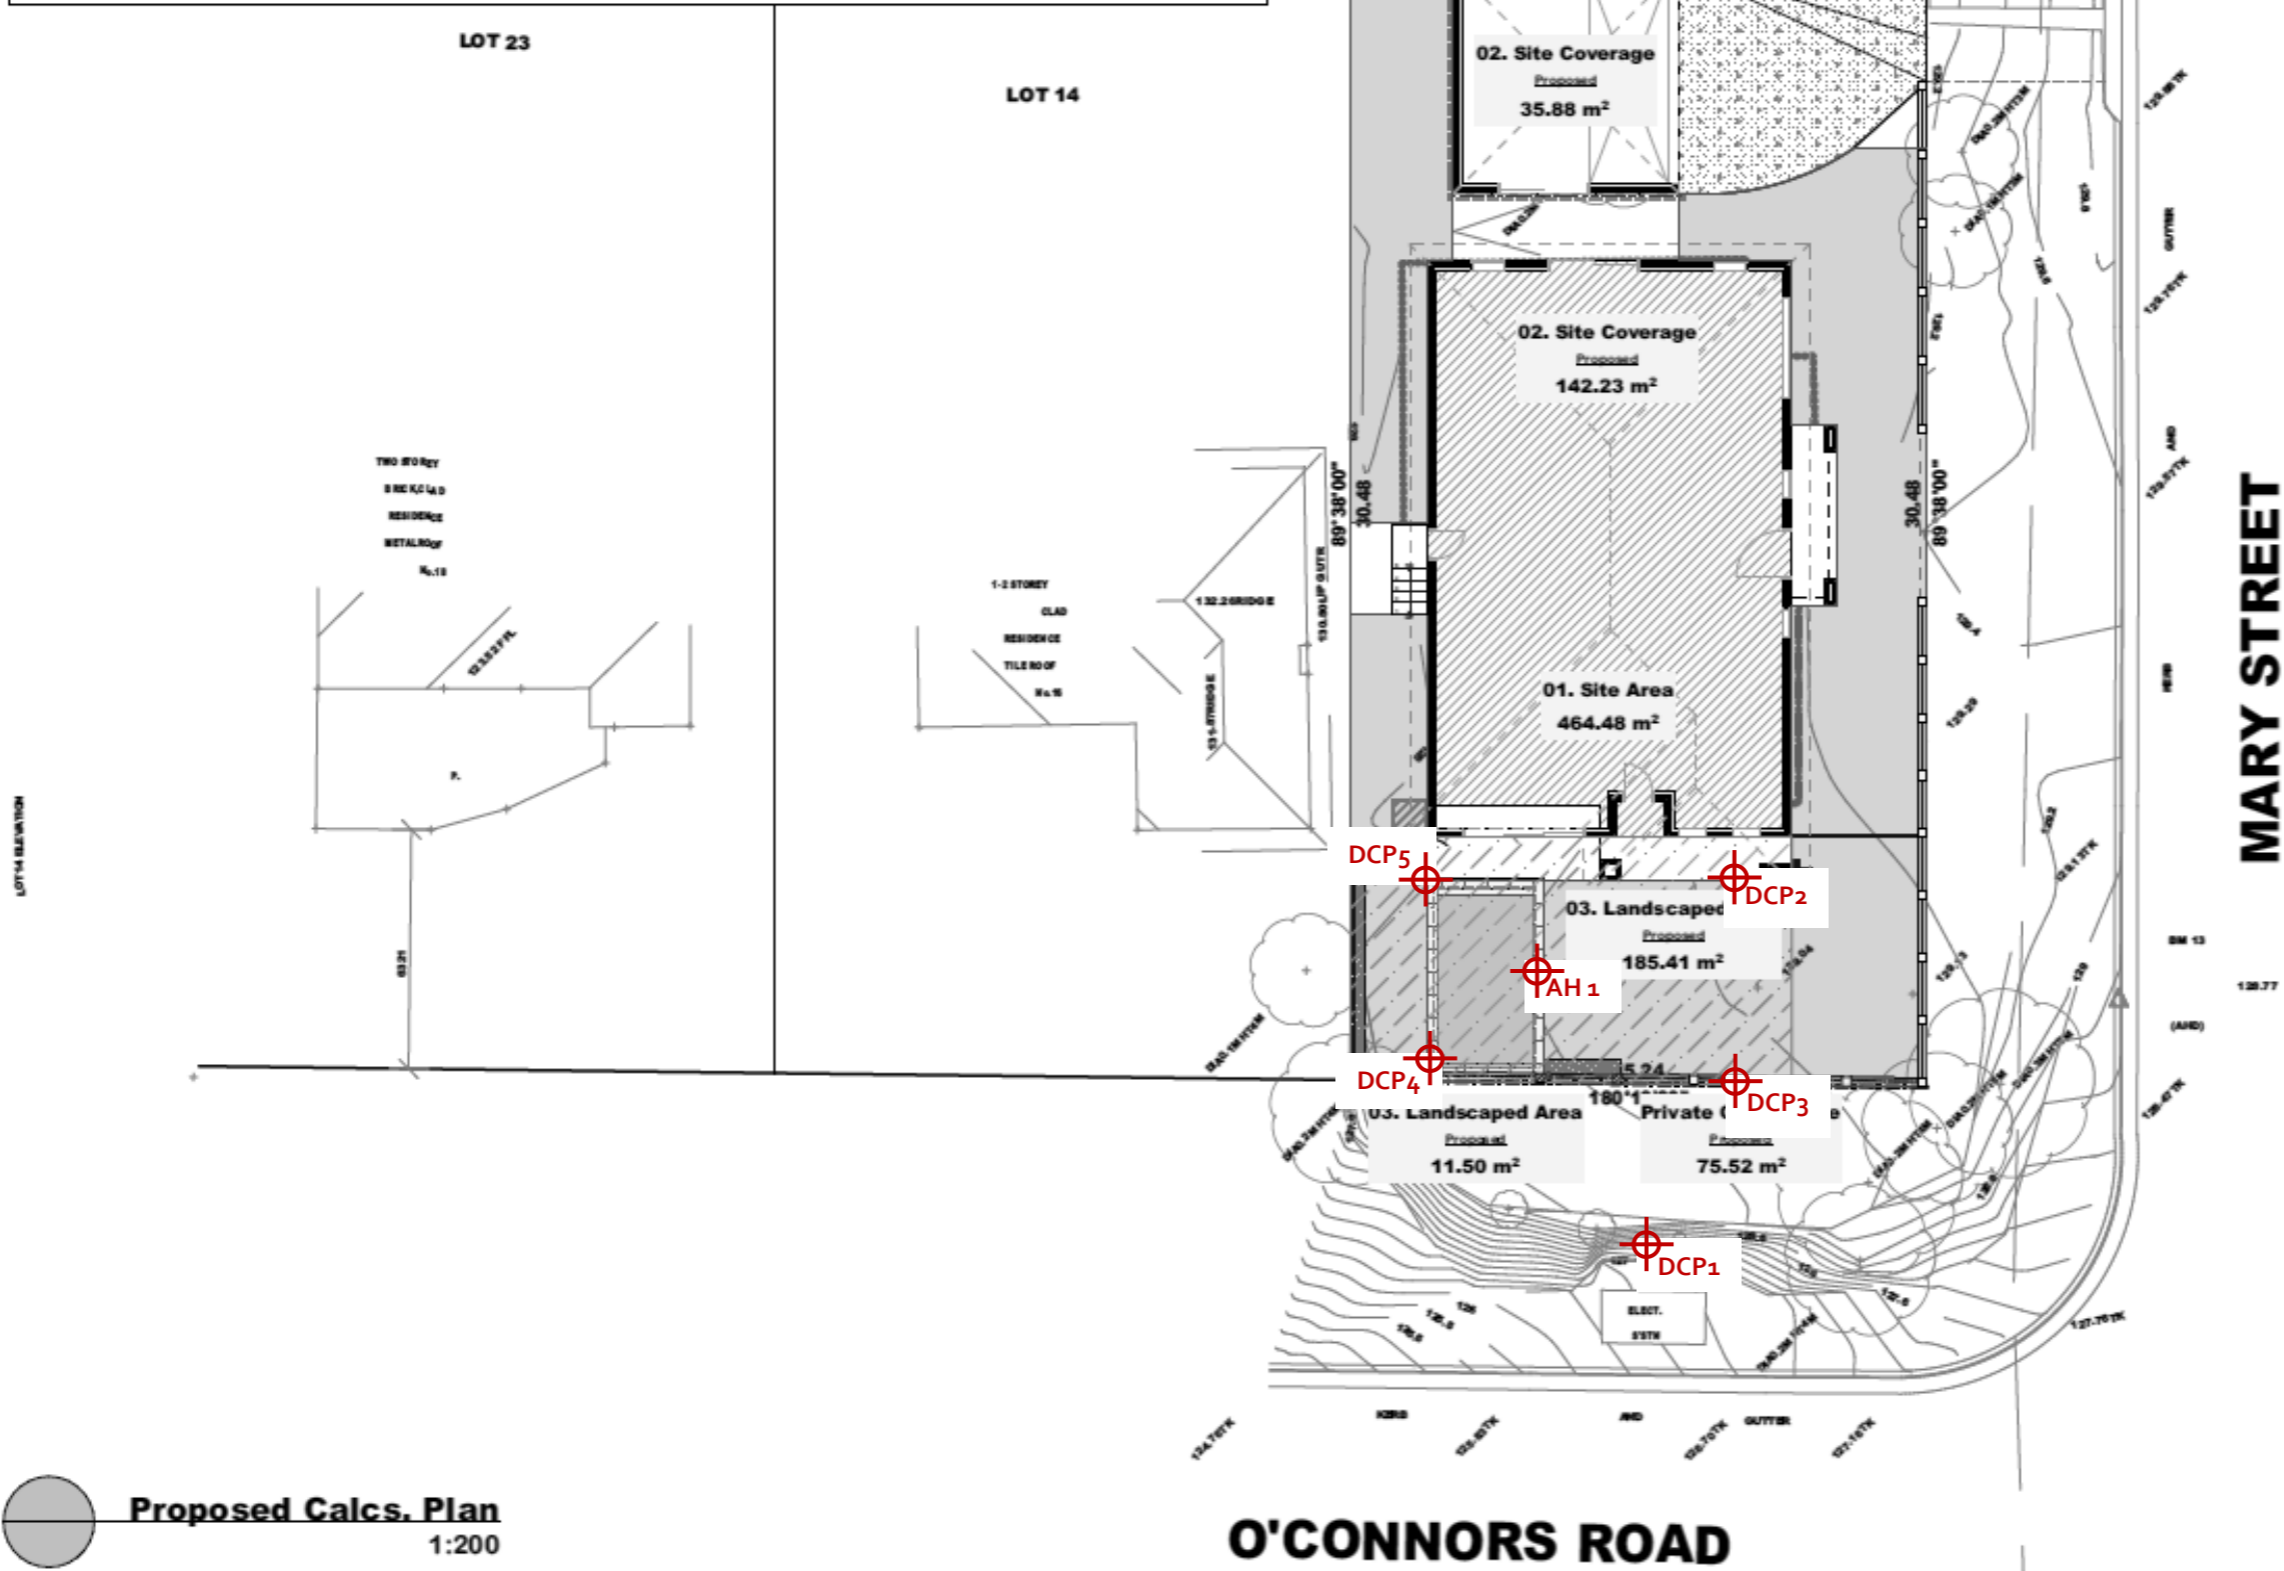
CALCULATIONS PLAN – showing test locations

One hand Auger Hole (AH) was put down to identify the soil materials. Five Dynamic Cone Penetrometer (DCP) tests were put down to determine the relative density of the overlying soil and the depth to bedrock. The locations of the tests are shown on the site plan attached. It should be noted that a level of caution should be applied when interpreting DCP test results. The test will not pass through hard buried objects so in some instances it can be difficult to determine whether refusal has occurred on an obstruction in the profile or on the natural rock surface. This is not expected to have been an issue for this site. But due to the possibility that the actual ground conditions vary from our interpretation there should be allowances in the excavation and foundation budget to account for this. We refer to the appended "Important Information about Your Report" to further clarify. The results are as follows:

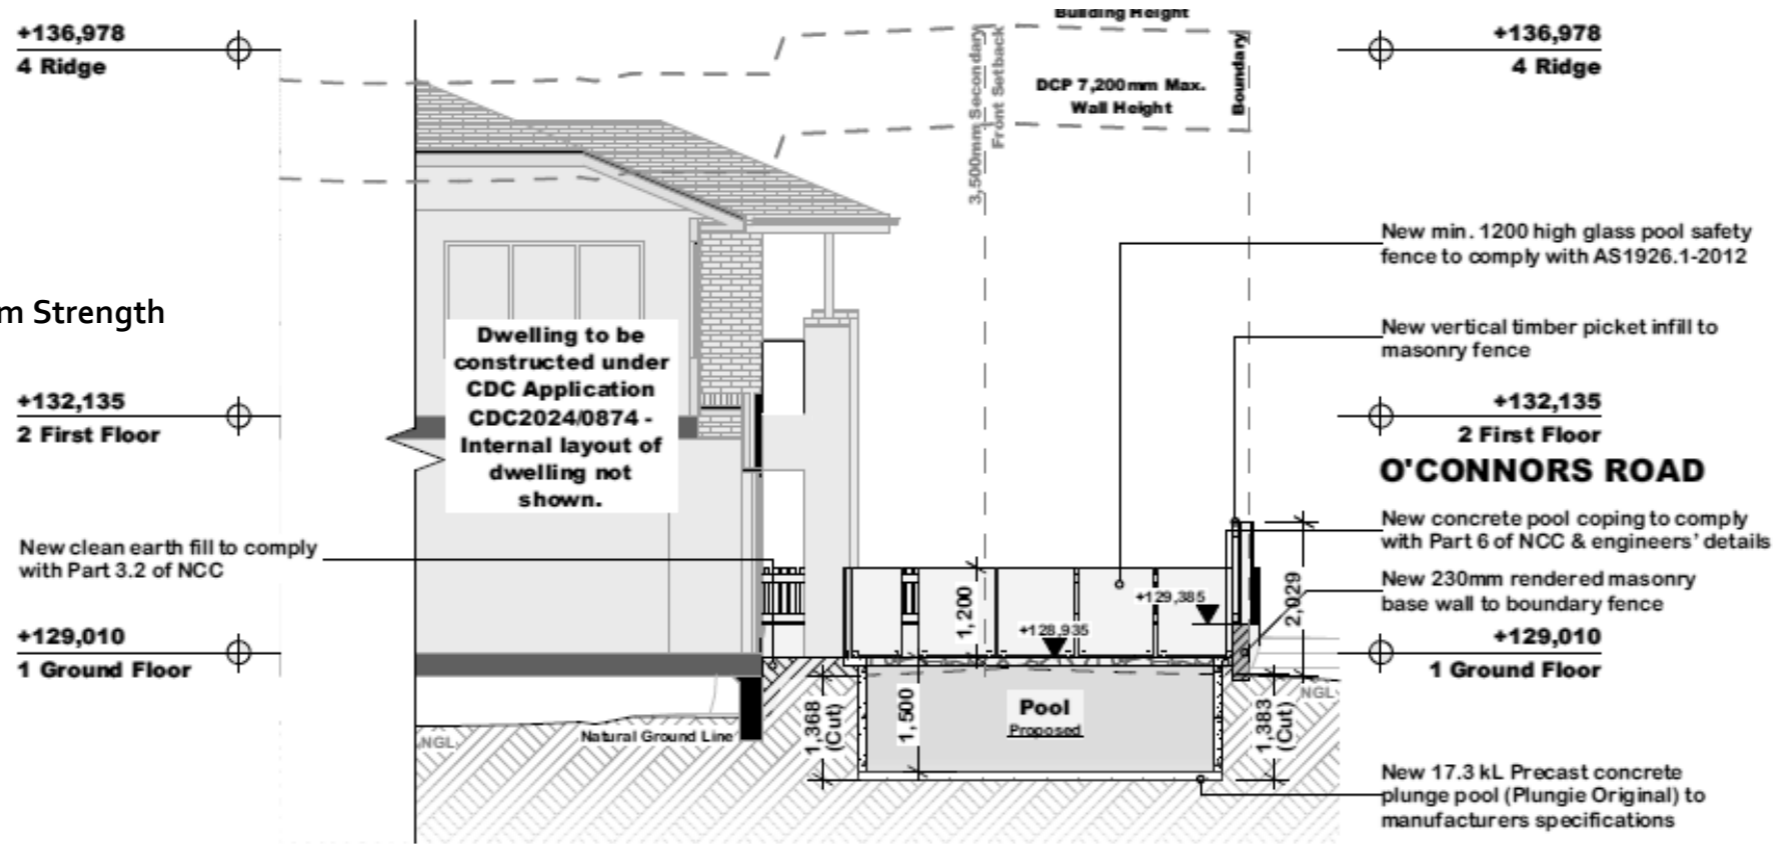
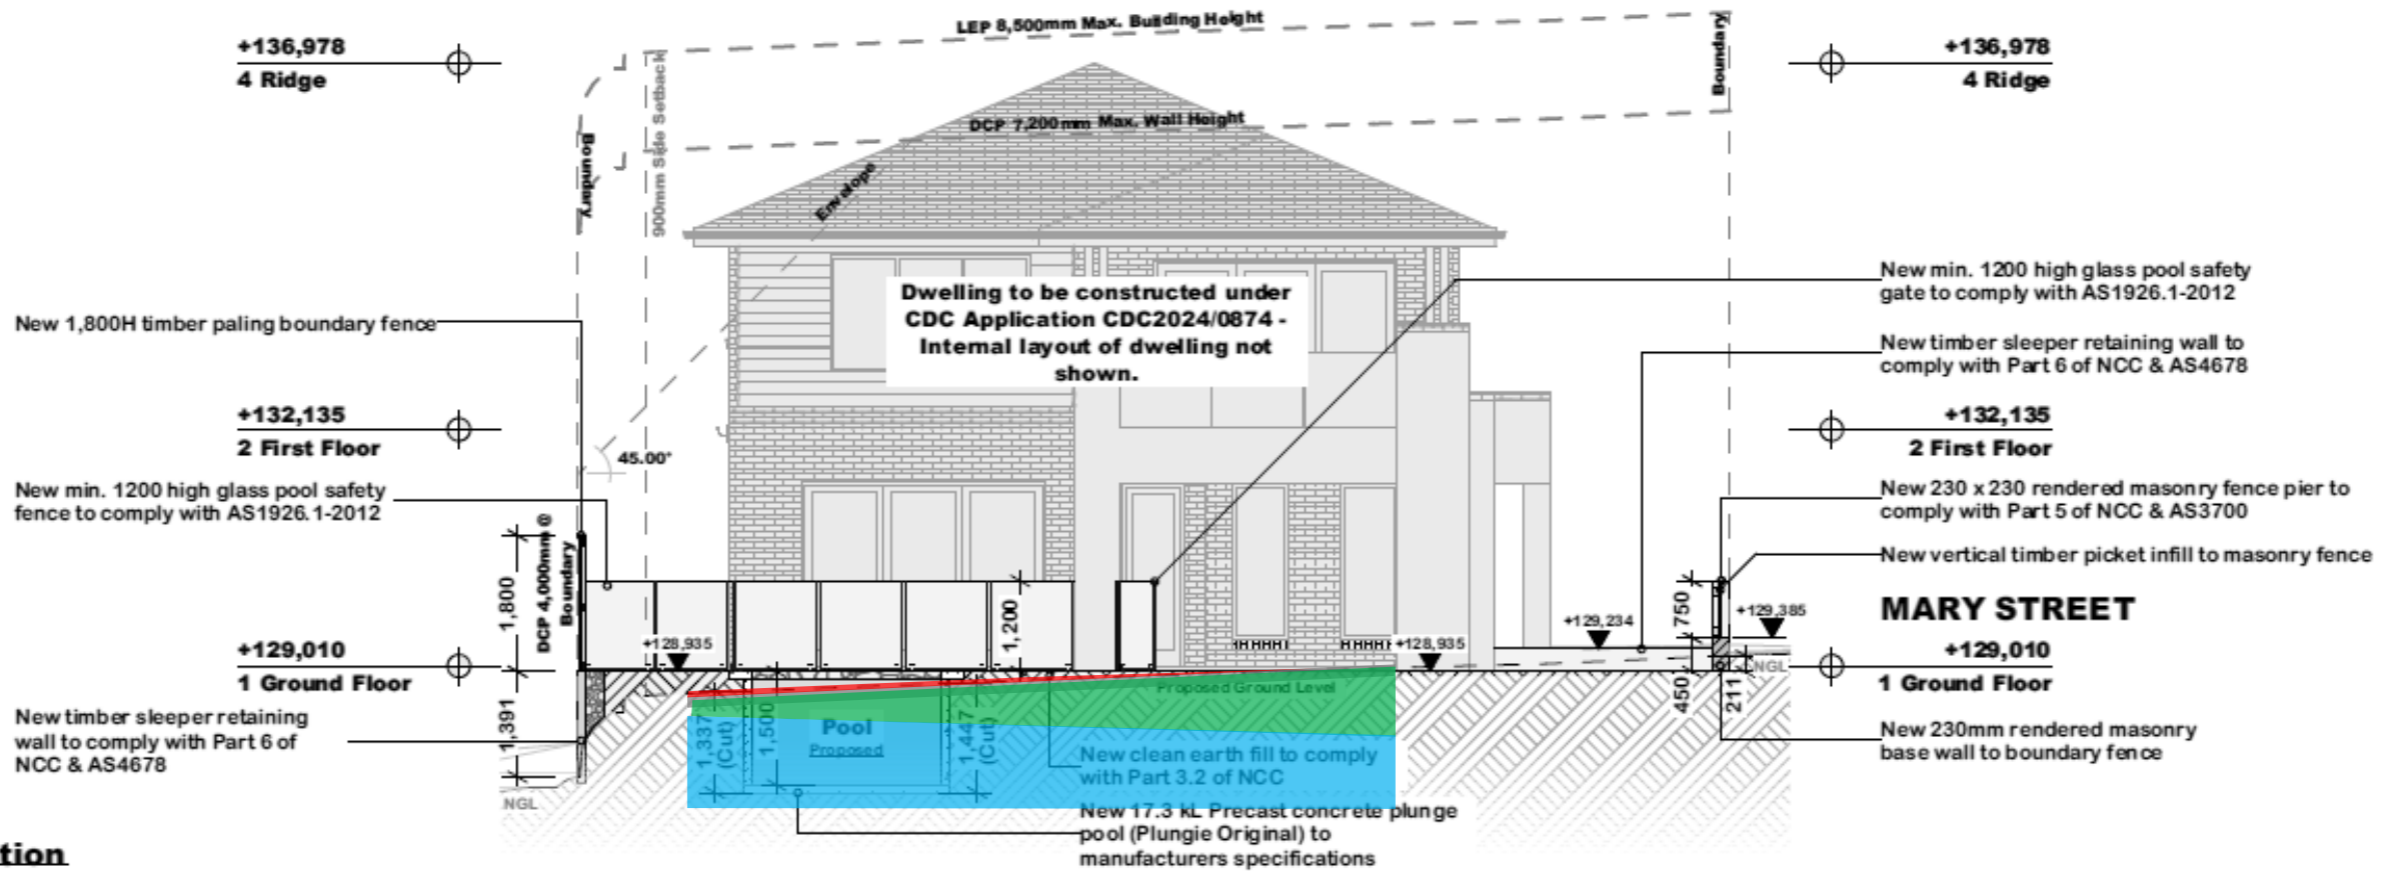
TYPE SECTION – Diagrammatical Interpretation of expected Ground Materials

The surface features of the block are controlled by the outcropping and underlying sandstone bedrock that steps across the property forming sub-horizontal benches between the steps. Where the grade is steeper, the steps are larger and the benches narrower. Where the slope eases, the opposite is true. Where the rock is not exposed, it is overlain by shallow soils over clays that fill the bench step formation. Filling has been placed around the house for landscaping. In the test locations, where the rock is not exposed, it was encountered at depths of between 0.3 to 1.3 m below the current surface, being slightly deeper due to the presence of fill and the stepped nature of the underlying bedrock. The outcropping sandstone on the property is estimated to be Very Low to Medium Strength. A similar strength rock was encountered during the DCP testing as the DCP ended after a high blow count for some tests. The Very Low Strength Rock is expected to be encountered at depths of between 0.3m and 0.6m below the current surface. See Type Section attached for a diagrammatical representation of the expected ground materials.

- Fill
- Topsoil
- Very Low Strength Rock
- Hawkesbury Sandstone – Medium Strength
