GEOTECHNICAL INVESTIGATION:

Alterations and Additions at **24A Hay Street, Collaroy Plateau**

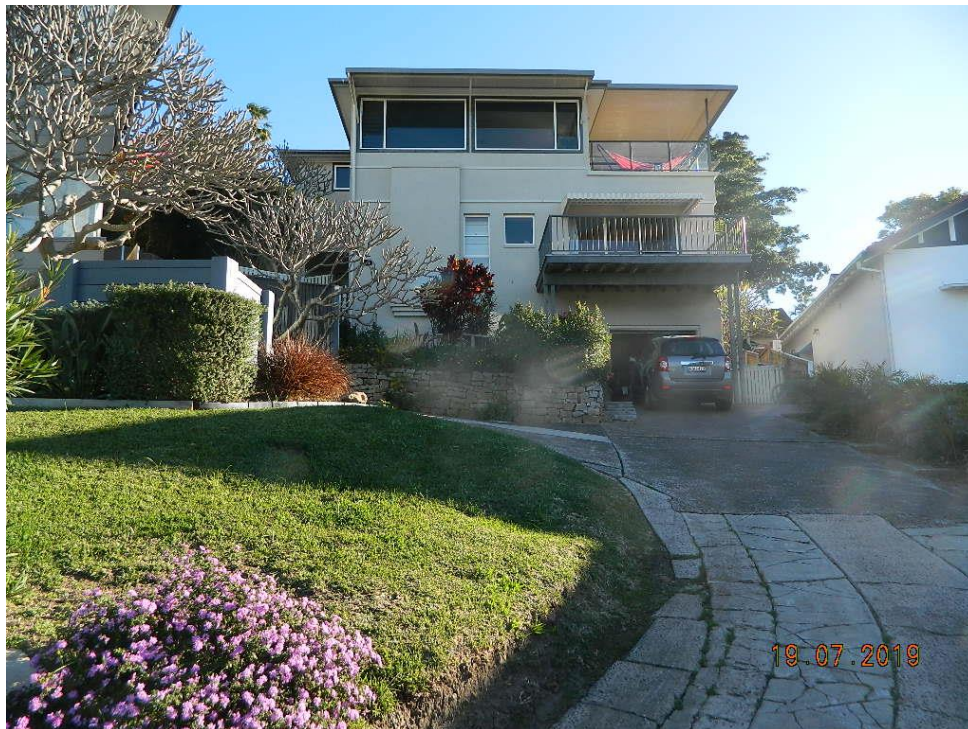
Photo 1

- 2.3** A moderately sloped driveway extends uphill from Hay St to the existing garage (Photo 1). The proposed rumpus area will extend downhill of the existing garage and will require minor levelling of the slope. The Three-storey rendered brick house is supported on brick walls and piers (Photo 2). No significant signs of movement were observed in the supporting brick walls. Beside the house a series of stacked sandstone rock retaining walls have been used to terrace the slope (Photo 3). The walls appear stable and continue uphill of the house to the boundary with Bedford Crescent (Photo 4). The fill laid to create Bedford Crescent merges into the natural slope. The vertical crest of fill is supported with a sand stone block retaining wall up to ~1.2m

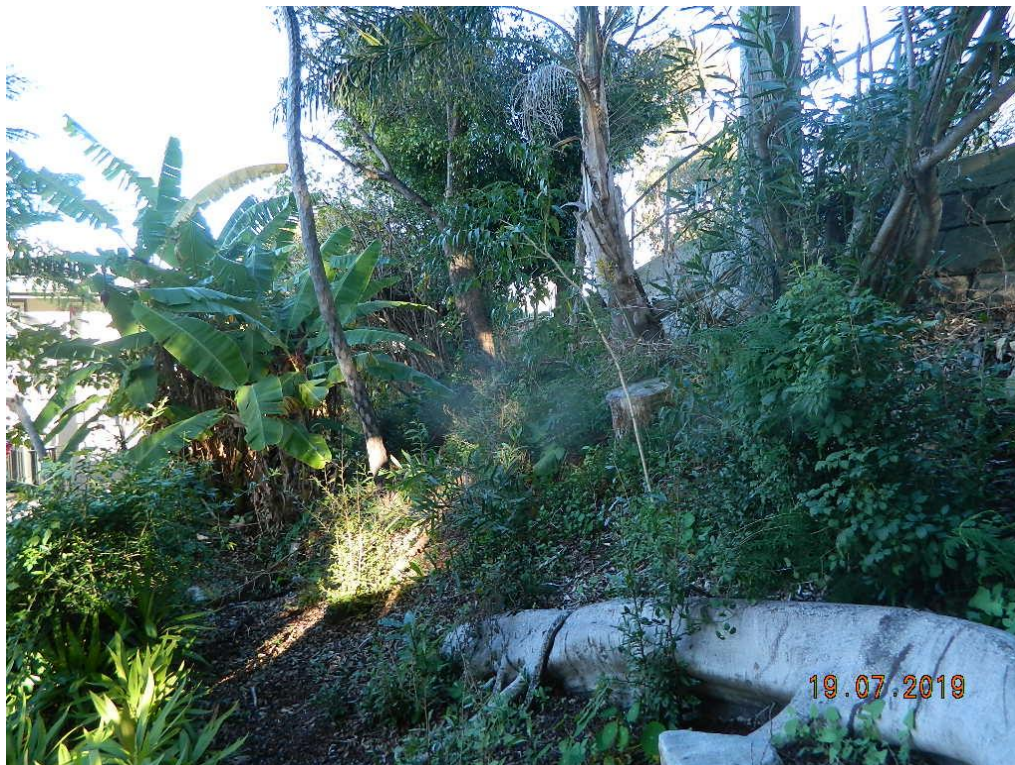
Photo 5

high. The walls line approximates the upper boundary (Photo 5). The proposed elevated garage and drive way will extend from Bedford Crescent to the uphill side of the house. Additionally uphill of the house, next to the porch, a lift is proposed.

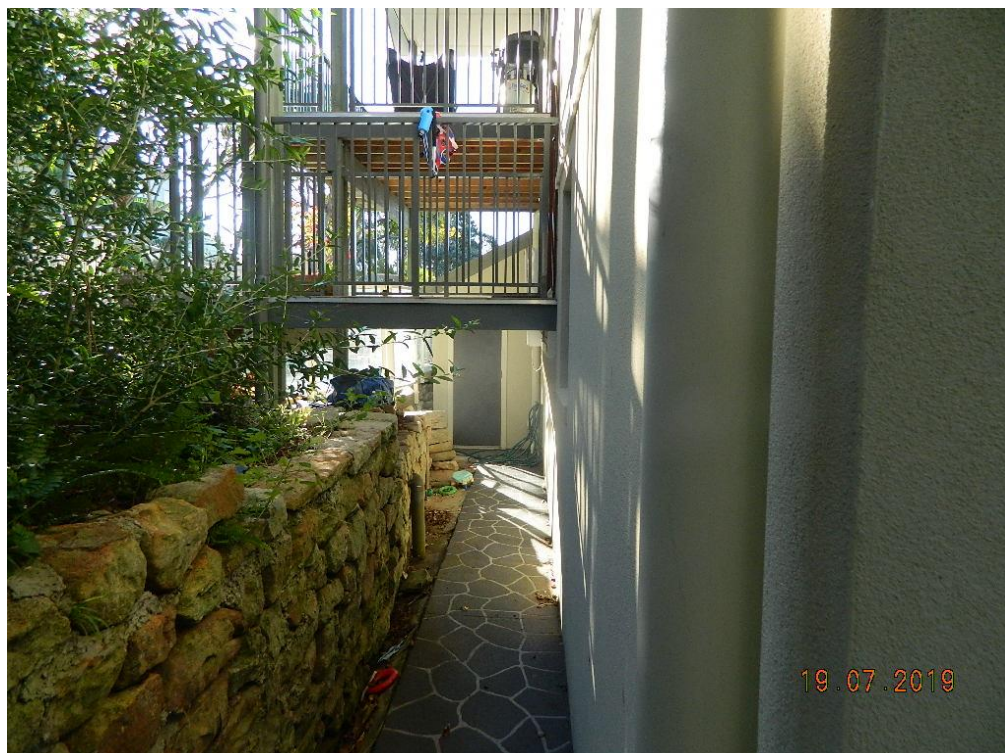
Photo 6

The proposed lift will require an excavation to a maximum height of ~1.2m through a retaining wall uphill of the house (Photo 6). This excavation is expected to be through clayey sand. It is envisaged that excavations through soil and clay be carried out with a bucket. Excavations for footings and minor levelling for the downhill rumpus area will also be required.

No structures or boundaries will be within the zone of influence of the proposed excavation for the lift. The relatively small excavations through clay are expected to stand at near vertical angles for short periods of time until retaining walls are in place provided it is prevented from becoming saturated.

Unsupported cut batters through soil and clay are to be covered to prevent access of water in wet weather and loss of moisture in dry weather. The covers are to be tied down with metal pegs or other suitable fixtures so they can't blow off in a storm. Upslope runoff is to be diverted from the cut faces by sandbag mounds or other diversion works. The materials and labour to construct the retaining structures are to be organised so on completion of the excavations they can be constructed as soon as possible. The excavations are to be carried out during a dry period. No excavations are to commence if heavy or prolonged rainfall is forecast.

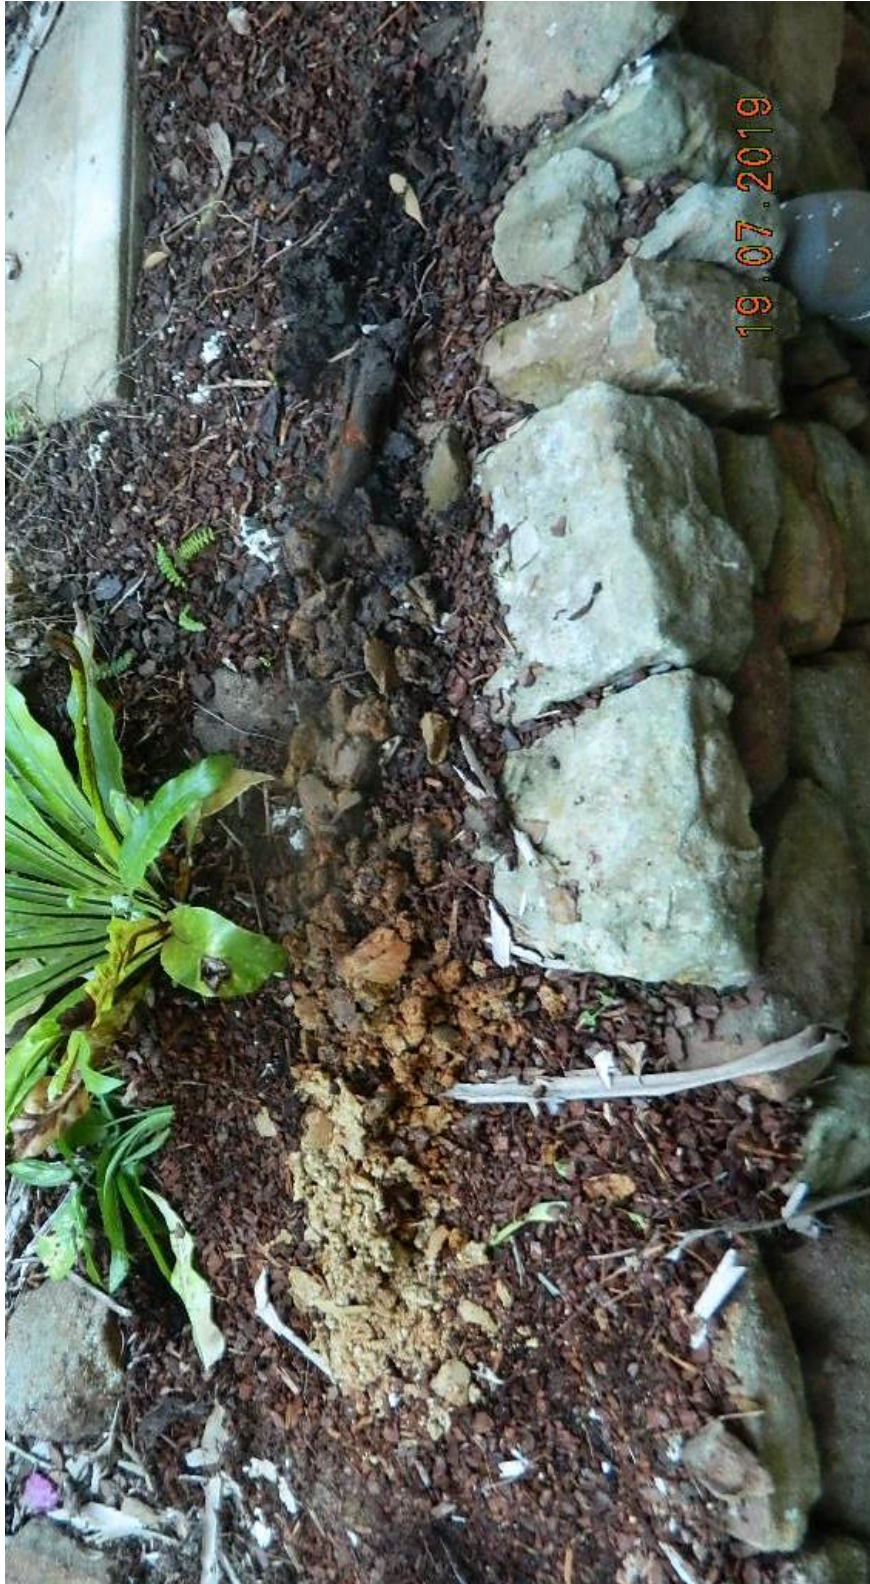
Photo 7: AH1

AUGER HOLE 1 (~RL39.9) – AH1 (Photo 7)

Depth (m)	Material Encountered
0.0 to 0.4	TOPSOIL , clayey sand, dark brown and grey, loose, medium grained with fine trace organic matter.
0.4 to 0.9	CLAY , brown, soft to firm.
0.9 to 1.2	CLAY , orange to brown, stiff to firm.
1.2 to 1.5	SANDY CLAY , yellow to white, dry, medium grained.

Refusal @ 1.5m grinding on rock, white dust on tip. No watertable encountered.

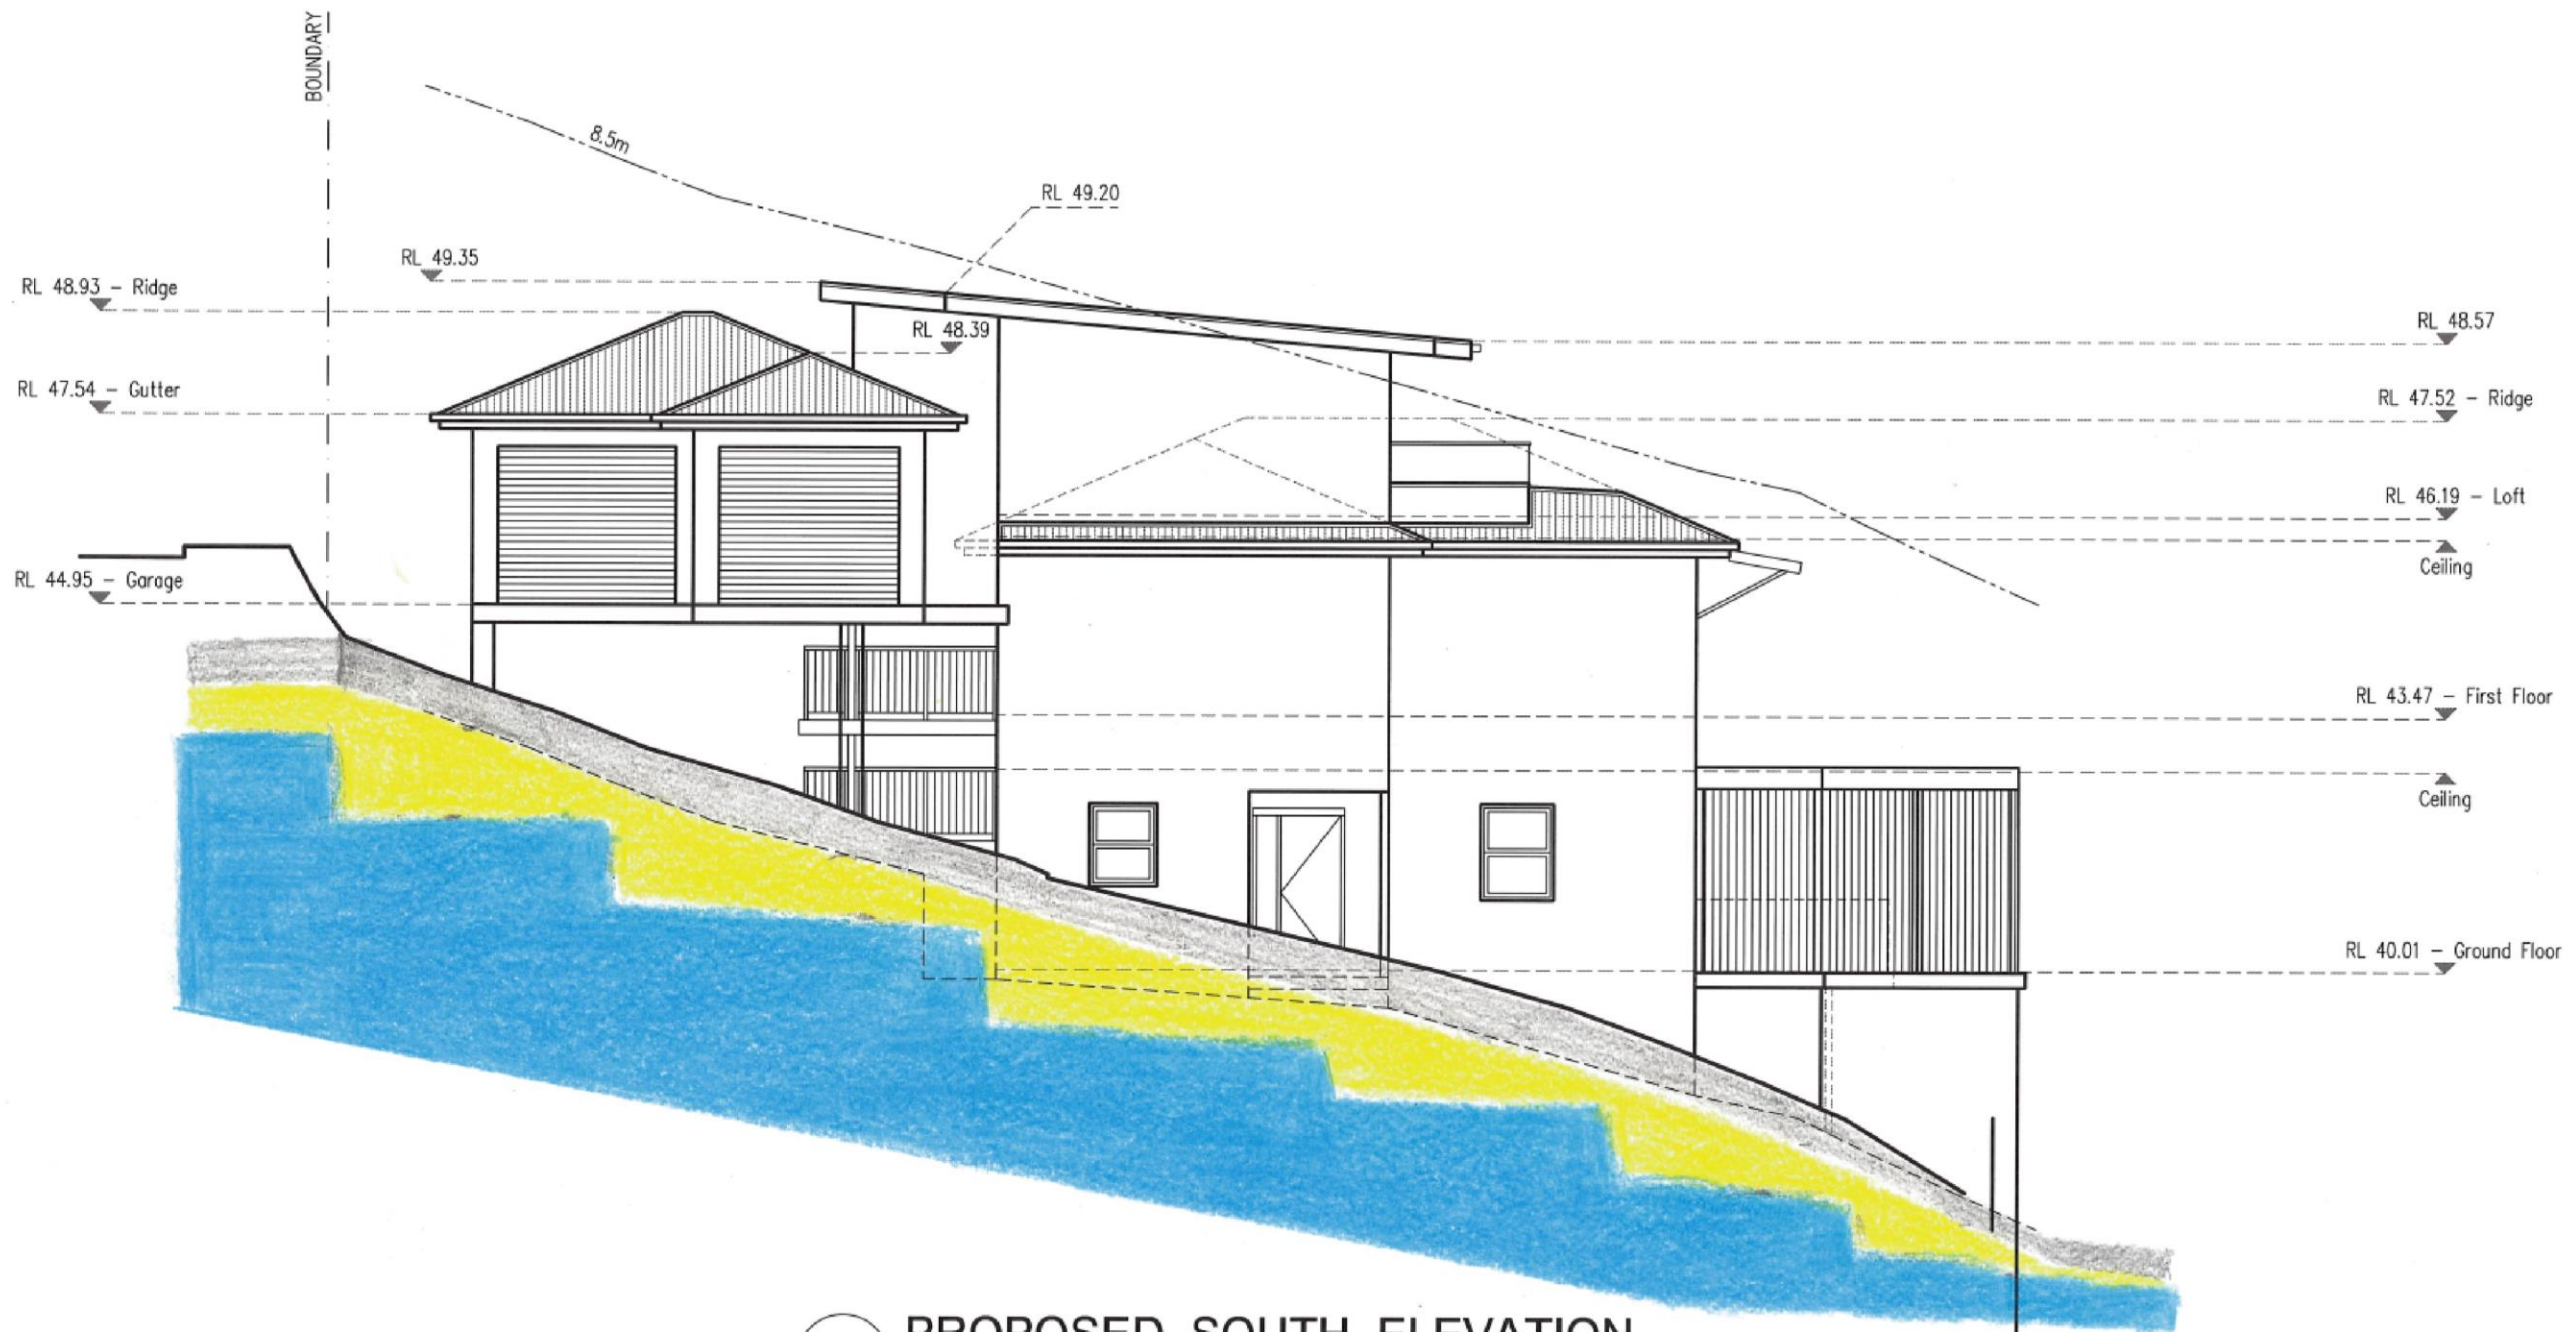
TYPE SECTION – Diagrammatical Interpretation of expected Ground Materials

The surface features of the block are controlled by the underlying sandstone bedrock that steps up the property forming sub-horizontal benches between the steps. Where the grade is steeper, the steps are larger, and the benches narrower. Where the slope eases, the opposite is true. The rock is overlain by sandy soils and firm to stiff sandy clays that fill the bench-step formation. In the test locations, the depth to Medium Strength Sandstone ranged from between 0.9 to 1.85m below the current surface, being deeper where filling is present

and due to the stepped nature of the underlying rock. See Type Section attached for a diagrammatical representation of the expected ground materials.
