# Geotechnical Investigation Report

**Project**  
**Proposed Residential Development**  
**4 Forest Road, Warriewood NSW**

**Report No**  
**18120-GR-1-1-Rev1**

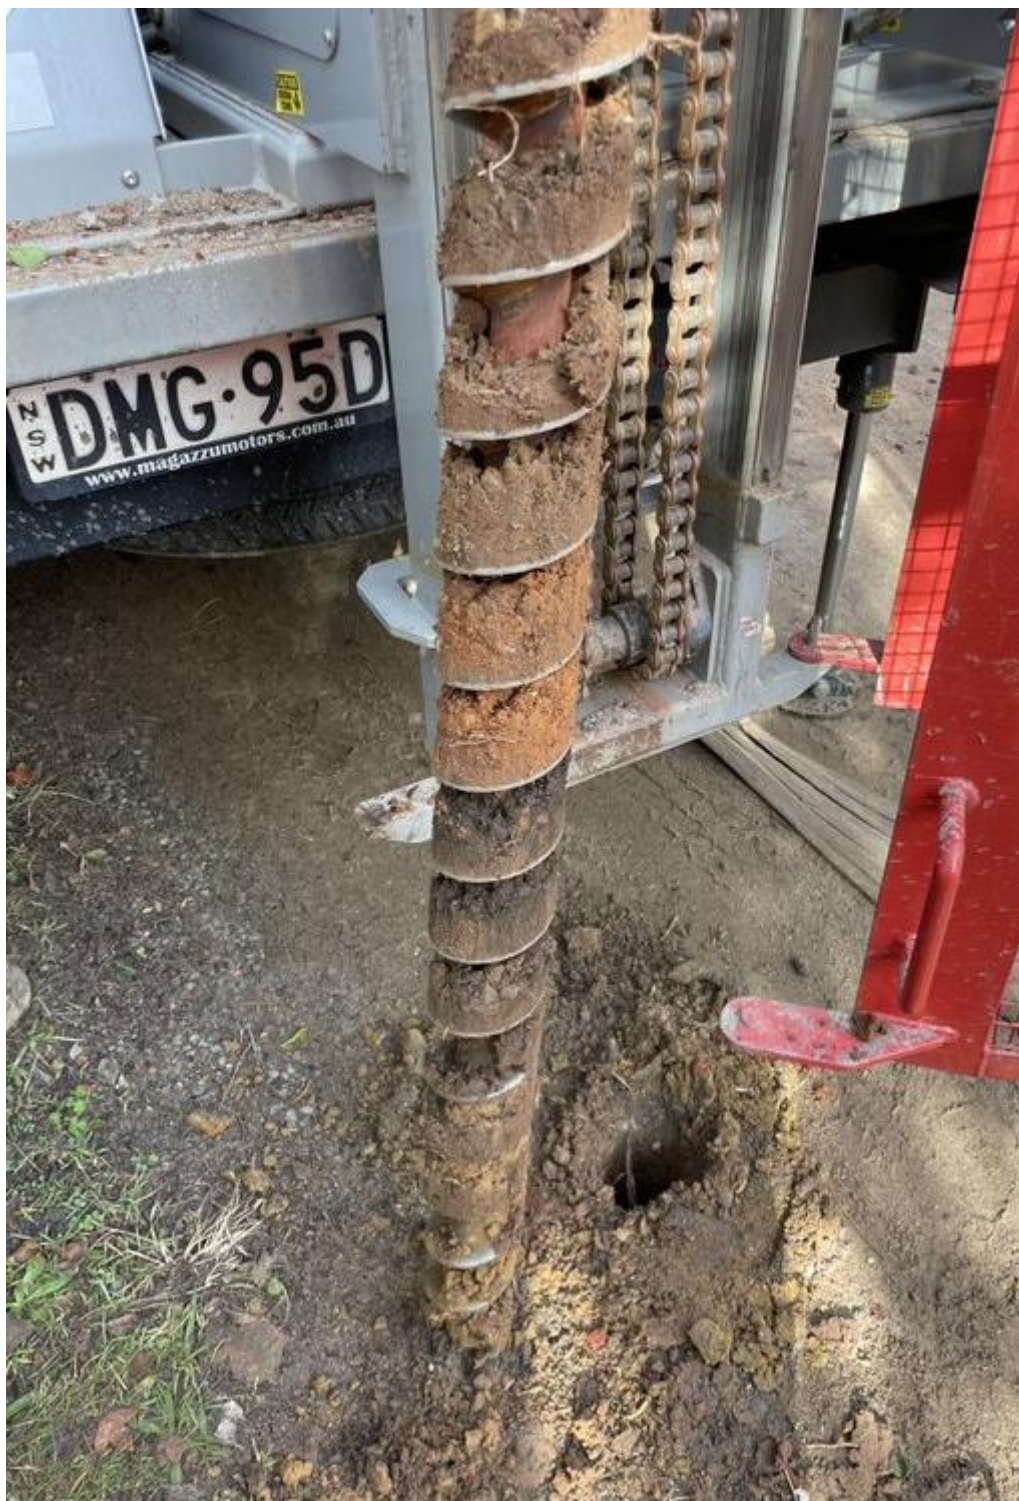
**Photo 3: Fill materials on the auger from BH101**

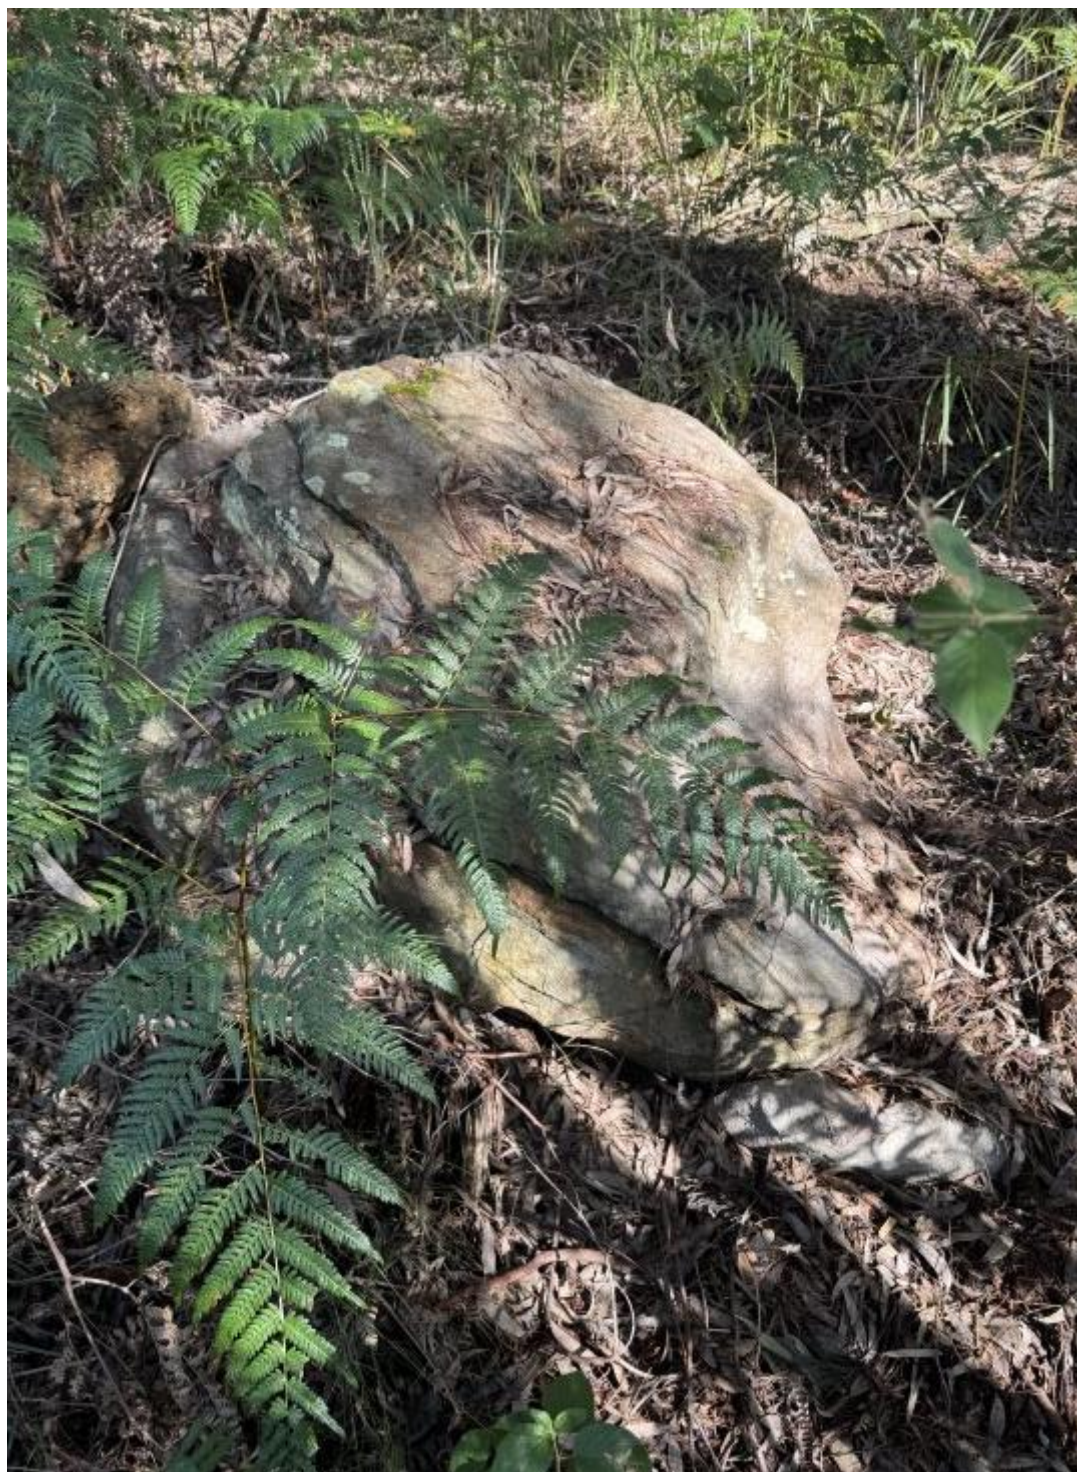
- The upper elevations of the block and the wooded bushland reserve to the western boundary contained a variety of detached sandstone floaters/joint blocks. These ranged in size from ~0.30-3.00m in size. These are interpreted to have originated from the Hawkesbury Sandstone which acts as a capping unit overlaying the Narrabeen Group bedrock which is found at lower elevations. These rocks will have moved down slope over geological timeframes and appeared to be well embed in the soil profile.

**Photo 4: Example of a detached sandstone floater present in the wooded reserve area to the west of the block.**
