Date: 31st July 2019

Project No.: 2019-083.2

**REPORT ON GEOTECHNICAL ASSESSMENT FOR
APPROVED ALTERATIONS AND ADDITIONS
82 BOWER STREET, MANLY.**

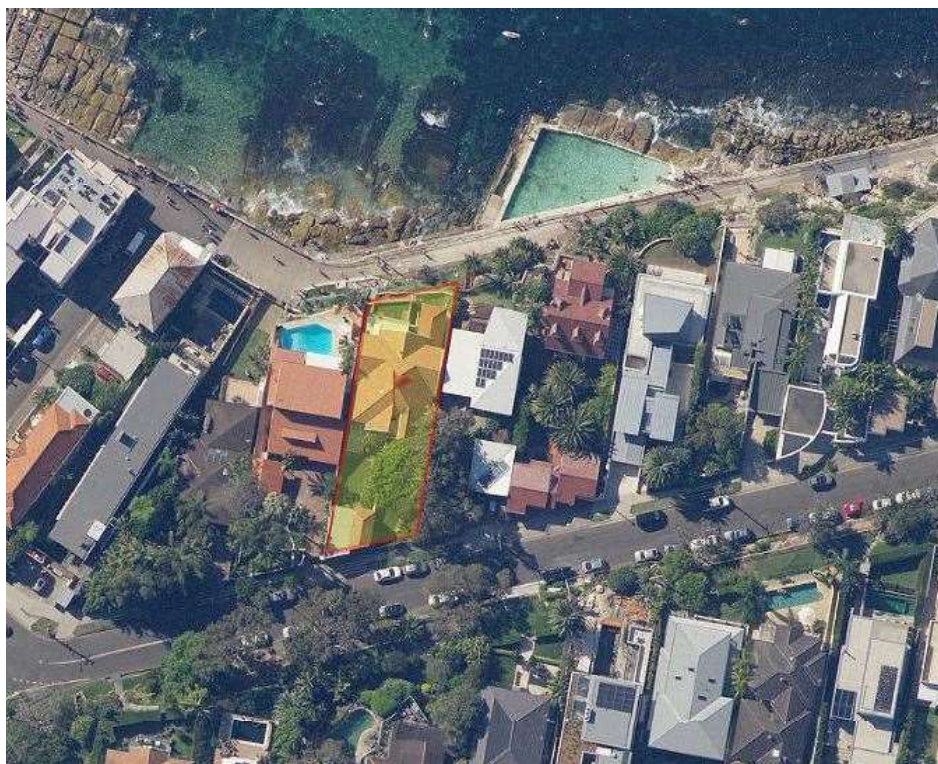
Photograph 1: Aerial photo of site and surrounds
