Tree Management Strategies

Arboricultural Impact Assessment

BROOKVALE OVAL
23-10-19

Leigh Brennan
Tree Management Strategies

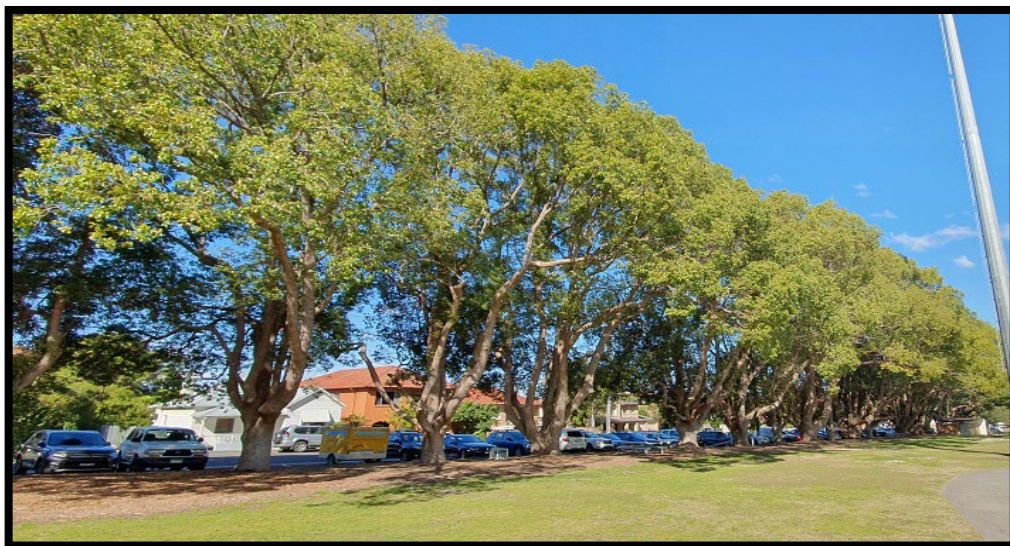
Figure 5

Figure 2: Depicts the form and modified growth habit of Camphor Laurel trees along Pine Avenue to the East of the subject site.

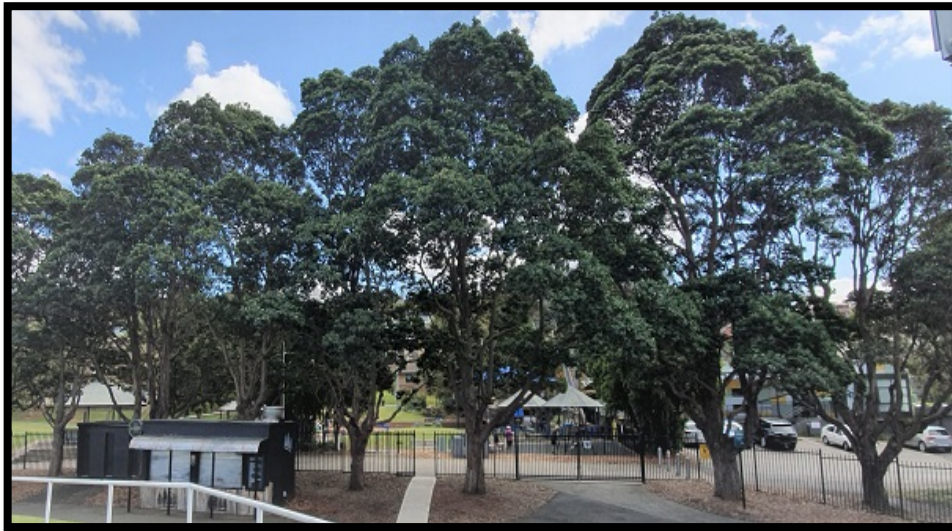
Figure 6

Figure 3: Depicts the form and modified growth habit of Brush Box trees to the north of the subject site.

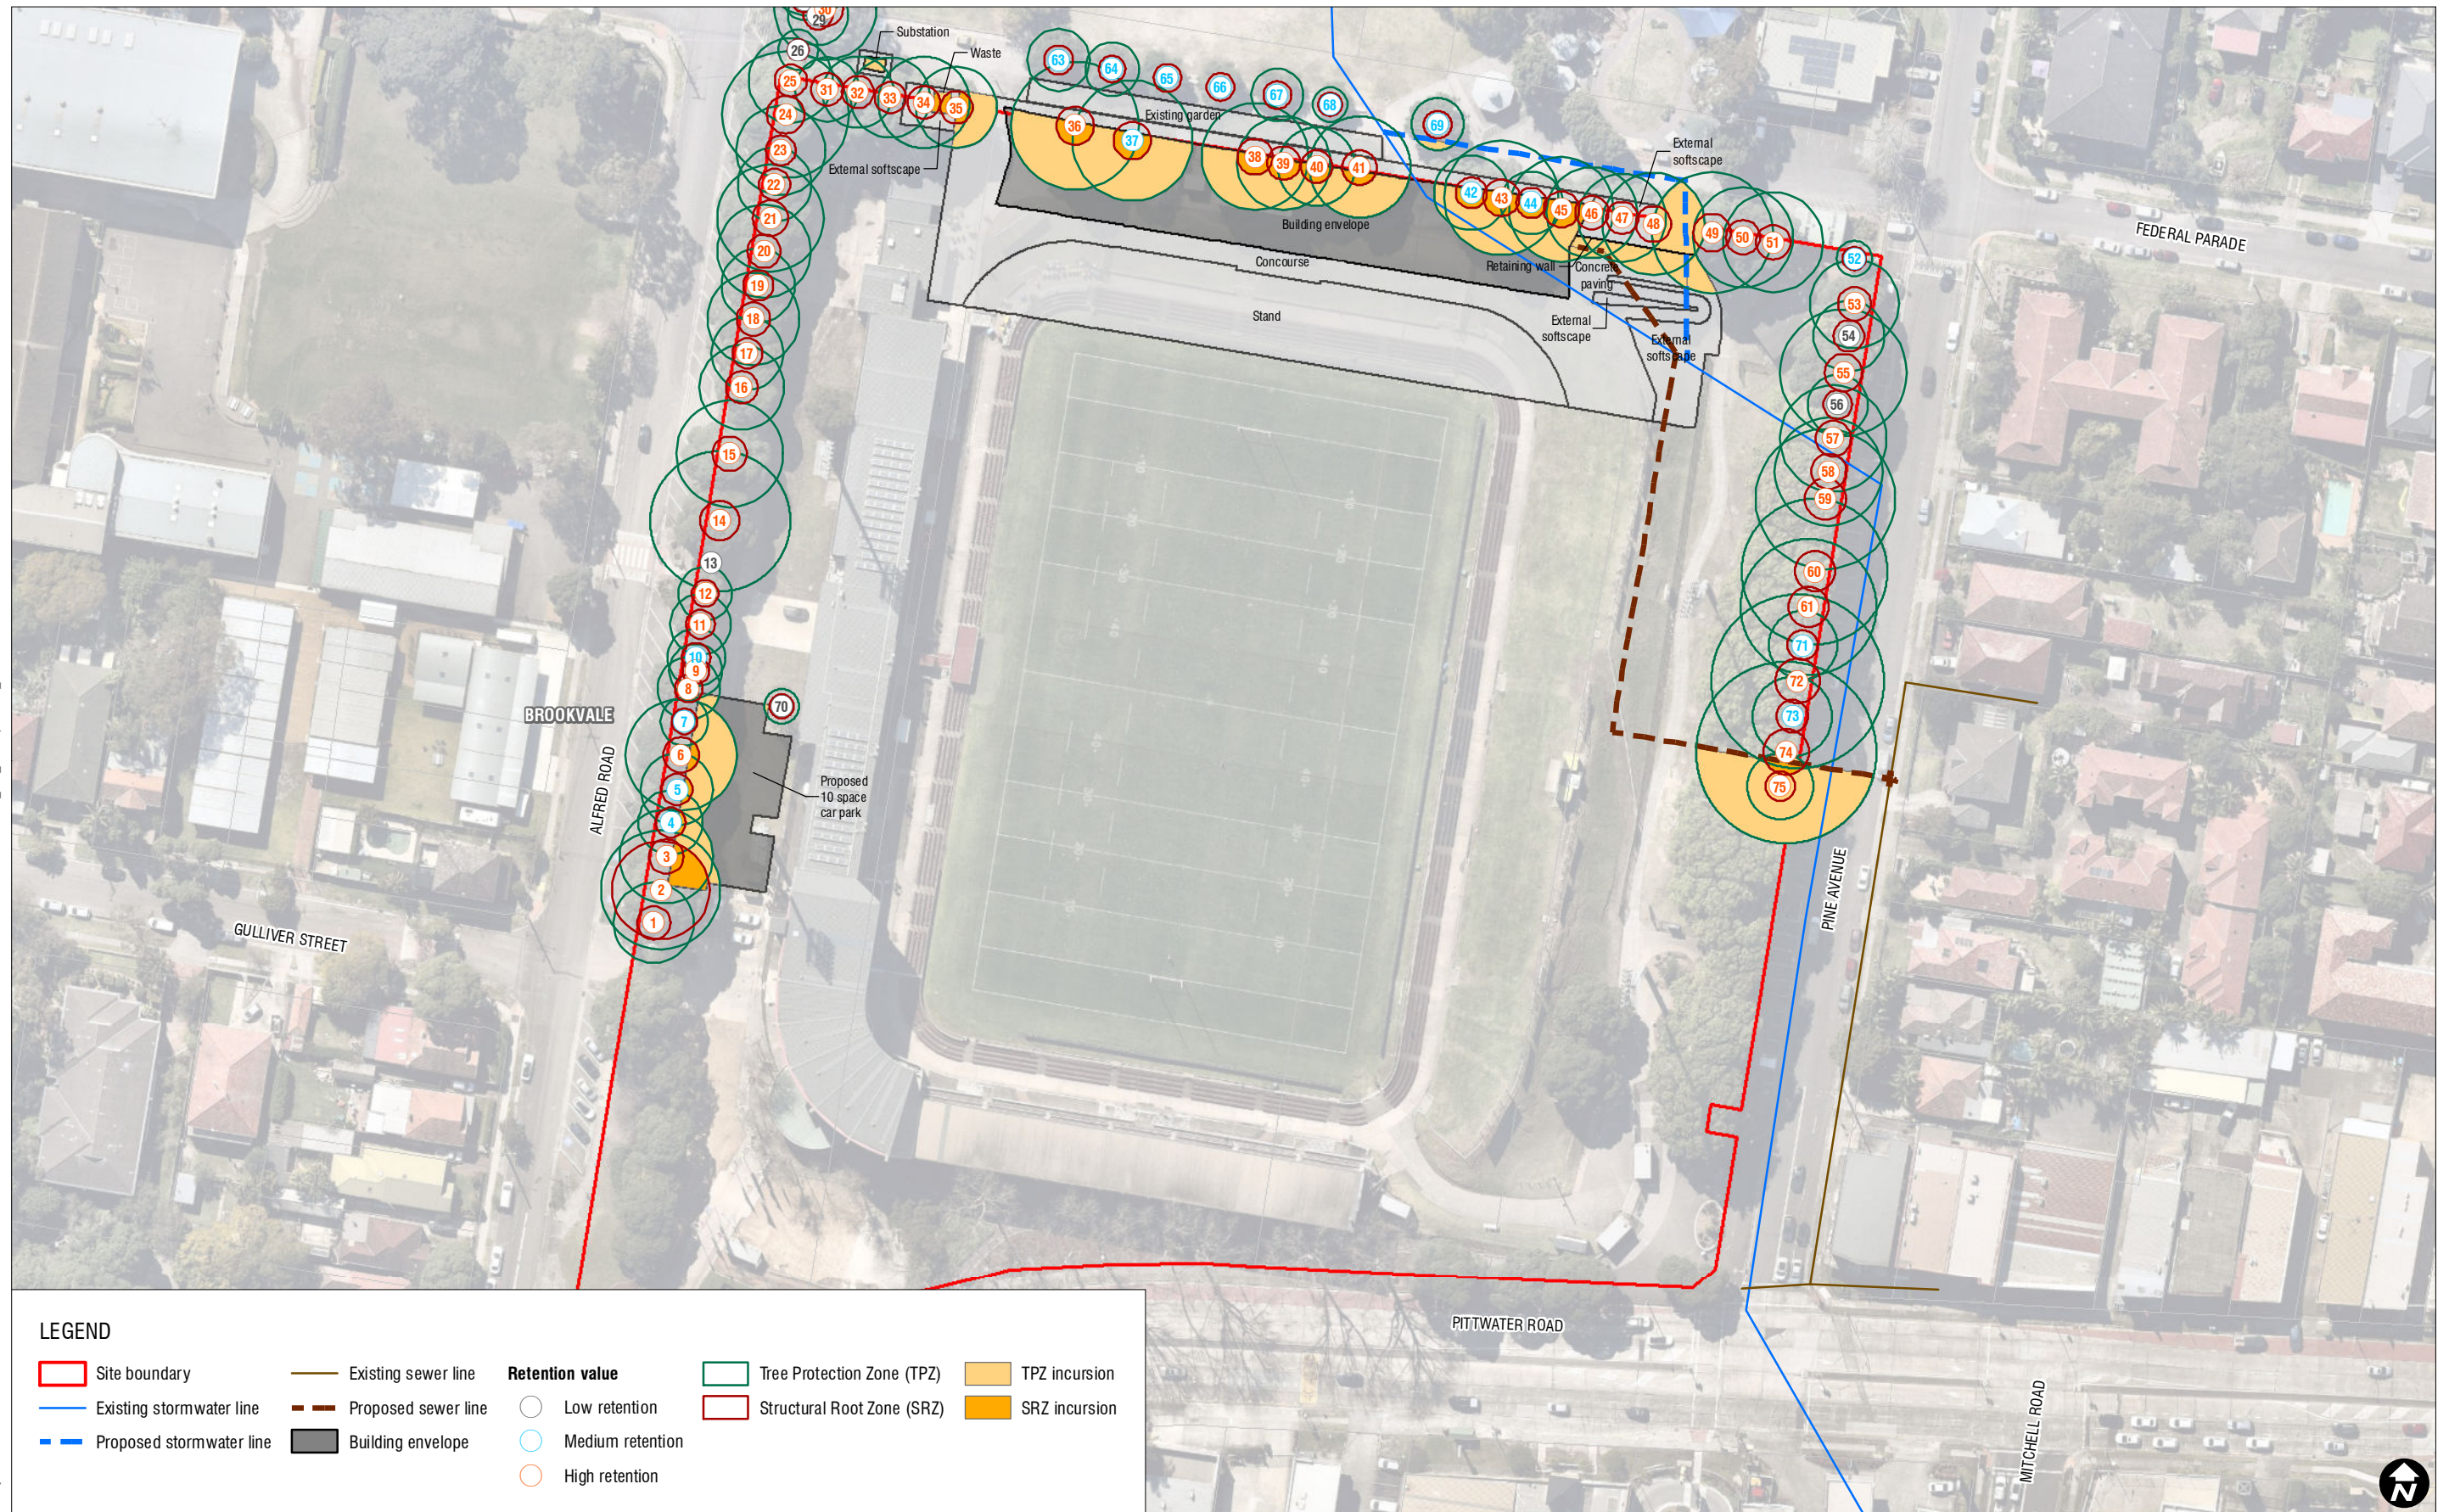
APPENDIX 2

As shown on the Tree Impact Plan (Appendix 3) Tree 34, 35, 47, 48, and 49 are potentially impacted by the proposed new concrete paving as part of the landscape design. The Landscape Plan indicates no changes to existing levels, however, to ensure no damage to roots within TPZ, no excavation is recommended to construct the new concrete paving.

Note:
 - Building envelope design based on HASSELL drawing GA Plan - Concourse Level 00 Rev J.
 - Potential increased incursion to trees 34 and 35 due to concrete paving.
 - Trees 47 to 49 impacted by retaining wall and paving.
