Geotechnical Assessment

Project: Swimming Pool
60 Cabarita Road, Avalon Beach NSW

Prepared for:
Geoff Smith

Ref: AG 24287
25 July 2024

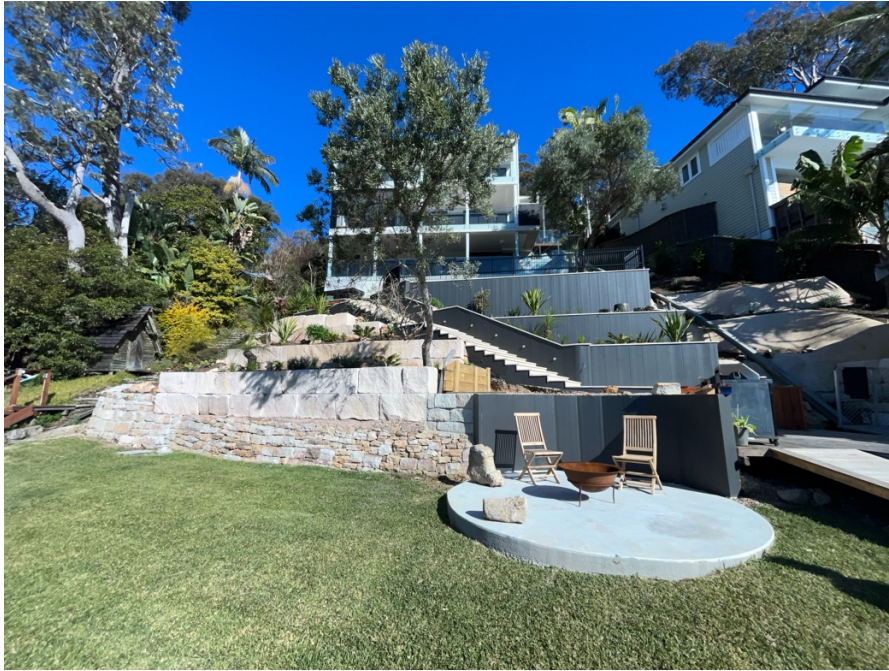
Photo 1: Residence rear and area of the proposed works – existing round slab

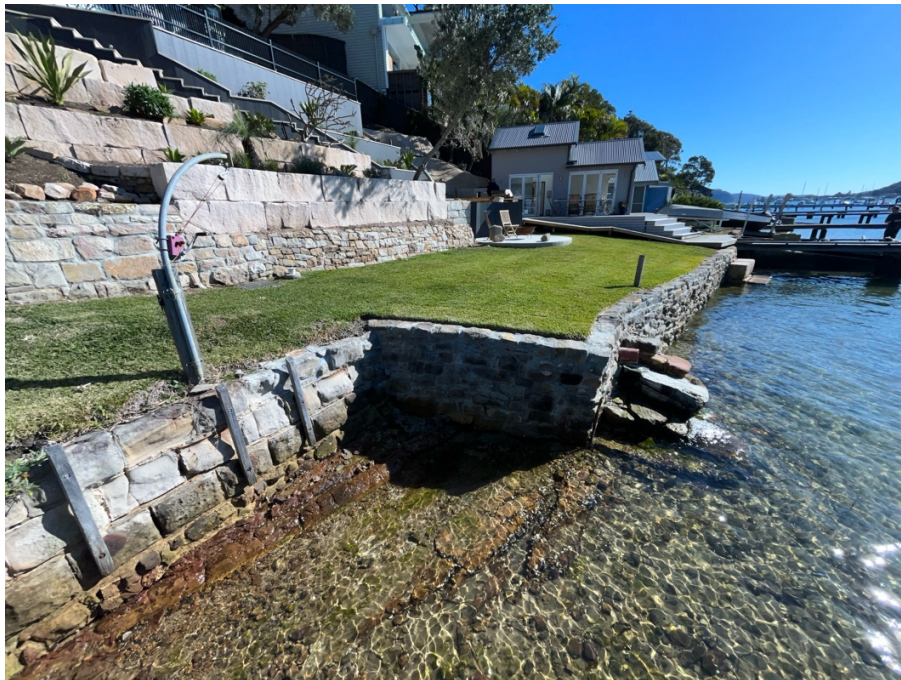
Photo 2: Careel Bay waterfront and area of the proposed works
