4 November 2020

1 MONTAUBAN AVENUE **SEAFORTH, NSW**

ARBORICULTURAL IMPACT **ASSESSMENT REPORT**

Report Ref No- 17420

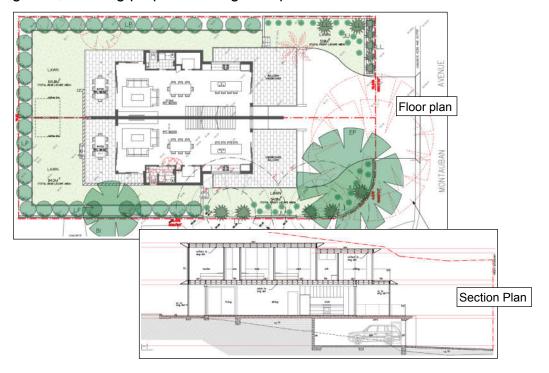
Figure 1, showing proposed design footprint

1.2.1 The development proposal consists of constructing two new residential dwellings with provisions for lower level cut to accommodate access, car parking and garage facilities. Entry level is proposed at or near RL83.5 with cut & fill located within tree protection zones of T4 & 6.

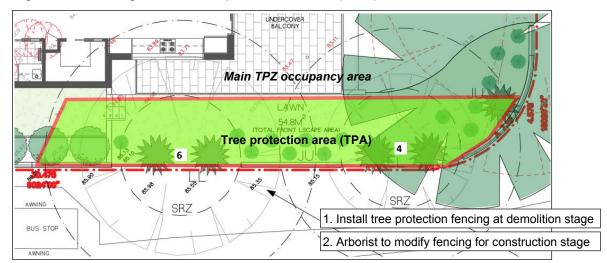
Figure 2, showing T4 & 6 tree protection area (TPA)

- Tree 2: requires removal being located just within the proposed driveway and Council verge crossover.
 - Trees 4: Receives a moderate level (<20%) at or near 17% encroachment & modification within the TPZ. Very slight SRZ incursion occurs by the driveway footprint which is considered manageable with onsite arborist supervision. Minimising impacts within the TPZ should consist of no more than 200mm over excavation to accommodate construction, arborist supervision during excavation to detail root management and no excavation within the SRZ for boundary walls or fencing without prior arborist advice. Given the leaning nature of the tree towards the adjacent bus shelter tree removal and replacement should be considered.</p>

- Tree 6: Receives a high level (>25%) at or near 28% encroachment & modification within the TPZ. That which would likely compensate for TPZ disturbance is the removal of the adjacent large tree T7 where tree removal would reduce nutrient & water competition. Removal of T7 may also expose T6 showing poor canopy form and balance from being suppressed by the dominant nature of T7. After removal of T7 arborist inspection of the tree should be conducted to determine any pruning requirements to make long exposed branches safe, or if the exposed tree contains a low retention value due to being suddenly exposed. Minimising impacts within the TPZ should consist of no more than 200mm over excavation to accommodate construction which includes adjacent stairs and retaining wall, arborist supervision during excavation to detail root management and no excavation within the SRZ for boundary walls or fencing without prior arborist advice, see Figure 2 p7.

- a) Trees 4 & 6: There is to be no site modification within radial SRZ setbacks. Over excavation to accommodate the design footprint should be limited to 0.2m (200mm) beyond the line of the proposed design shown within construction drawings with arborist supervision for excavation within the TPZ managing encountered tree roots in accordance with Section 2.3 e). Tree protection fencing shall be installed at a 3m setback from the tree during demolition and only be modified and certified by an appointed site arborist to allow for construction activities where trunk and ground protection may suffice.
- b) Neighbouring trees: The pruning of neighbouring trees back to the boundary is to be conducted in accordance with Section 2.3 g). Where root pruning may be required for T12 root pruning is to be conducted in accordance with Section 2.3 e).
