GEOTECHNICAL REPORT

PROPOSED ALTERATIONS AND ADDITIONS

CURRAWONG BEACH CABINS, CURRAWONG NSW

Project No.: 2017-084.3 November, 2018

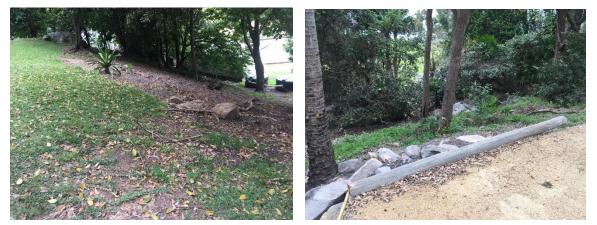
To the front of the cabins the grass covered terrace extends variable distances between approximately 7m and 10m to the east/north-east of the cabins with a change in gradient to a moderate (average 15 deg) east to north-east dipping soil slope which drops down to the near level valley floor. The slope is covered in grass and low bushes along with medium to large trees and scattered partially buried sandstone boulders.

Terrace edge and slope to east of cabins

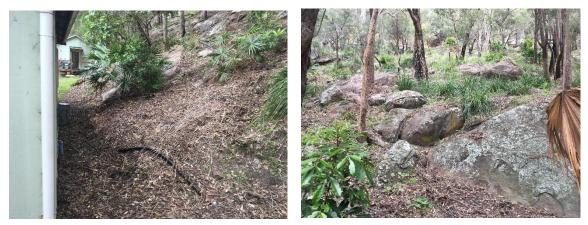
To the rear of the cabins is the base of another moderate (15 ó 19 deg) natural slope that rises up to the west approximately 50 to 70m to the base of a large cliff line. The soil slope is covered in low bushes and moderate density of medium to large trees with numerous small to large boulders partially buried across its surface.

Slope rising up from rear of cabins towards the west

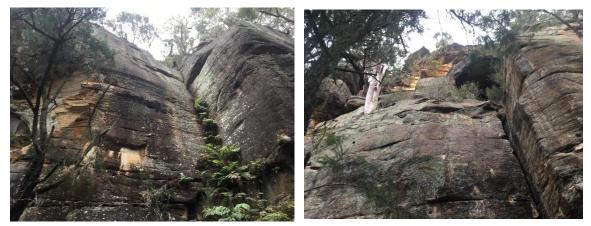
At the crest of this soil slope is an approximately 10 to 15m high sub-vertical sandstone bedrock cliff line that is formed along north-west and south-west striking, planar, continuous joint defects. Above this section of cliff are further outcrops/cliffs that were inaccessible but appear to rise another 15 to 20m in elevation and are sub-vertical to steeply sloping outcrops of sandstone bedrock.

Lower sub-vertical joint defined cliff line and upper more variable cliff/outcrop partially viewed

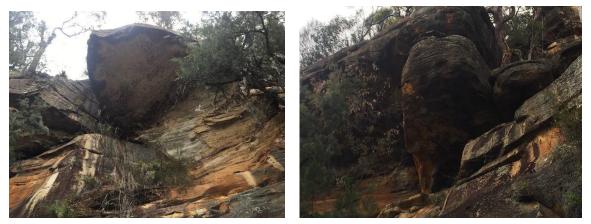
In general the lower cliff line showed no signs of recent or apparent impending instability, however several overhangs have developed through weathering that will eventually become unstable whilst some boulders were noted at the crest of the upper cliff line.

Two identified overhangs through weathering and defects that appear of potential limited stability.

There were no indicators of impending instability within the inspected portion of the cliff line however the two significant overhangs identified along with boulders or unseen overhangs from the upper section of cliff do present an ongoing hazard to the site. The failure of any of these sections will result in a rock fall/topple style failure with fragments of rock of variable size impacting the soil slope below and potentially travelling down slope towards the cabins.

The majority of the cliff line to the west is inaccessible and would require specialized rope access or aerial photographic methods for a detailed assessment. It is recommended that further inspection with specific focus on the two identified overhangs detailed in this report be considered to allow better assessment of the potential risk levels and implementation of support measures as required.

The inspection and assessment identified no obvious impending significant slope movement, excess surface stormwater flow, seepage or erosion within the areas of the existing cabins. The cliff line to the west does contain several identified overhangs and detached sections which will eventually fail from the cliff line, however none show impending collapse. The majority of the cliff is inaccessible to standard access therefore it is recommended that further assessment using either ropes or aerial methods be considered, especially for the two overhangs detailed in this report.
