Report Title: Geotechnical Report 47 The Serpentine, Bilgola

Report Date: 1/4/19

GEOTECHNICAL INVESTIGATION:

New Pool at **47 The Serpentine, Bilgola**

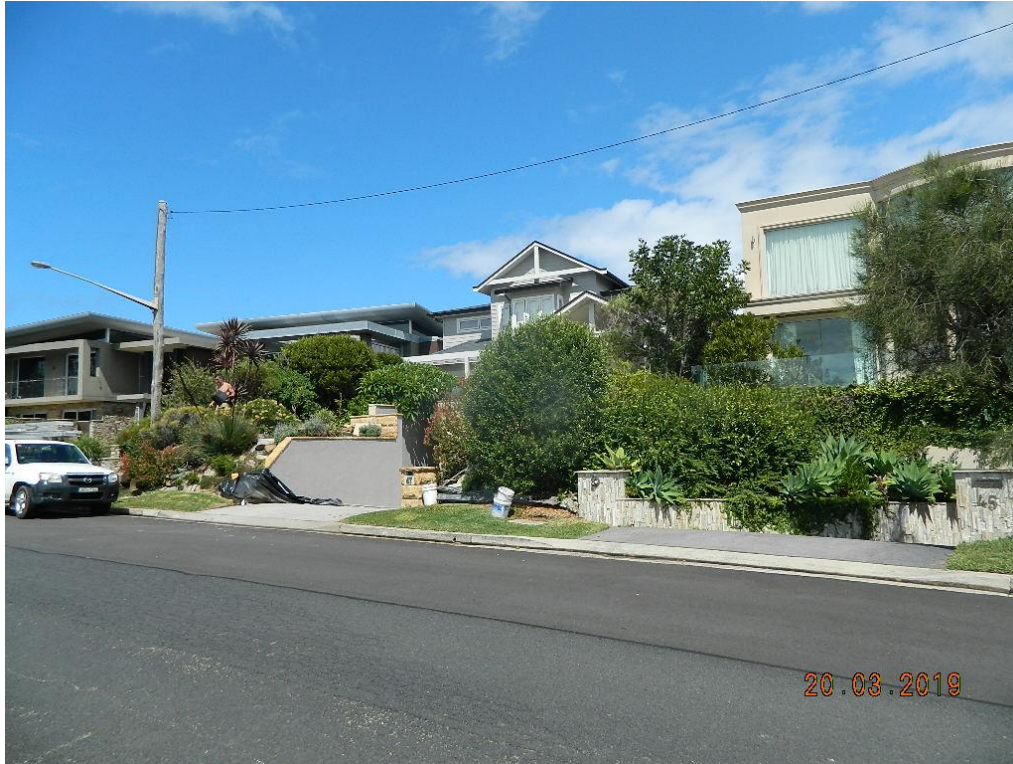
Photo 1

- 2.3** At the NE road frontage a concrete driveway runs to a garage on the NE side of the property (Photos 1 & 2). An excavation has been made for the garage and driveway. Stable concrete retaining walls reaching a maximum height of ~2.5m support the cut for the driveway (Photo 3). Medium Strength Sandstone was observed outcropping at the road frontage and in the garden on the SE side of the garage and driveway (Photo 4). The part three-storey, concrete block, brick, sandstone flagging and timber clad and framed house is supported on concrete block and brick walls, and brick and timber piers (Photo 5). No significant signs of movement or cracking were observed in the external supporting walls of the house and the brick piers stand

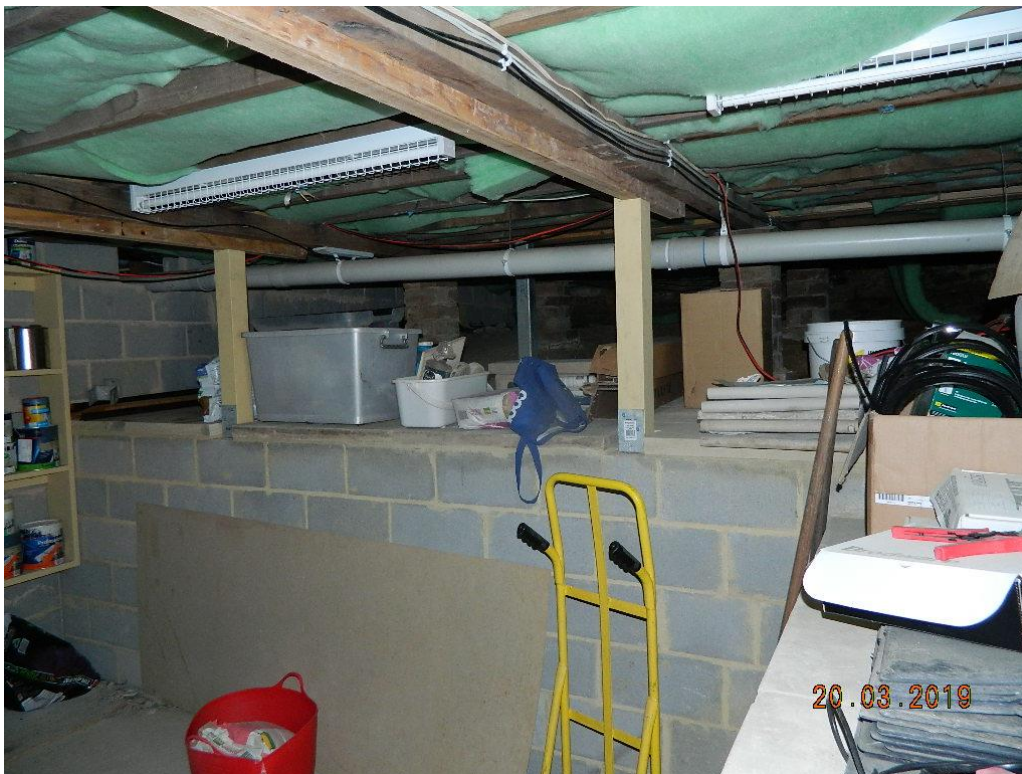
Photo 6

vertical (Photo 6). An excavation has been made on the NW side of the house along the boundary for the lower ground floor of the subject house. The cut is supported by a stable concrete wall reaching a maximum height of ~1.0m (Photo 7). The slope below the house is landscaped with a series of stable terraced gardens and intermittent open grassy areas that extend to the road frontage along the SW boundary (Photos 8 & 9). The terraces are constructed of large, stacked sandstone boulders. No significant signs of movement were observed on the property. No geotechnical hazards that could impact on the subject property were observed on the neighbouring properties as seen from the subject property and the road.

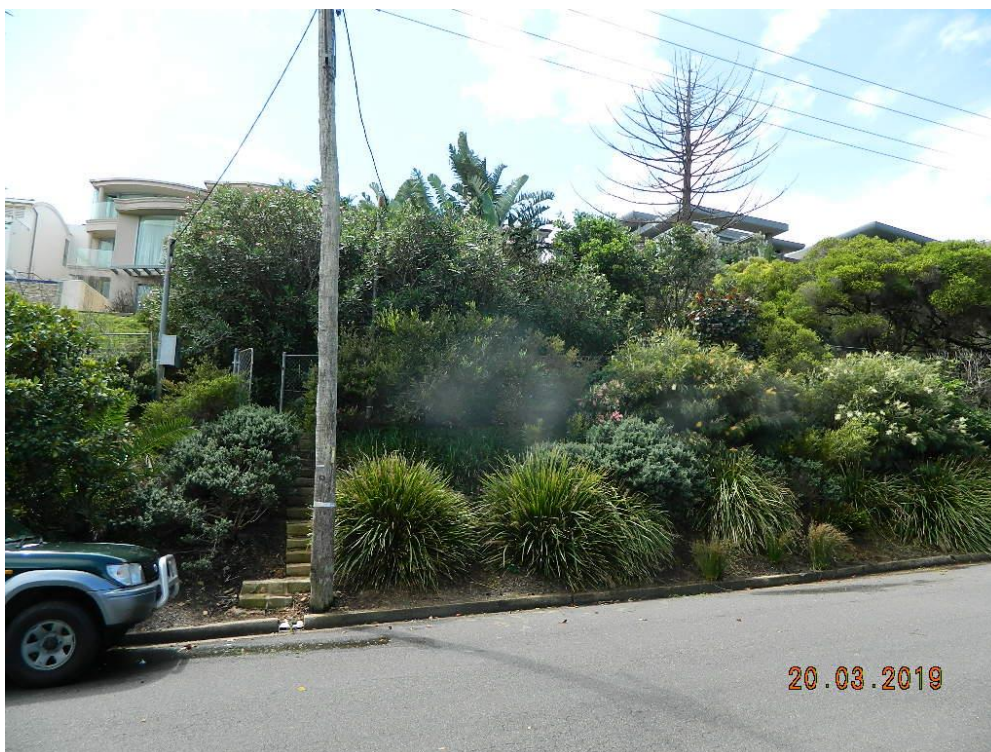
No geotechnical hazards were observed above or beside the property. The moderately graded slope that falls below the house and continues below is a potential hazard (**Hazard One**).

HAZARDS	Hazard One
TYPE	The moderately graded slope that falls below the house and continues below failing and impacting on the proposed works (Photo 10).
LIKELIHOOD	'Unlikely' (10^{-4})
CONSEQUENCES TO PROPERTY	'Minor' (9%)
RISK TO PROPERTY	'Low' (5×10^{-6})
RISK TO LIFE	8.3×10^{-7} /annum
COMMENTS	This level of risk is 'ACCEPTABLE'.

Photo 10: Downhill boundary at The Serpentine

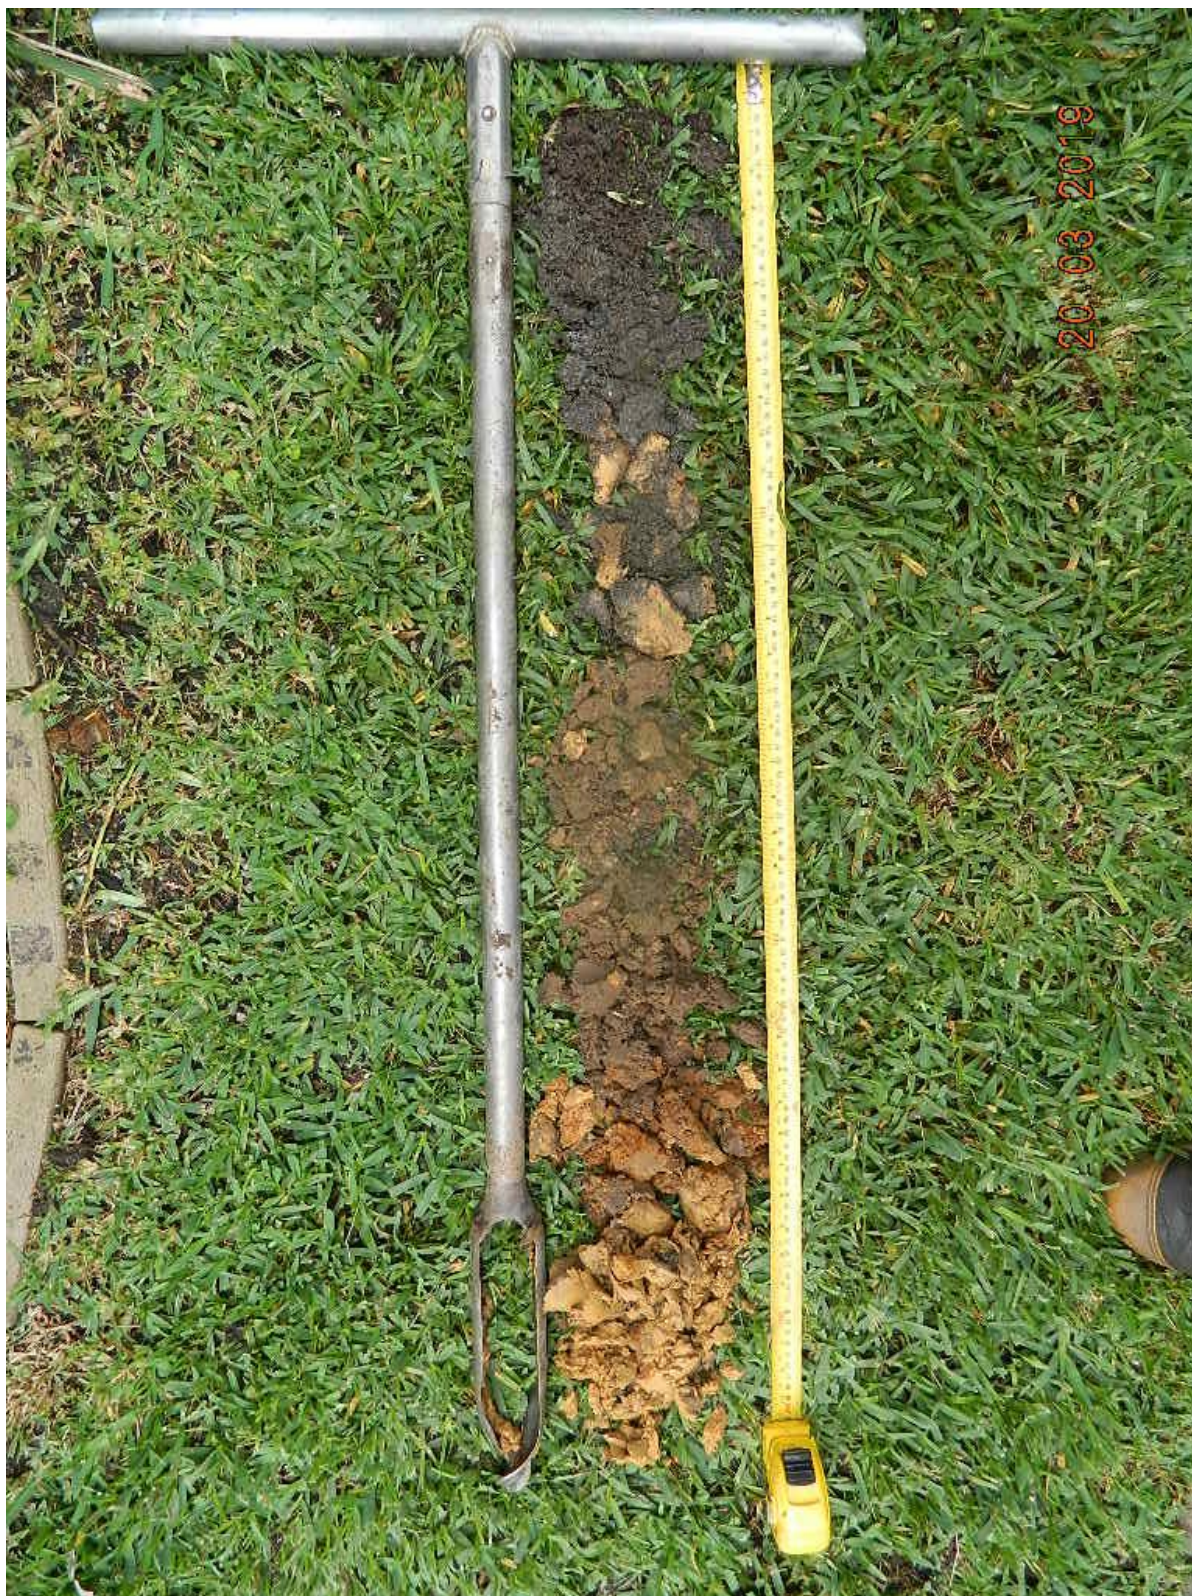
AUGER HOLE 1 (~RL55.0) – AH1 (Photo 11)

Depth (m)	Material Encountered
0.0 to 0.2	FILL , greyish dark brown/black, loose, damp, fine to medium grained, rock fragments, organic matter.
0.2 to 0.4	FILL , disturbed sandy clay, yellow, stiff, fine to medium grained, red rock fragments, dry.
0.4 to 0.7	LOAMY SOIL , marks the original ground surface, brown, roots, fine to medium grained, rock fragments, firm.
0.7 to 1.0	CLAY , yellow, very stiff, orange mottling, fine grained, dry.

Refusal @ 1.0m in very stiff clay. No watertable encountered.

Photo 11: Auger Hole 1; base of hole at base of image.

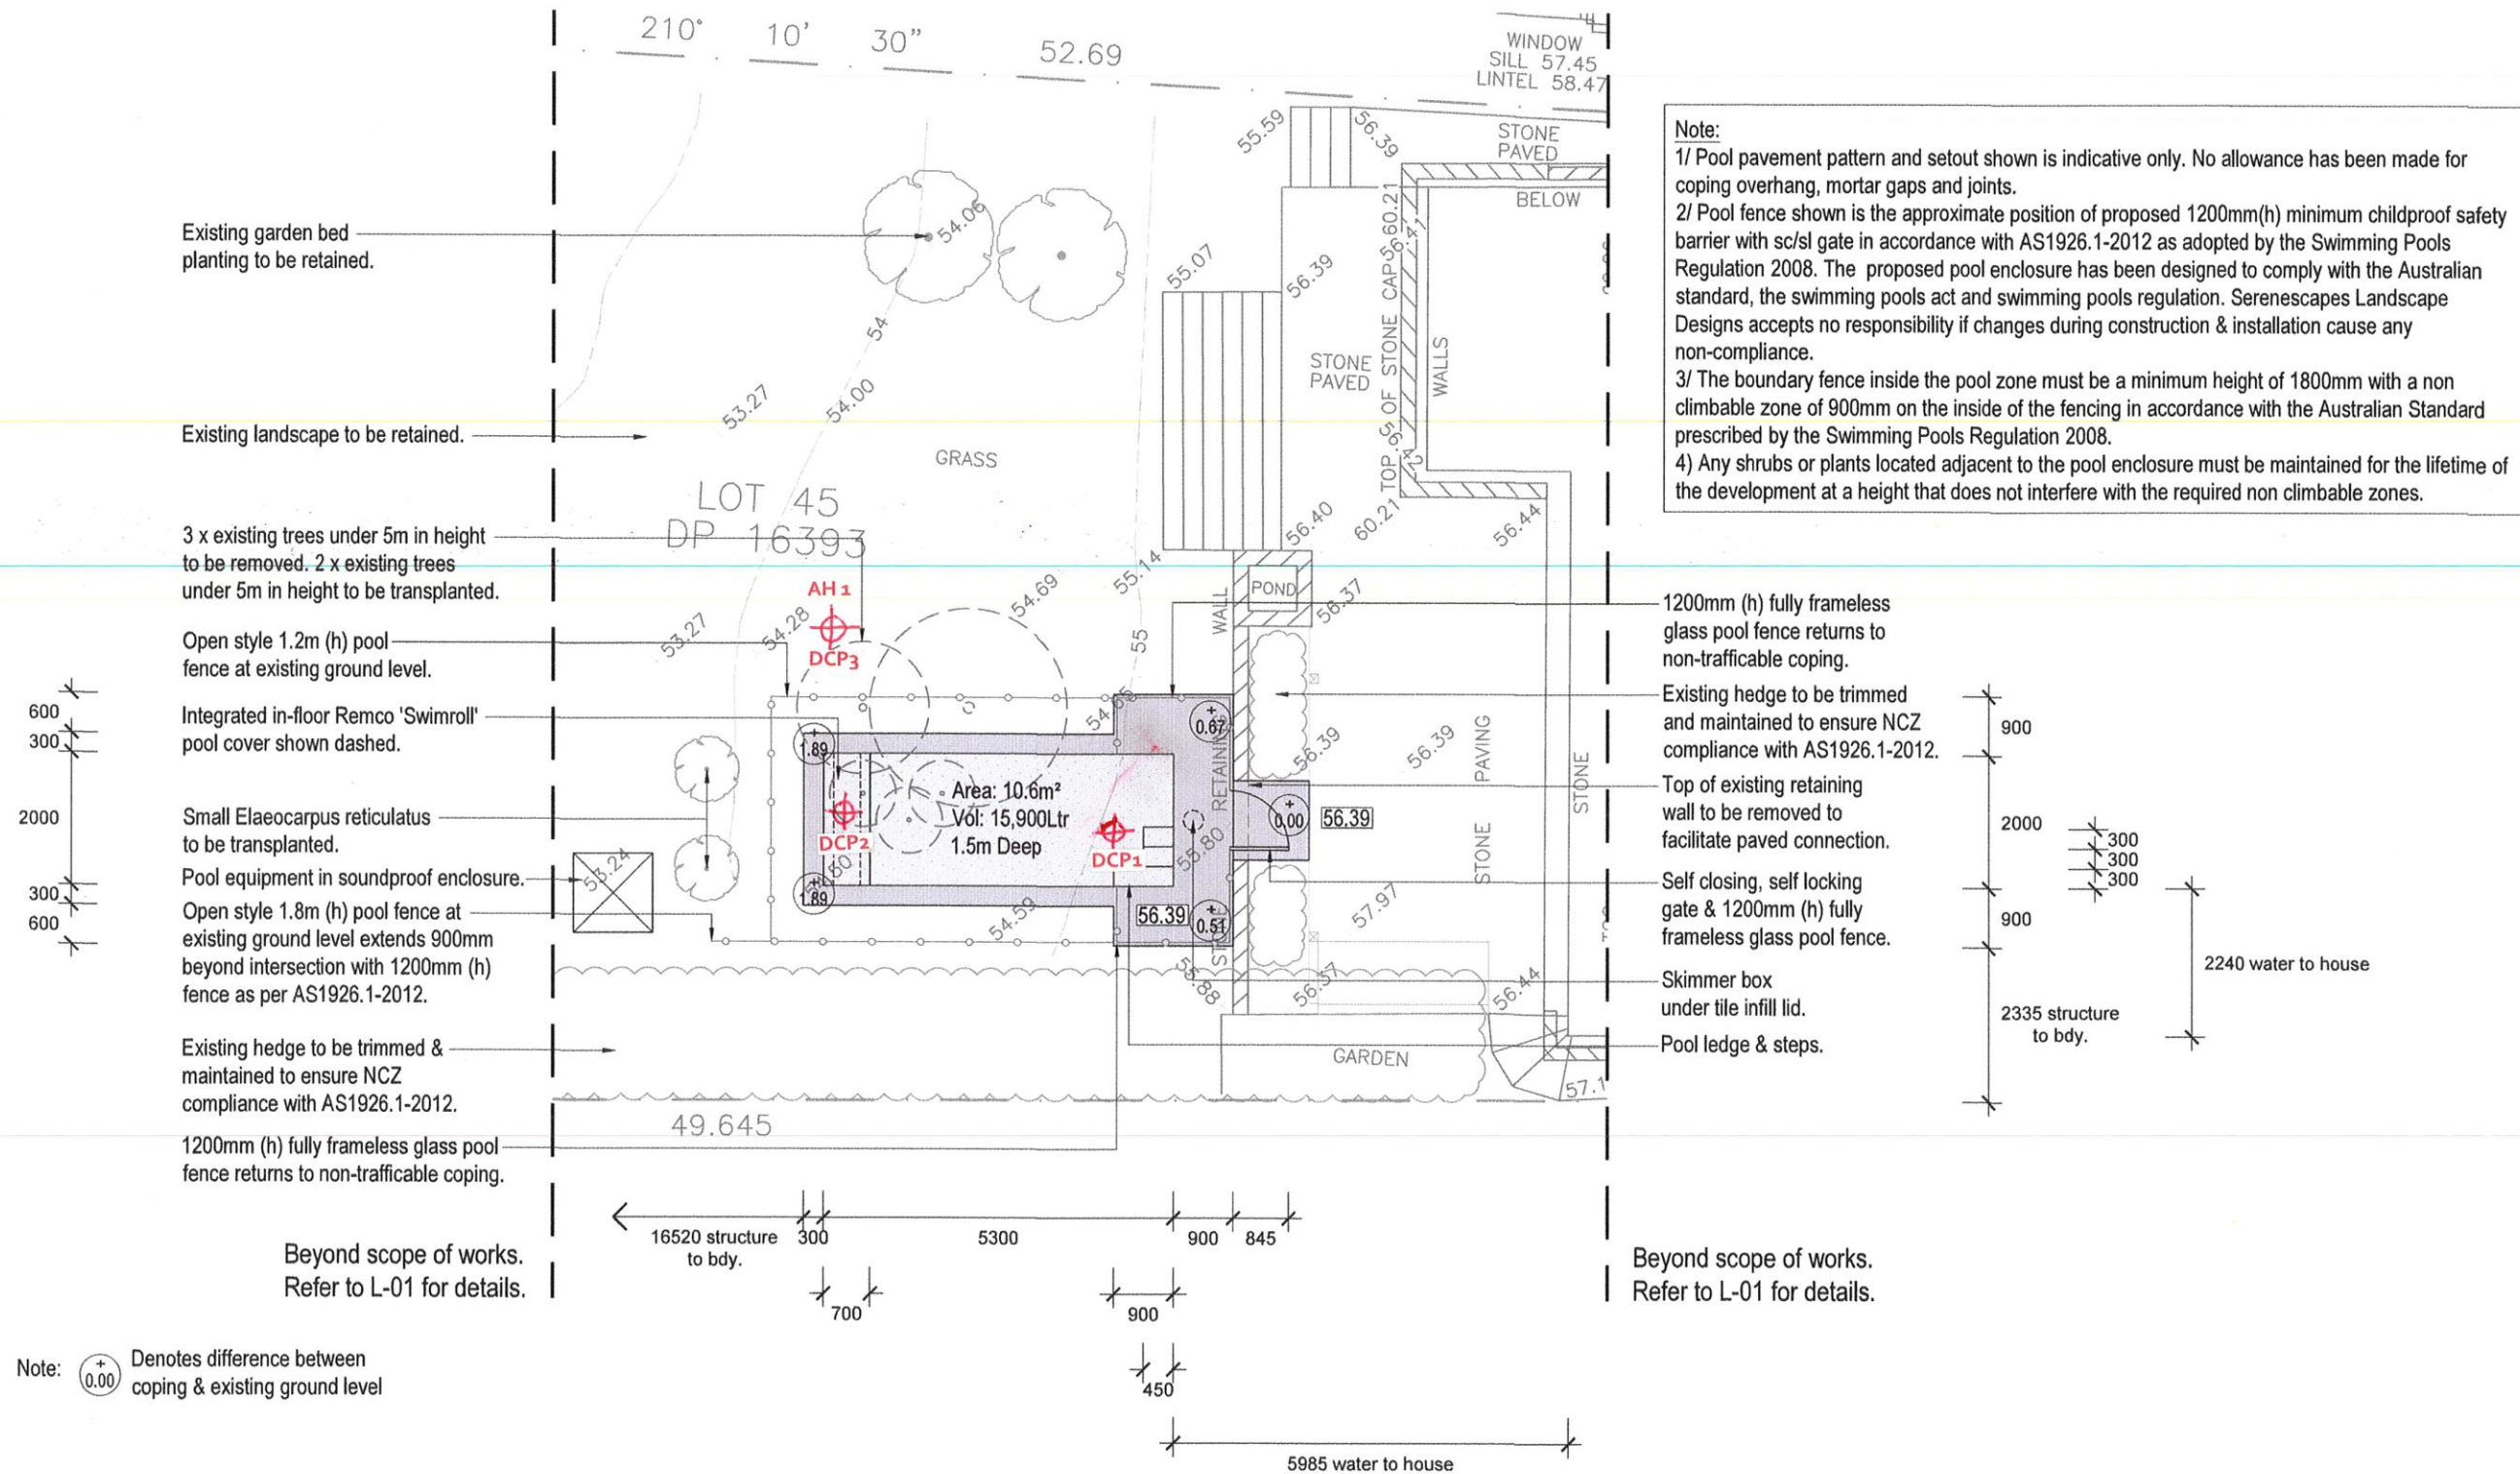
SITE PLAN – showing test locations

One Hand Auger Hole (AH) was put down to identify the ground materials. Three Dynamic Cone Penetrometer (DCP) tests were put down to determine the relative density of the overlying soil and the depth to weathered rock. The locations of the tests are shown on the site plan. It should be noted that a level of caution should be applied when interpreting DCP test results. The test will not pass through hard buried objects so in some instances it can be difficult to determine whether refusal has occurred on an obstruction in the profile or on the natural rock surface. This is not expected to be an issue for the testing on this site and the results are as follows:

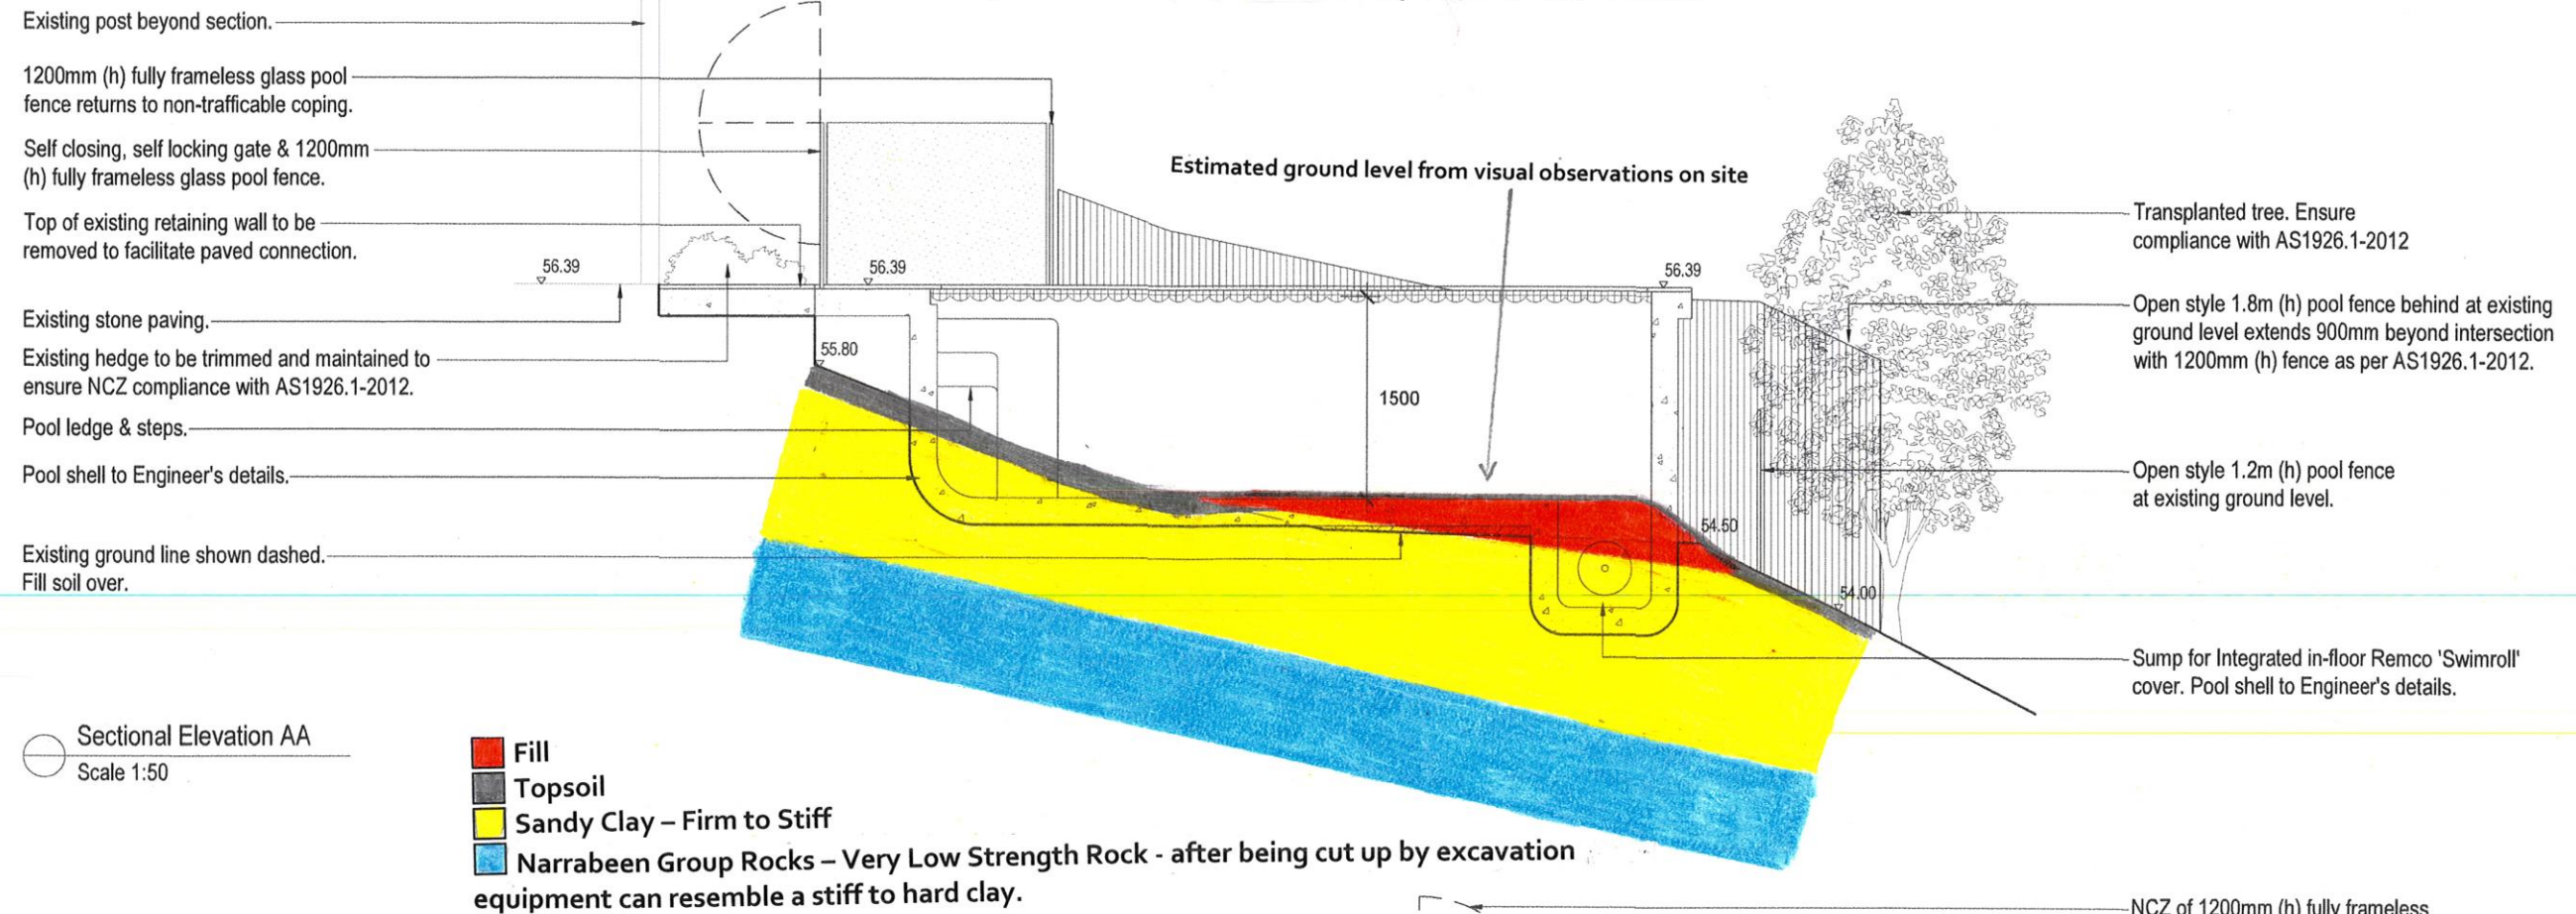
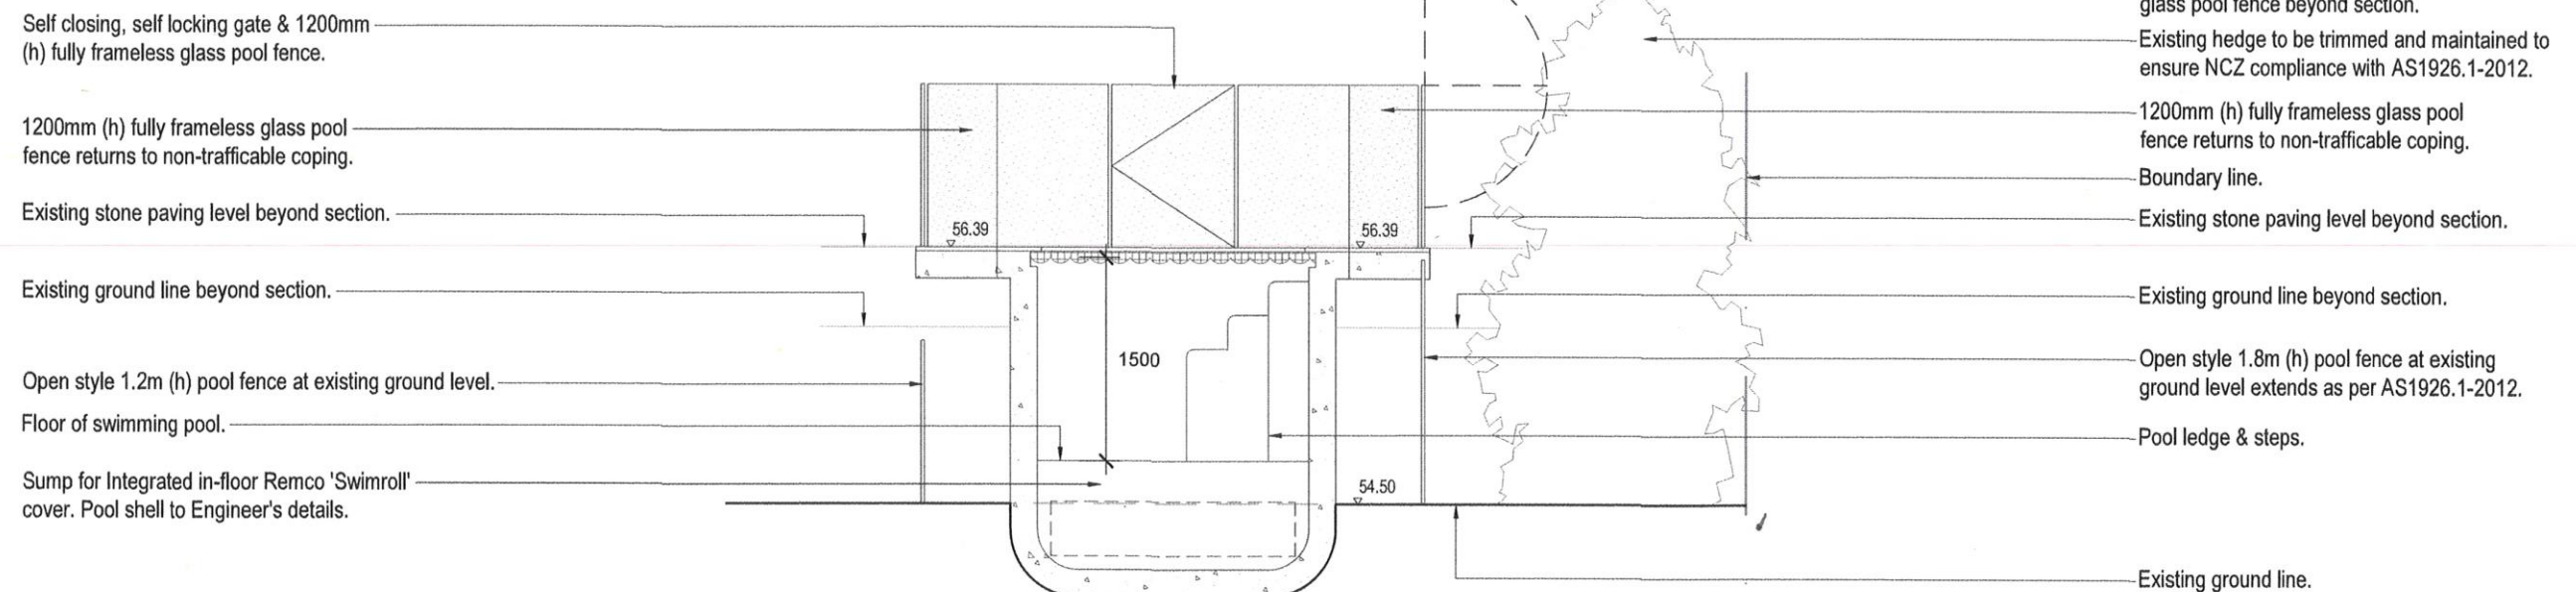
TYPE SECTION – Diagrammatical Interpretation of expected Ground Materials

The slope materials are colluvial at the near surface and residual at depth. They consist of fill and loamy soil over clay with rock fragments throughout the profile. In the test locations the clays merge into the weathered zone of the underlying rock at an average depth of ~1.5m below the current ground surface. The tests indicate sandstone beds may be present in the otherwise shale dominated profile. To be prudent we interpret the underlying rock as Very Low Strength Rock. Filling to a maximum depth of ~0.4m was encountered on the SW side of the property during the testing on the site. No other significant fills were observed during the testing on the site. See Type Section attached for a diagrammatical representation of the expected ground materials.
