Proposed alterations & additions at 51 Grandview Drive, Lot 26, D.P. 16029, in Newport, NSW

Stage 3 (Detailed design) Road Safety Audit

May 2020

Prepared for **Elizabeth McCartney Royal**, the resident of 51 Grandview Drive, in Newport, NSW

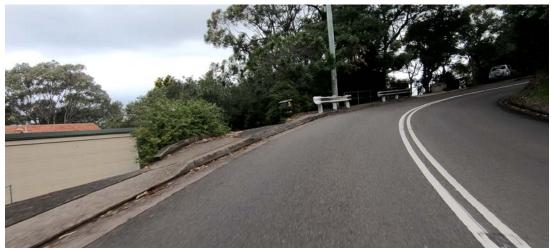
Photo 3.1: Grandview Drive, looking westbound toward the development site – in daylight (Photo: Traffic Engineering Centre Pty Ltd)

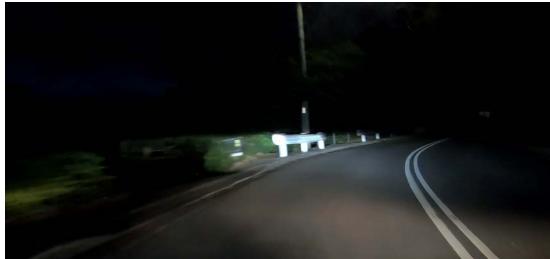
Photo 3.2: Grandview Drive, looking westbound toward the development site – at night (Photo: Traffic Engineering Centre Pty Ltd)
