Geotechnical Assessment

Project: New Dwelling
63 Gondola Road, North Narrabeen NSW

REF: AG 19241
9th March, 2020

For New Dwelling at
63 Gondola Road, North Narrabeen NSW

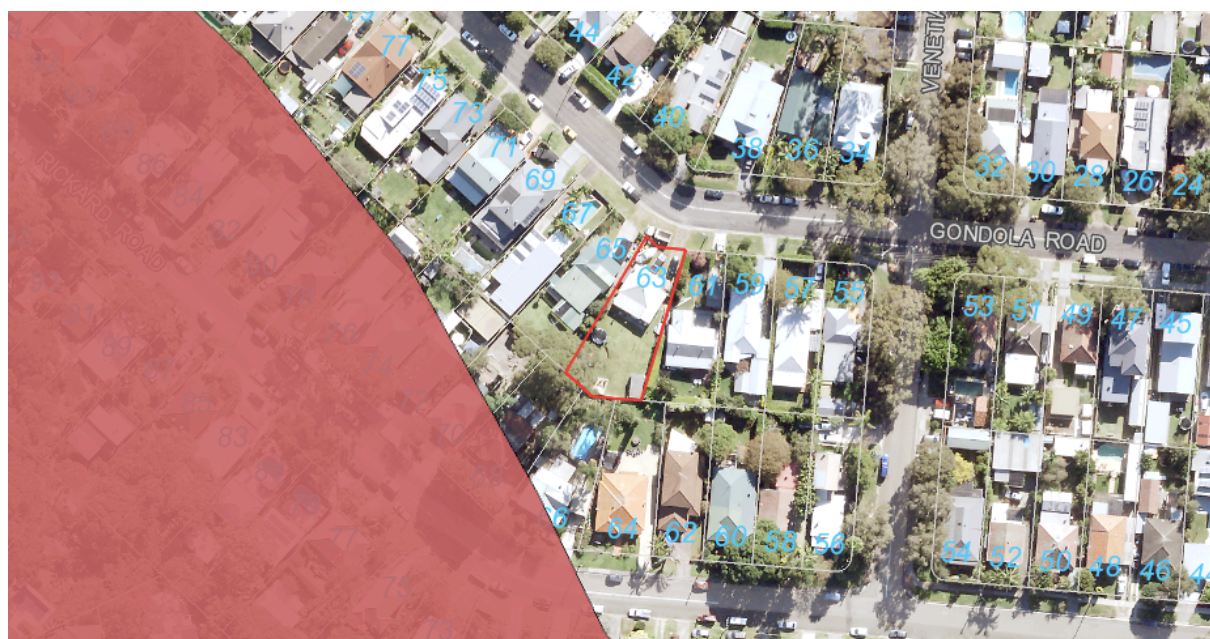
Image 2: 63 Gondola Road, North Narrabeen NSW – **Geotechnical Hazard Map**– Red polygon (PLEP 2014)

- No evidence of significant soil creep, tension cracks or other indicators of slope instability were identified at the time of our inspection.
- The existing structure displayed no evidence of significant cracking or settlement that could be attributed to slope instability.
- The property is not mapped as a Geotechnical Hazard Zone in Northern Beaches Council PLEP Geotechnical Hazard Map (PLEP Geotechnical Hazard Map **Image 2** below).

No significant geotechnical hazards were identified above, beside or below the subject site.

The slope across the subject site has an average gradient of ~10 degrees. The soil profile is interpreted to be comprised of organic sandy top soils, with sand & clay overlying weathered bedrock at depths beyond 3300mm across the block. The likelihood of the slope failing is assessed as '**UNLIKELY**', the consequences of such a failure are assessed as '**MINOR**'. The risk to property is '**LOW**'. The existing conditions and proposed development are considered to constitute an '**ACCEPTABLE**' risk to life and a '**LOW**' risk to property provided that the recommendations outlined in **Section 3.6** are adhered to.

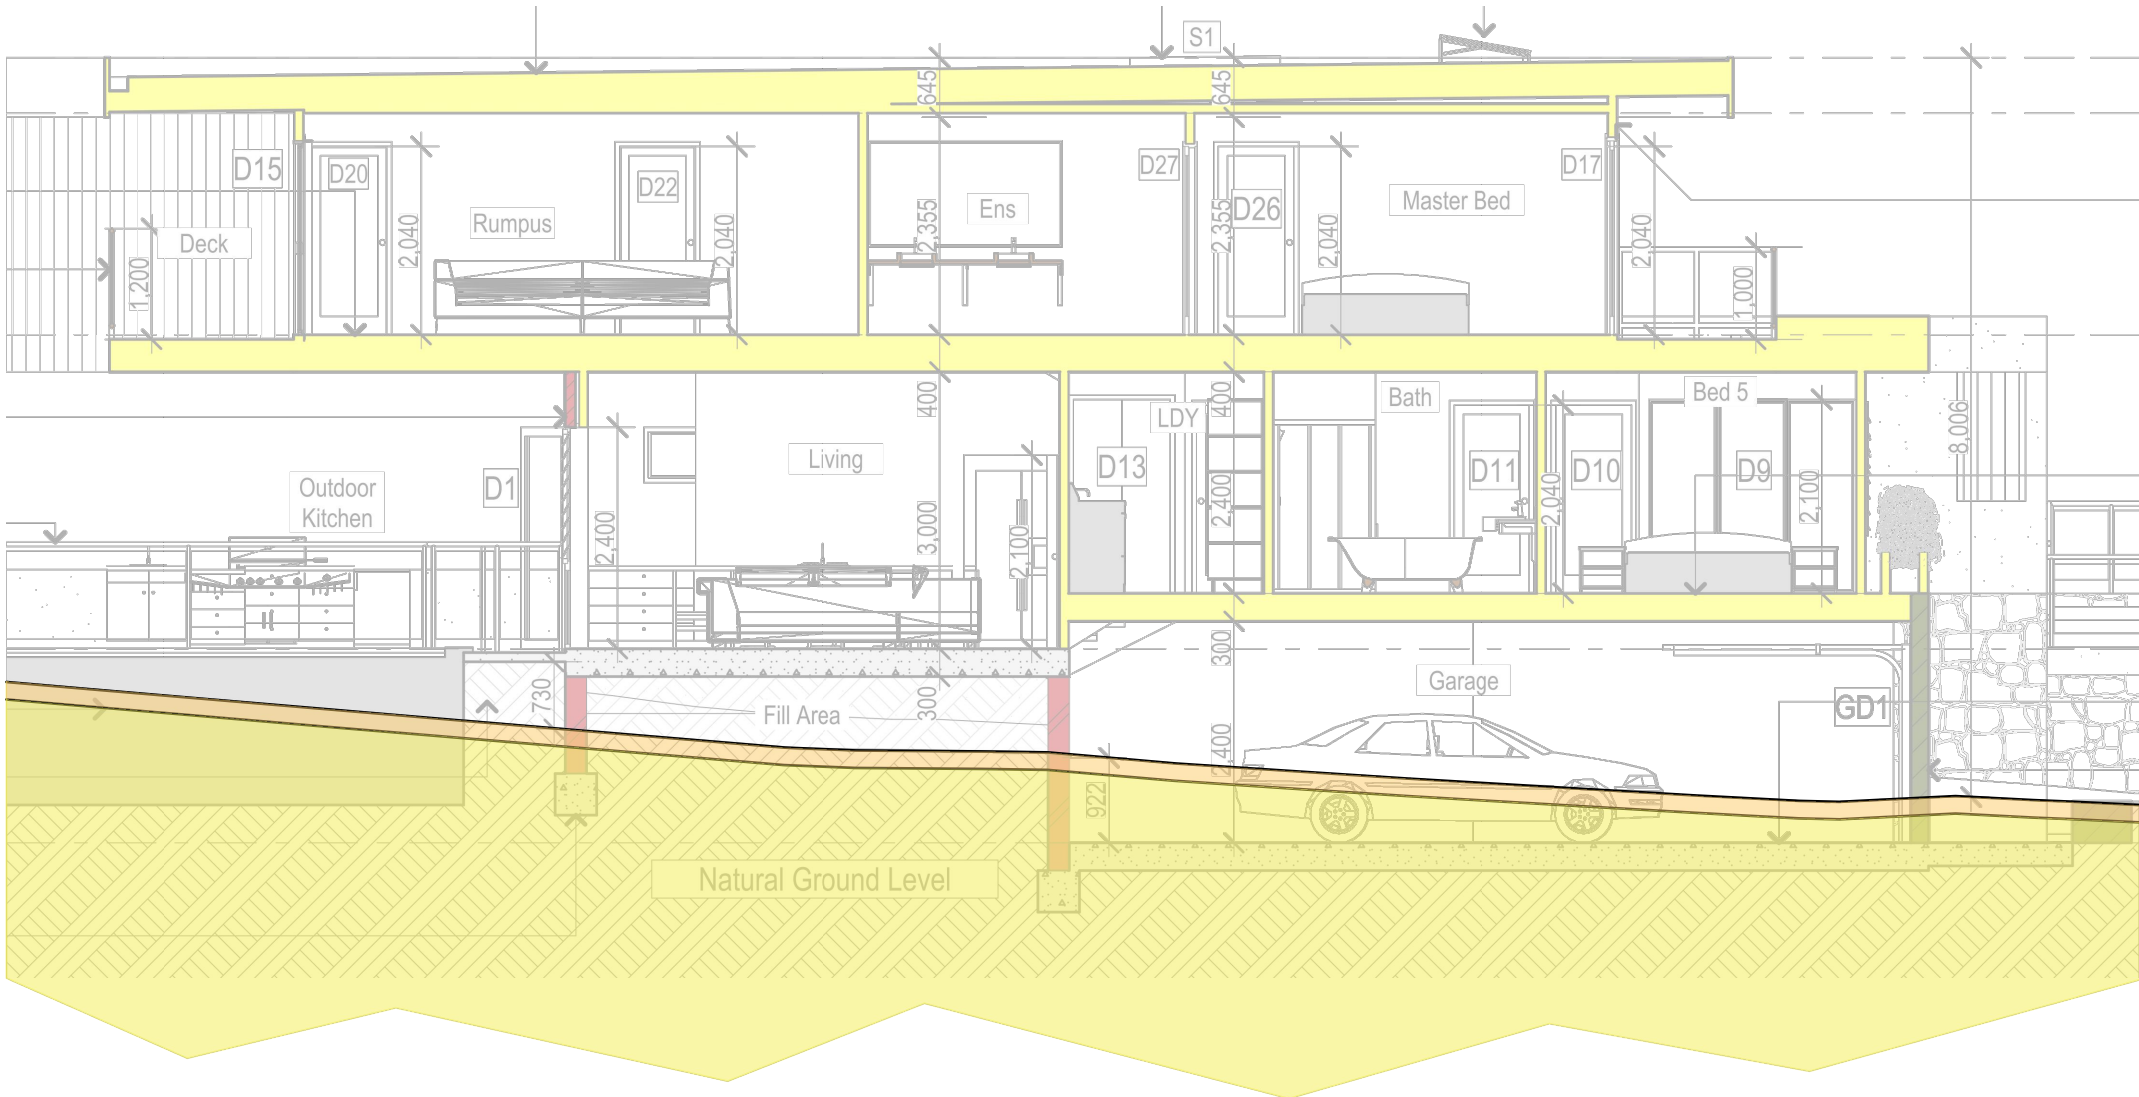
INFERRED GEOLOGICAL SECTION
SCALE NTS

INTERPRETED SUBSURFACE SECTION ONLY.
ACTUAL GROUND CONDITIONS MAY VARY.
