Arborist Statement: 66 Bower Street, Manly

Blues Brothers Arboriculture has been engaged to inspect and report on trees located in the front yard of the property for development purposes. Site attendance occurred on the 18th November 2019 to undertake the assessment of nine trees.

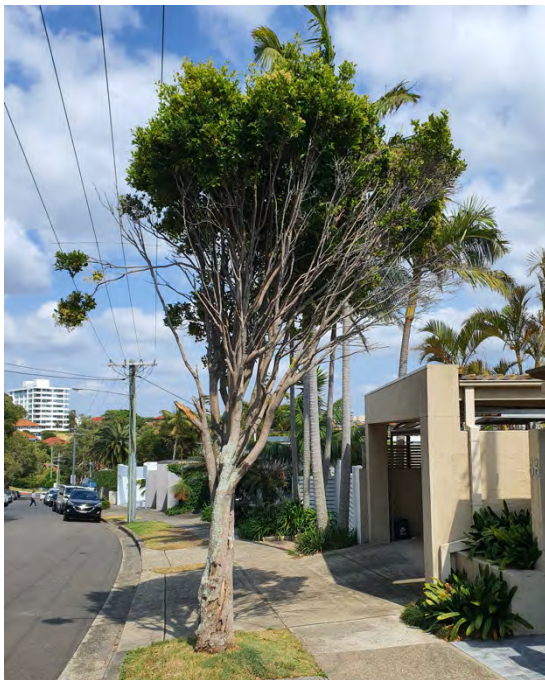
Tree 9 (Lilli Pilli) is a street tree assessed to be in moderate health. The tree presented with an almost (80%) dead eastern trunk and signs of impact from Borer and line trimmer. The tree displayed a moderate vigour and appeared to be struggling to recover as evidenced by the limited visible reaction wood around wounds.

Image 2: T9 (Lilli Pilli).

It is recommended that application for the removal of the street tree, T9, is submitted in conjunction with DA lodgement. The proposed driveway construction will likely overwhelm the already struggling Lilli Pilli. Alternative options are unviable.

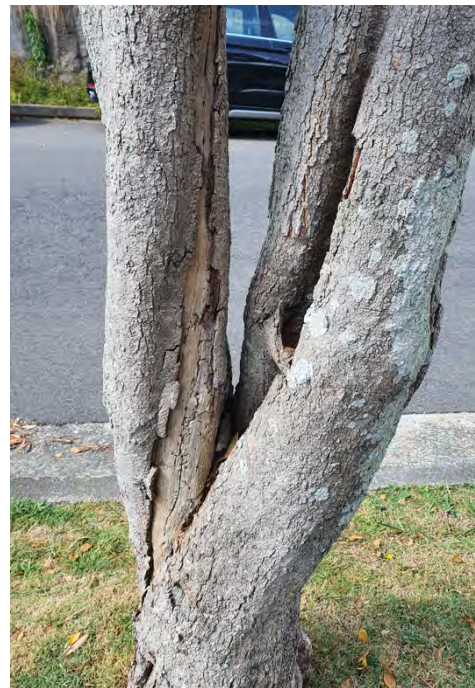
Image 3: Close-up of decay in T9.

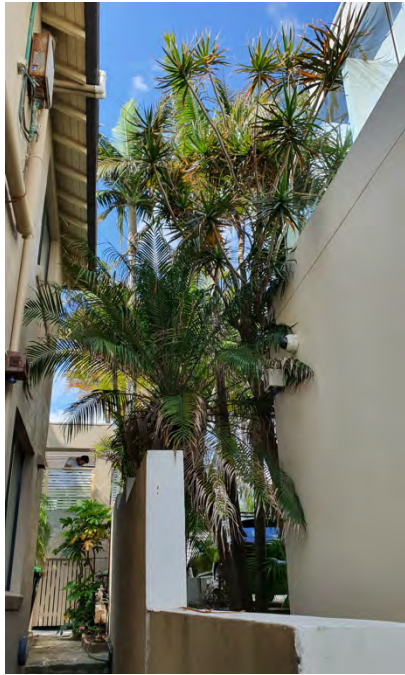
Trees 6-8 are neighbouring palms (exempt species) and are separated from the development site by a large masonry retaining wall (and associated footings). It is suspected that these trees were planted shortly after the construction of the wall which has likely acted as a barrier to root growth. Due to the wall and characteristic fibrous root ball of palms, development impacts are likely to be low.

It was noted during inspection that Tree 6 was in contact with the dividing masonry wall and has likely been a contributing factor of wall displacement into 66 Bower Street. The remediation of the wall is considered to be outside of the scope of this report; Commentary is provided for completeness of assessment regarding this development only.

Image 5: Neighbouring Palms. Note masonry wall.

It is recommended that the demolition of the existing western garage is undertaken with attention to protecting the neighbouring palms:

- Trees 7 & 8 require trunk armouring to be installed prior to the commencement of development. Trunk protection shall consist of wrapping the trunk in a porous material (Shade cloth, GeoTech Fabric, Hessian) and arranging timber battens around the Trunk. Battens shall be a minimum of 40x90mm and spaced no further than 100mm apart. Under no circumstances may the tree be drilled, nailed into or otherwise used for the securing of ropes, cables, guy wires during development.
- Tree 6, whilst separated by the masonry wall, may still have roots growing within the development area. Due to the unknown construction of the retaining wall and associated shallow soil volumes of the area, it is recommended that an AQF5 Arborist is onsite to supervise excavation.

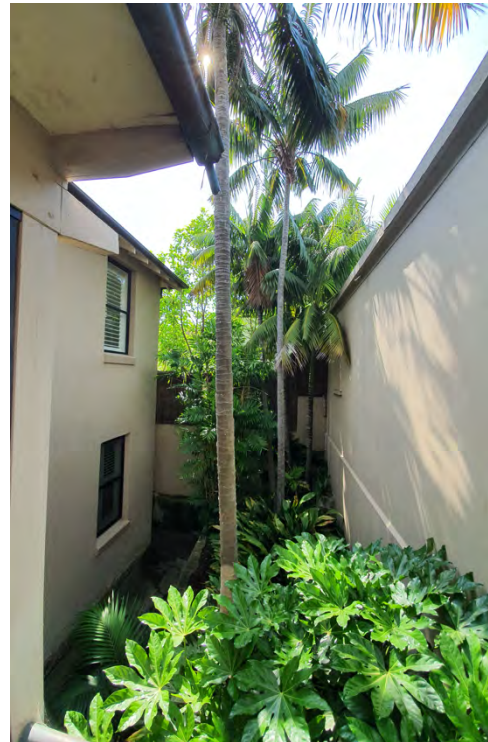
Trees 1-5 are exempt due to size or species are located within the proposed development area and are not retainable.

Image 4: Trees 1-3.

It is recommended that Trees 1-5 are removed due to their location in respect to the proposed development.

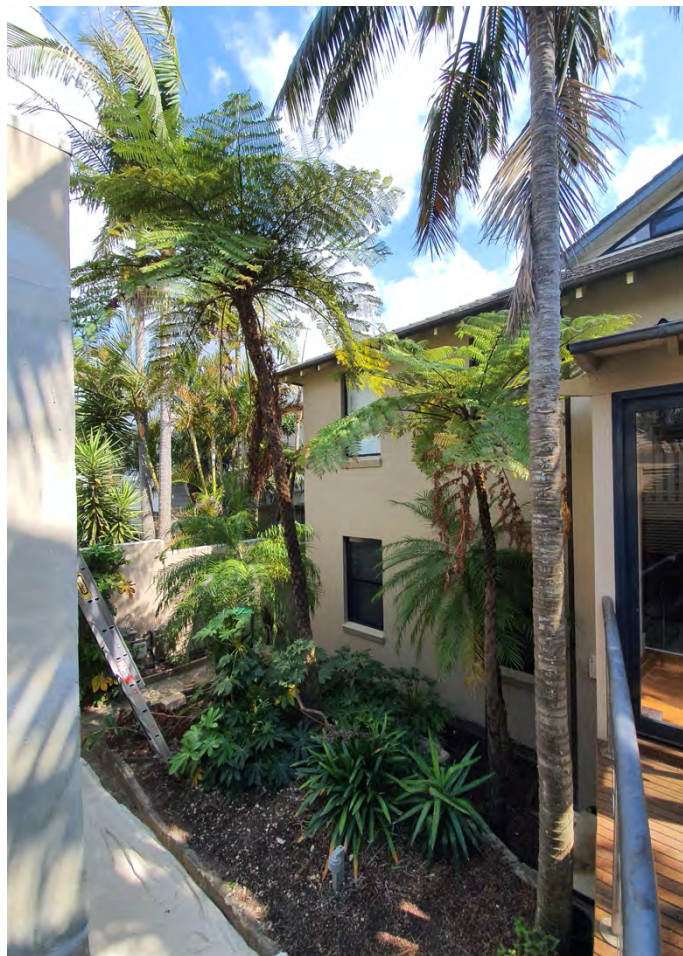
Trees: 4-6 from existing landing.
