J4052. 18th February, 2022. Page 1.

GEOTECHNICAL INVESTIGATION:

New Cabana at 39B Ocean Road, Palm Beach

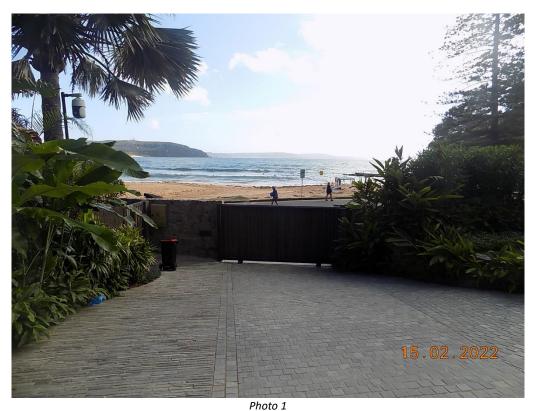
- 2.3 At the road frontage to Ocean Road, a Right of Carriageway (ROW) runs up the slope to a gate at the property frontage (Photo 1). A paved driveway runs from the gate to a paved parking area and garage under the subject house (Photo 2). A retaining wall along the E side of the downhill boundary supports a fill for a level lawn that extends off the downhill side of the house (Photo 3). The downhill side of the wall was not accessible however, no signs of movement were observed in the soil immediately behind the wall on the uphill side. The part three-storey rendered brick house is supported on brick walls. The external walls of the house showed no significant signs of movement. A pool on the E side of the property appears to be in good condition

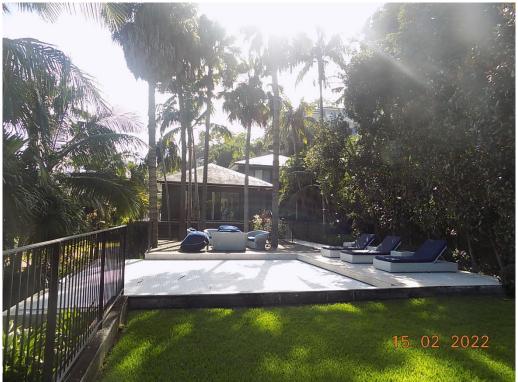
with no significant signs of cracking or movement observed in the visible pool shell

(Photos 4). Stable sandstone block retaining walls reaching a maximum height of

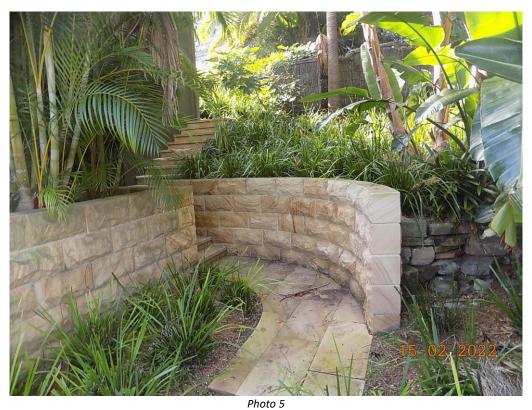
~1.0m support a cut for a staircase that runs up the E side of the house (Photo 5). The

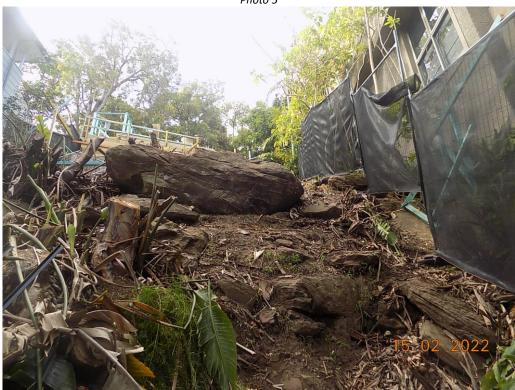
Photo 6

Road above. Medium to large detached sandstone joint blocks scatter the steep slope

(Photo 6). A stable ~2.2m high sandstone block retaining wall supports a fill for a level

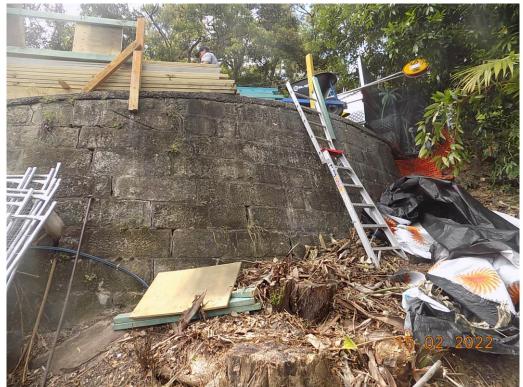
Photo 7

area on the uphill side of the property (Photo 7).

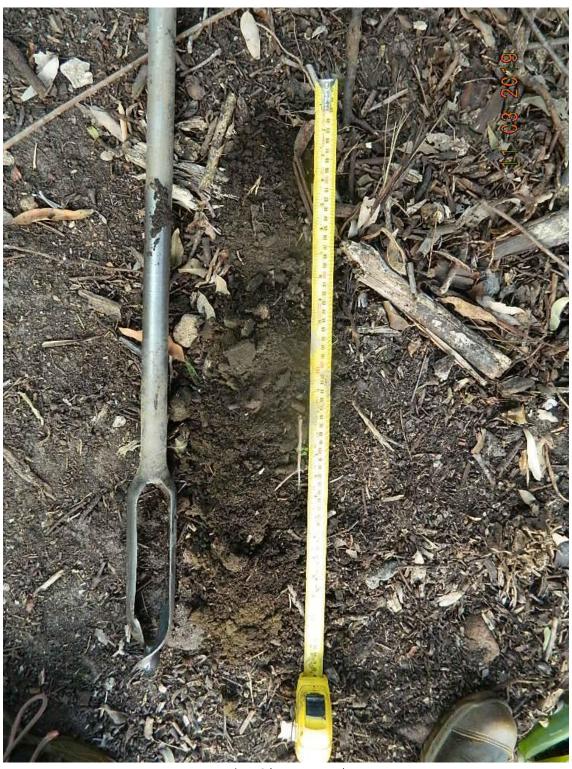
Photo 8 (Top to Bottom)

AUGER HOLE 1 (~RL33.6) – AH1 (Photo 8)

Depth (m)	Material Encountered
0.0 to 0.5	FILL , sandy soil, brown, loose, rock fragments, fine to medium grained, dry.
0.5 to 0.6	SILTY SAND , light brown, loose, rock fragments, fine to medium grained, dry.

End of test @ 0.6m in silty sand. No watertable encountered.

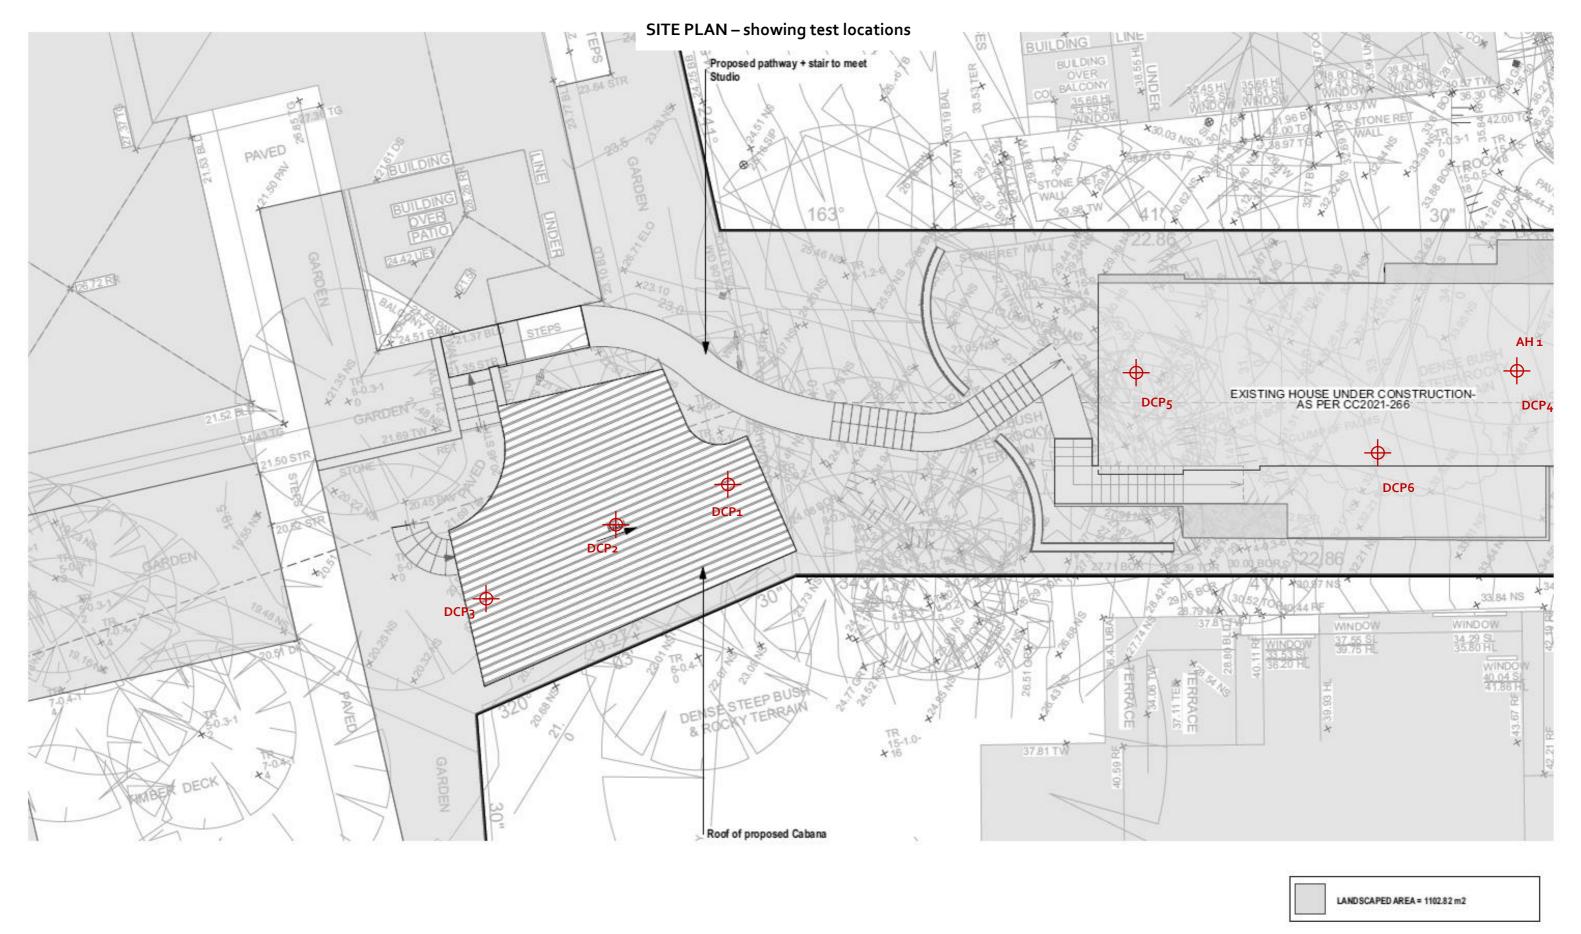
See site plan attached for extent of minimum required shoring.

Where the W common boundary falls within the zone of influence of the cabana excavation,

the cut face will require the installation of shoring. Staged temporary or permanent support

installed along the W side as the excavation is progressed in spans not less than 2.0m
