Geotechnical Assessment

Project: Alterations & Additions
15 Southern Cross Way, Allambie Heights NSW

Prepared for:
Louise & Wes Quick

Ref: AG 24476
8 November 2024

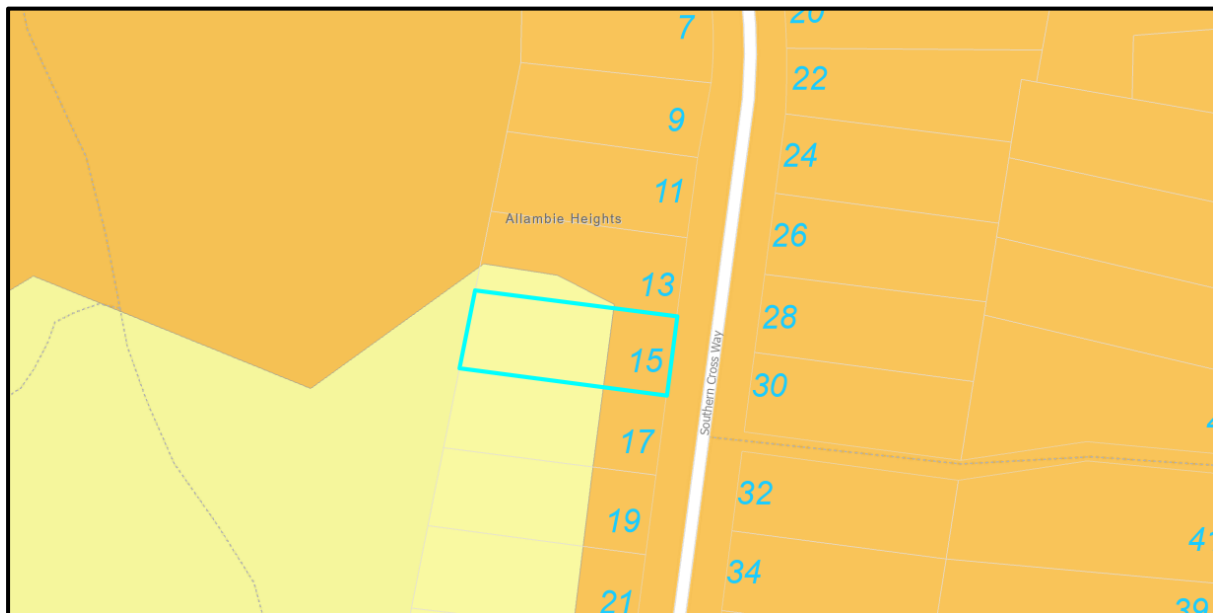
Image 2. Warringah Landslip Risk Map:
15 Southern Cross Way, Allambie Heights (© NBC Maps)

- No evidence of significant soil creep, tension cracks or landslip instability were identified across the site or on adjacent properties as viewed from the subject site at the time of our inspection.
- The site is underlain by relatively shallow sandstone bedrock.
- The property is classified as **Area B** with reference to Northern Beaches Council WLEP – Warringah Landslip Risk Map (**Image 2**).

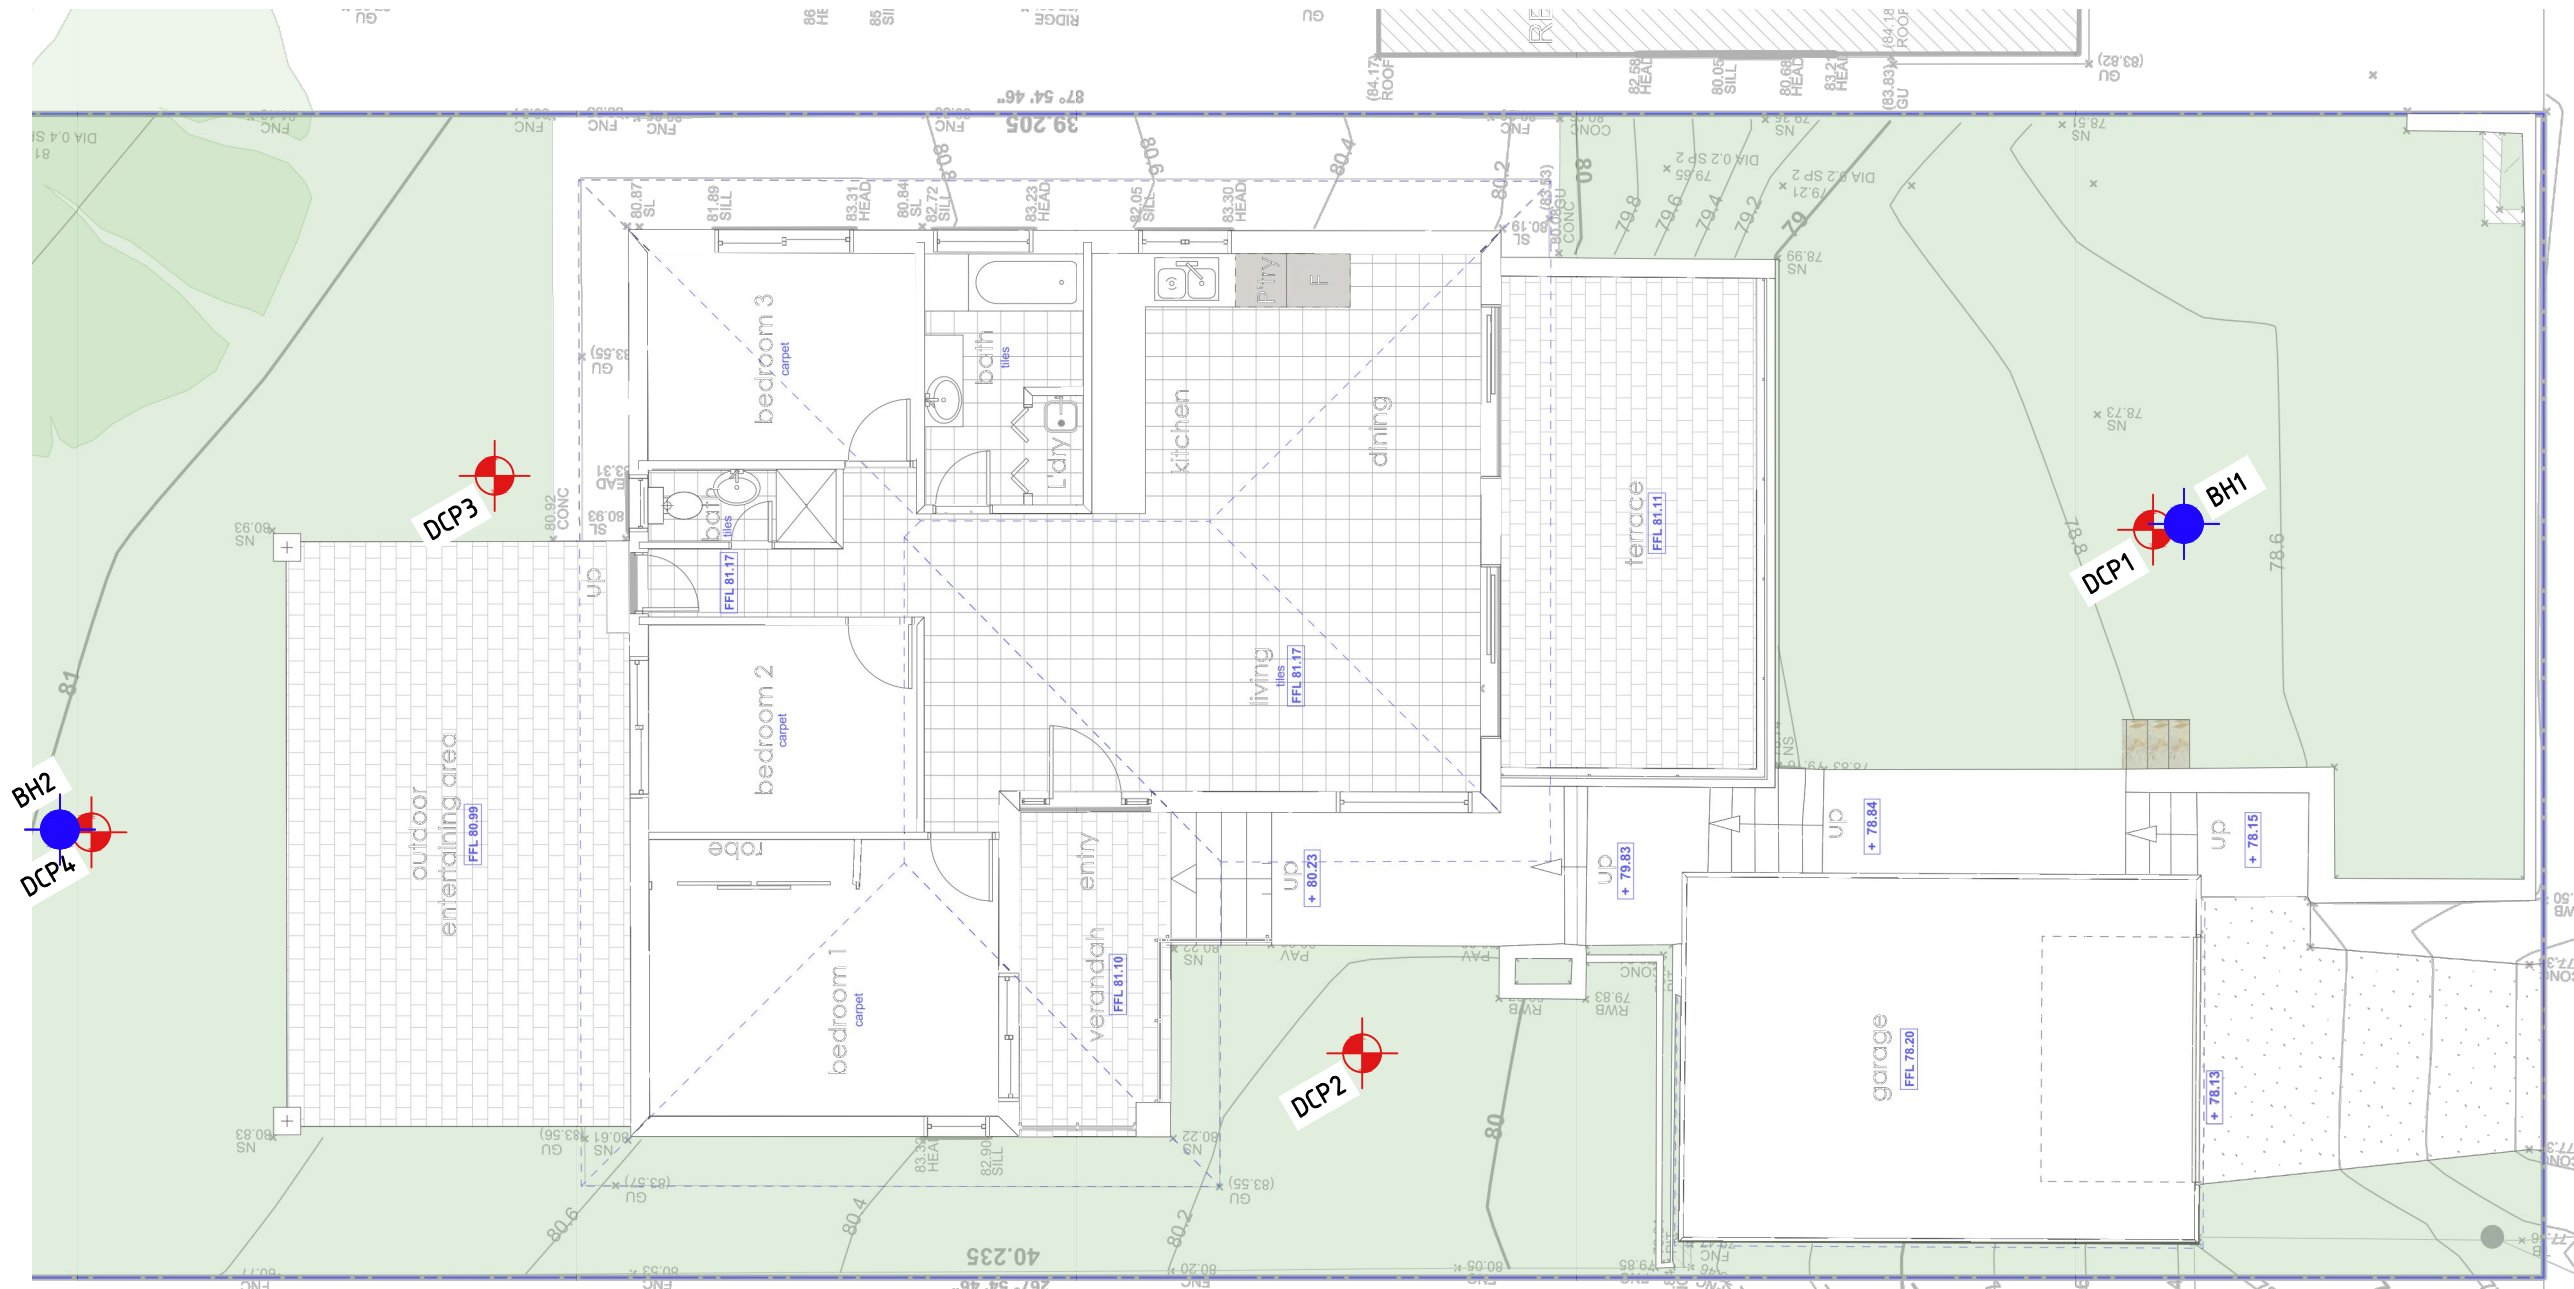
SITE PLAN/GROUND TEST LOCATIONS
SCALE NTS

Test	DCP 1	DCP 2	DCP 3	DCP 4
Summary	Refusal @ 0.45m Double bouncing on bedrock. Red & white sand on moist tip.	Refusal @ 0.15m Double bouncing on bedrock. White dust on dry tip.	Refusal @ 0.55m Double bouncing on bedrock. Grey clayey sand on wet tip.	Refusal @ 0.55m Double bouncing on bedrock. Grey clayey sand on moist tip.

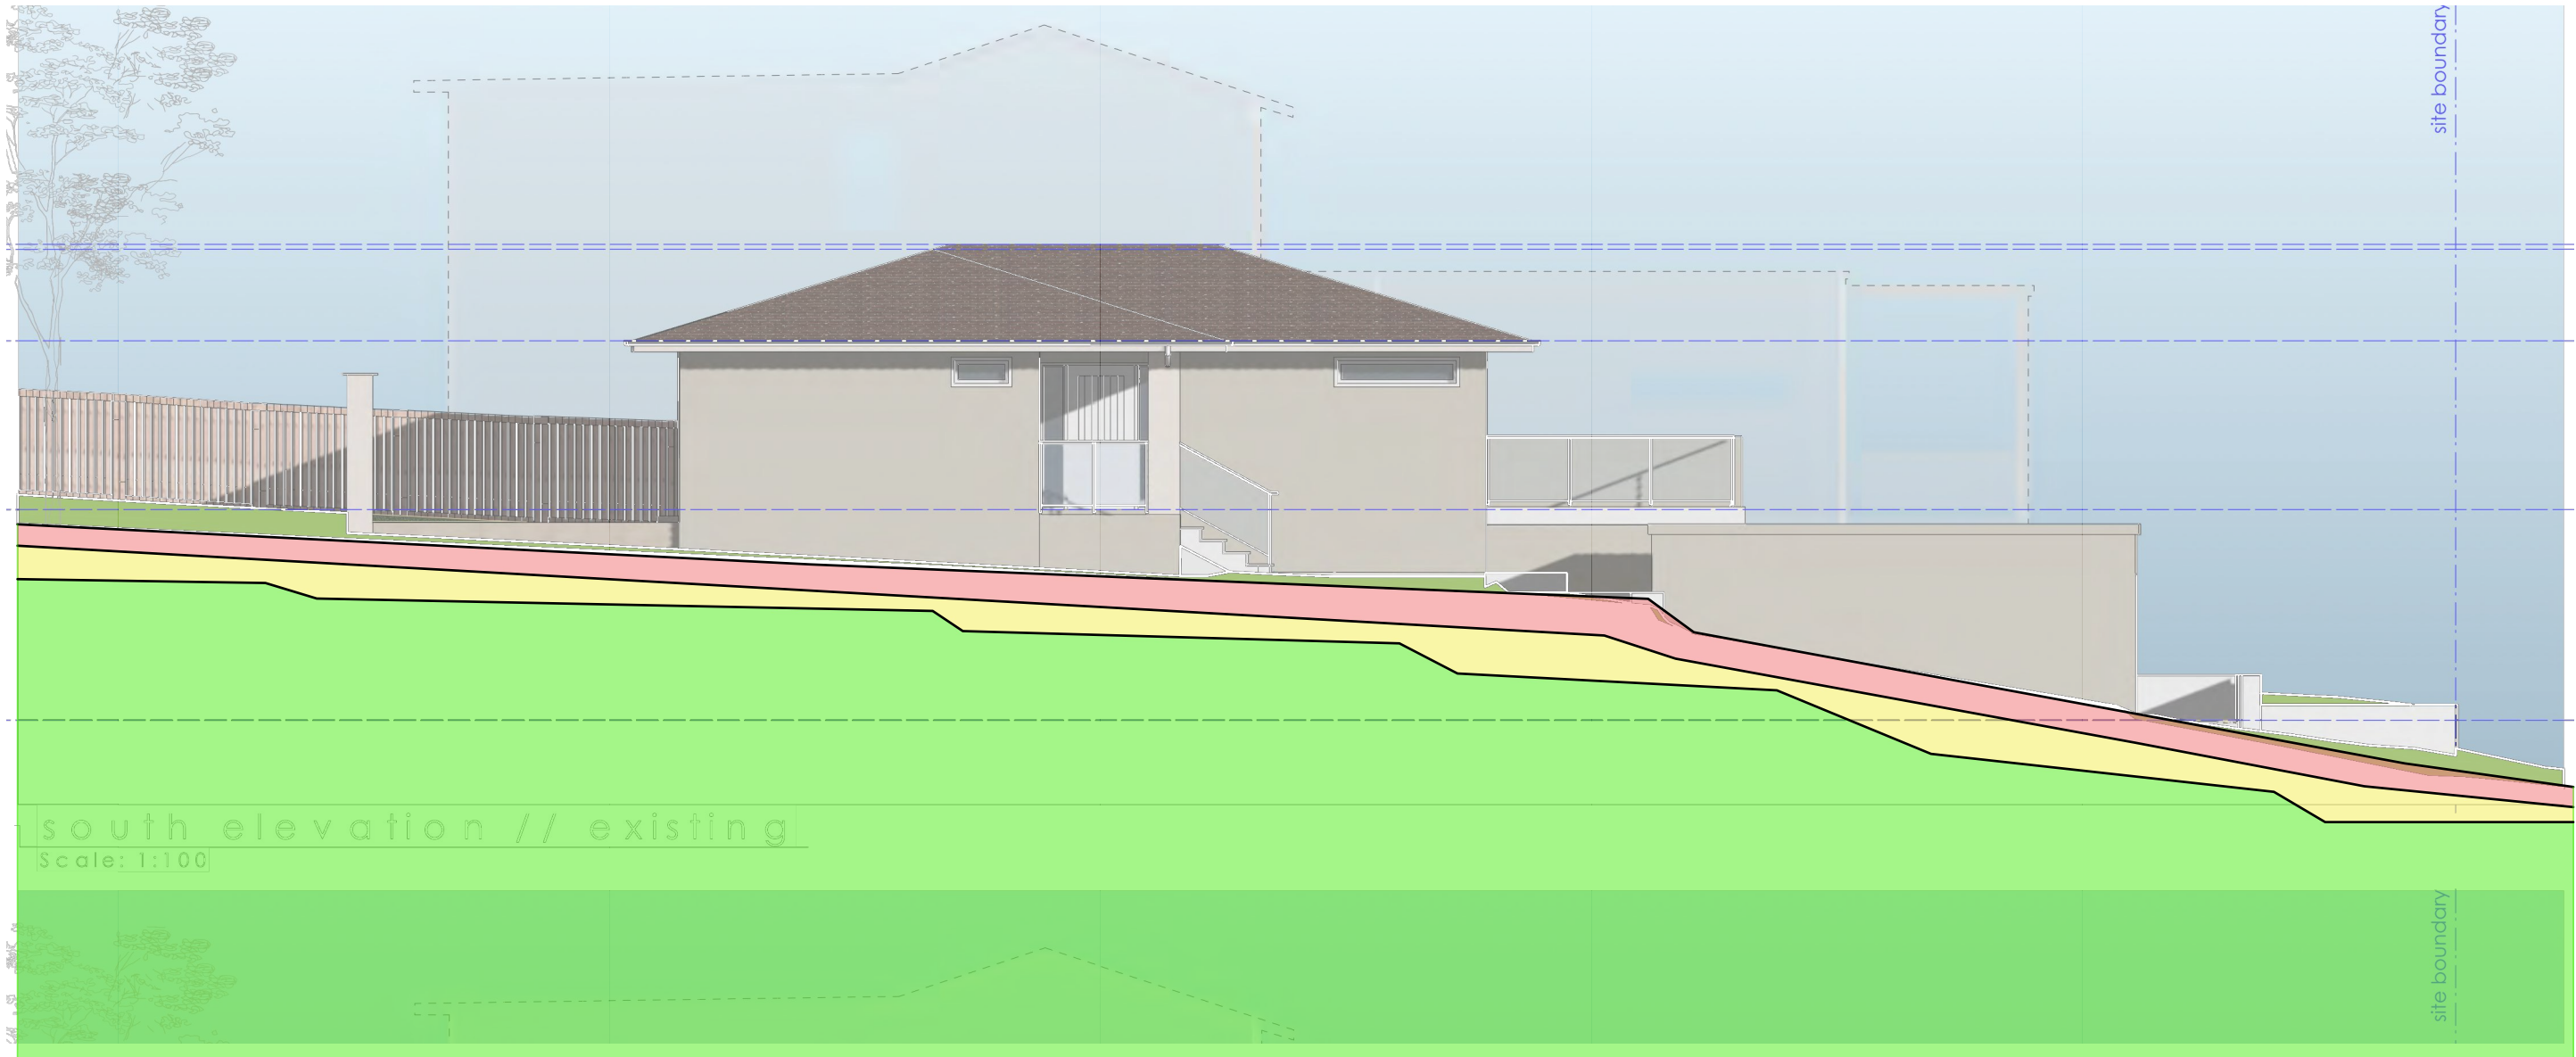
Unit	Material	Comments
1	Topsoil / Fill	Sandy topsoil and fill material. Unit 1 is inferred to be uncontrolled and poorly compacted
2	Sandy Clay	Low-medium plasticity silty clay, generally soft consistency.
3	Sandstone	Low strength or greater sandstone bedrock (Class III+*) expected to be found below the weathered crust (Class IV-V*).

INTERPRETED SUBSURFACE SECTION ONLY.
ACTUAL GROUND CONDITIONS MAY VARY.

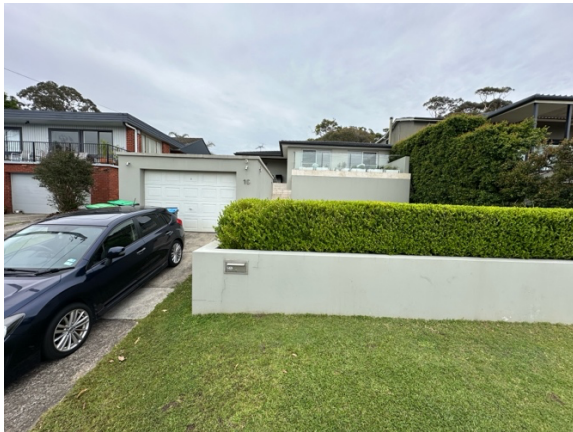
Photo 1: Frontage of the dwelling looking west.

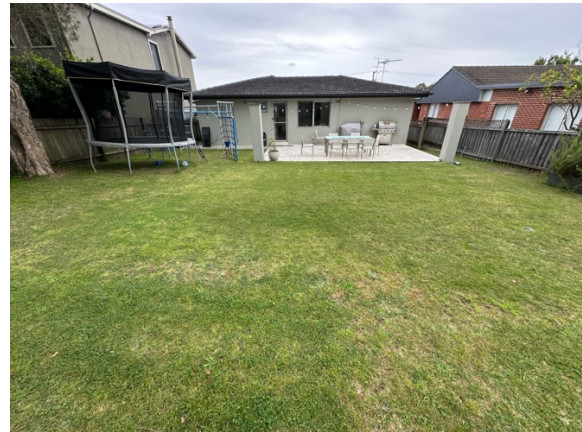
Photo 2: Rear of the dwelling looking east.

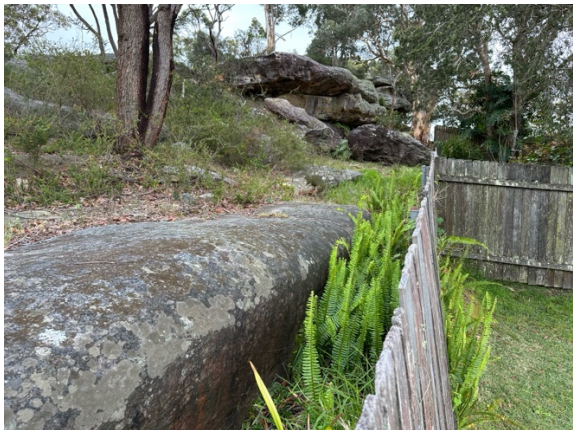
Bedrock was not outcropping on the subject site but is visible beyond the rear boundary toward Manly Dam. Where outcropping, the sandstone bedrock is highly weathered with moderately spaced bedding defects and considered to be low-medium strength.

Photo 3: Highly weathered sandstone bedrock outcropping on the rear boundary of the site.

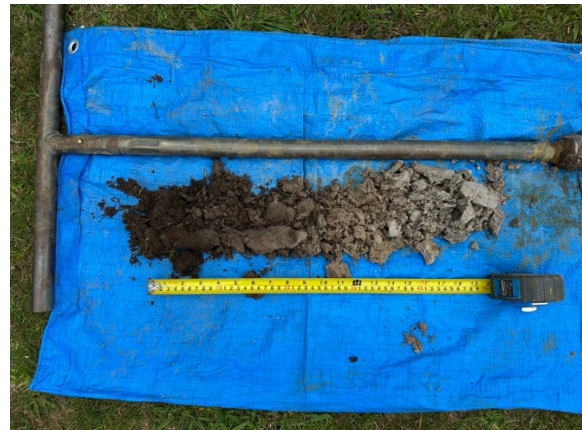
Photo 4: Subsurface soil profile seen in BH2.

Depth (m)	Water	Graphic Log	Drilling Method	Material Description	Consistency	Moisture	Classification Code
				Fill Silty SAND SM: poorly compacted, black, fine to coarse grained, with fine to coarse sized gravel, moist.	PC	M	SM
				Natural Sandy CLAY CL: soft, low plasticity, light brown grey, fine to medium grained sand, inorganic, moist.	S		CL
1				BH2 refusal at 0.5m (Auger tip grinding on bedrock.)			
2
