GEOTECHNICAL INVESTIGATION:

New Houses and Pools at **27 Alan Avenue, Seaforth**

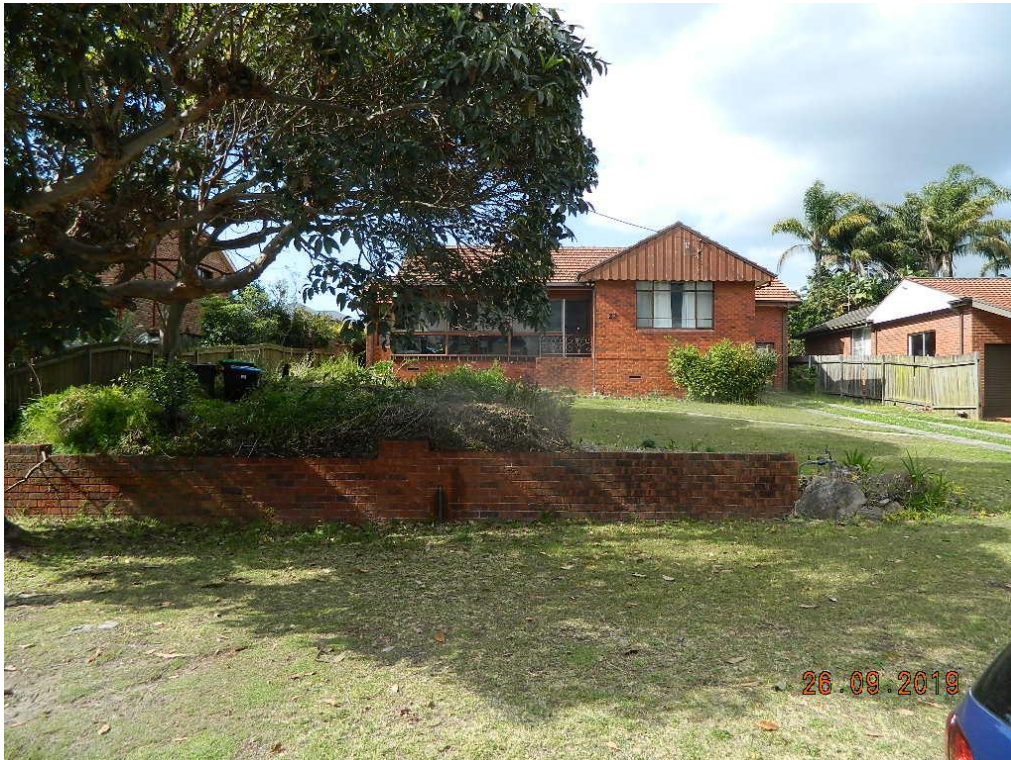
Photo 1

- 2.3** At the road frontage a concrete driveway runs to a garage attached to the W side of the house. Between the road frontage and the house is a gently sloping lawn covered fill. The fill is supported by a stable ~ 1.0 m high brick retaining wall (Photo 1). The single story brick house will be demolished as part of the proposed works (Photo 2). The Piers stand vertical and are considered stable. A brick paved patio extends off the uphill side of the house (Photo 3). Above the patio a gently sloping lawn extends to the uphill common boundary. Outcropping sandstone is visible across the lawn (Photo 4).

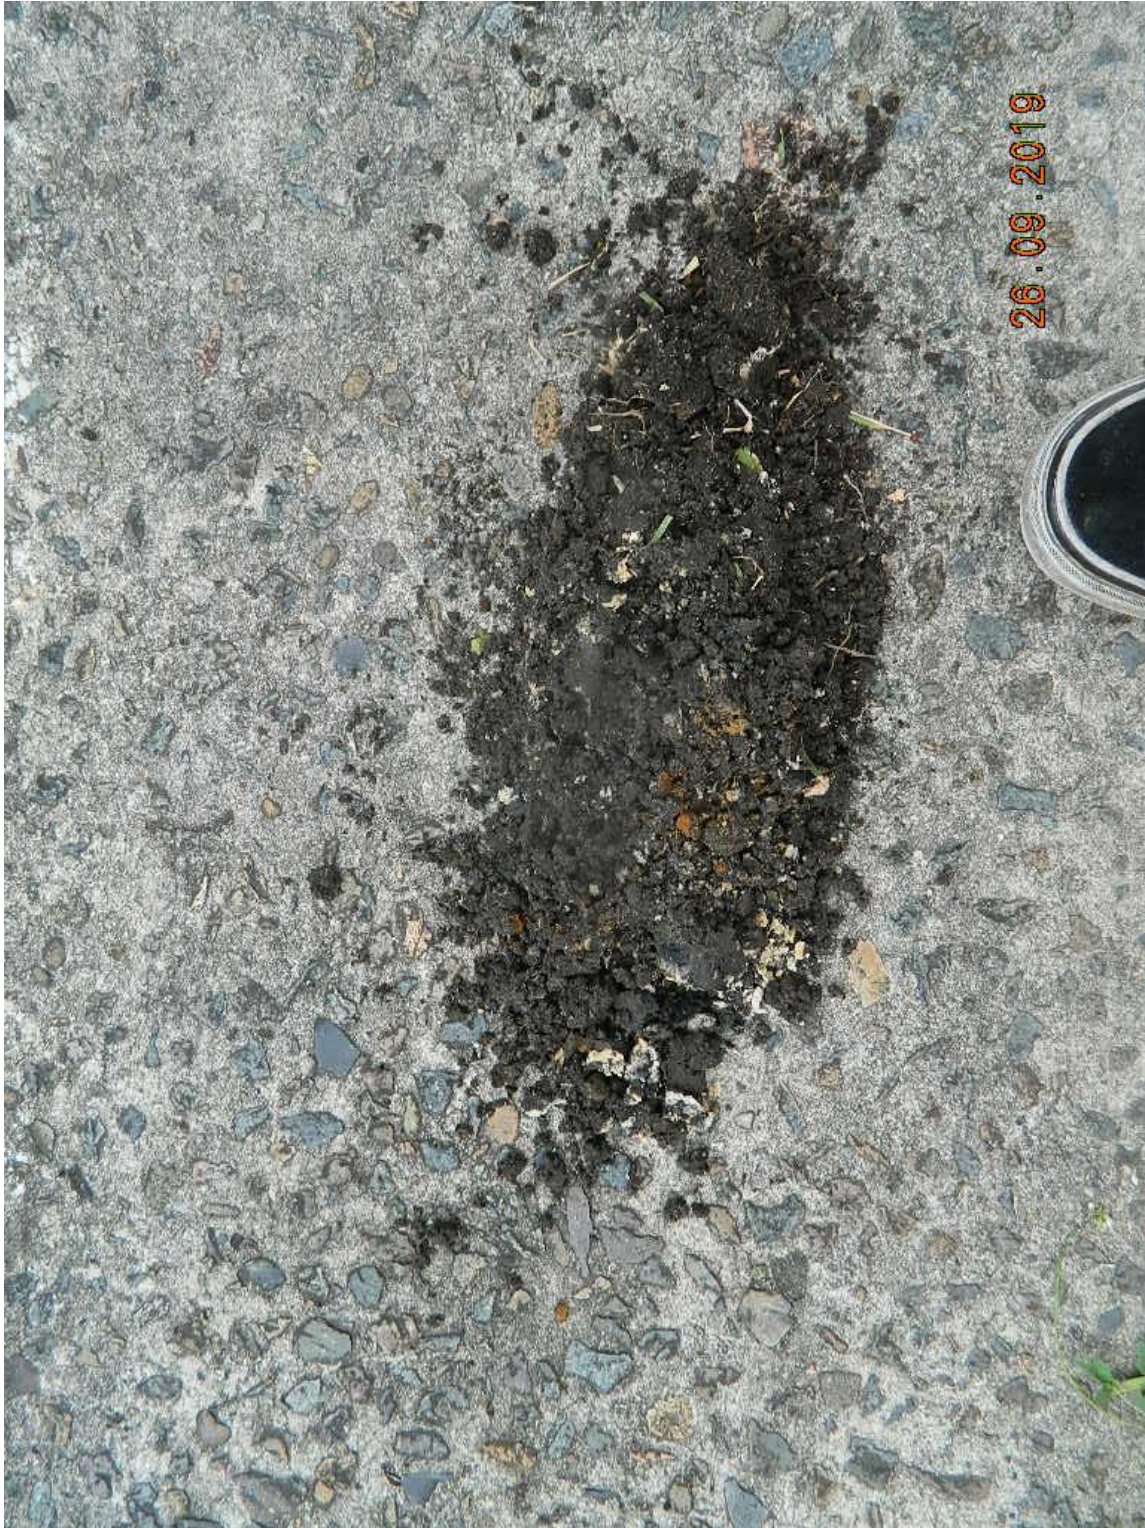
Photo 5 – AH1

AUGER HOLE 1 (~RL57.7) – AH1 (Photo 5)

Depth (m)	Material Encountered
0.0 to 0.1	TOPSOIL , brown, medium grained with trace organic matter
0.1 to 0.3	SANDY SOIL , dark brown, medium grained with sandstone gravel

Refusal @ 0.3m grinding on gravel. No watertable encountered.

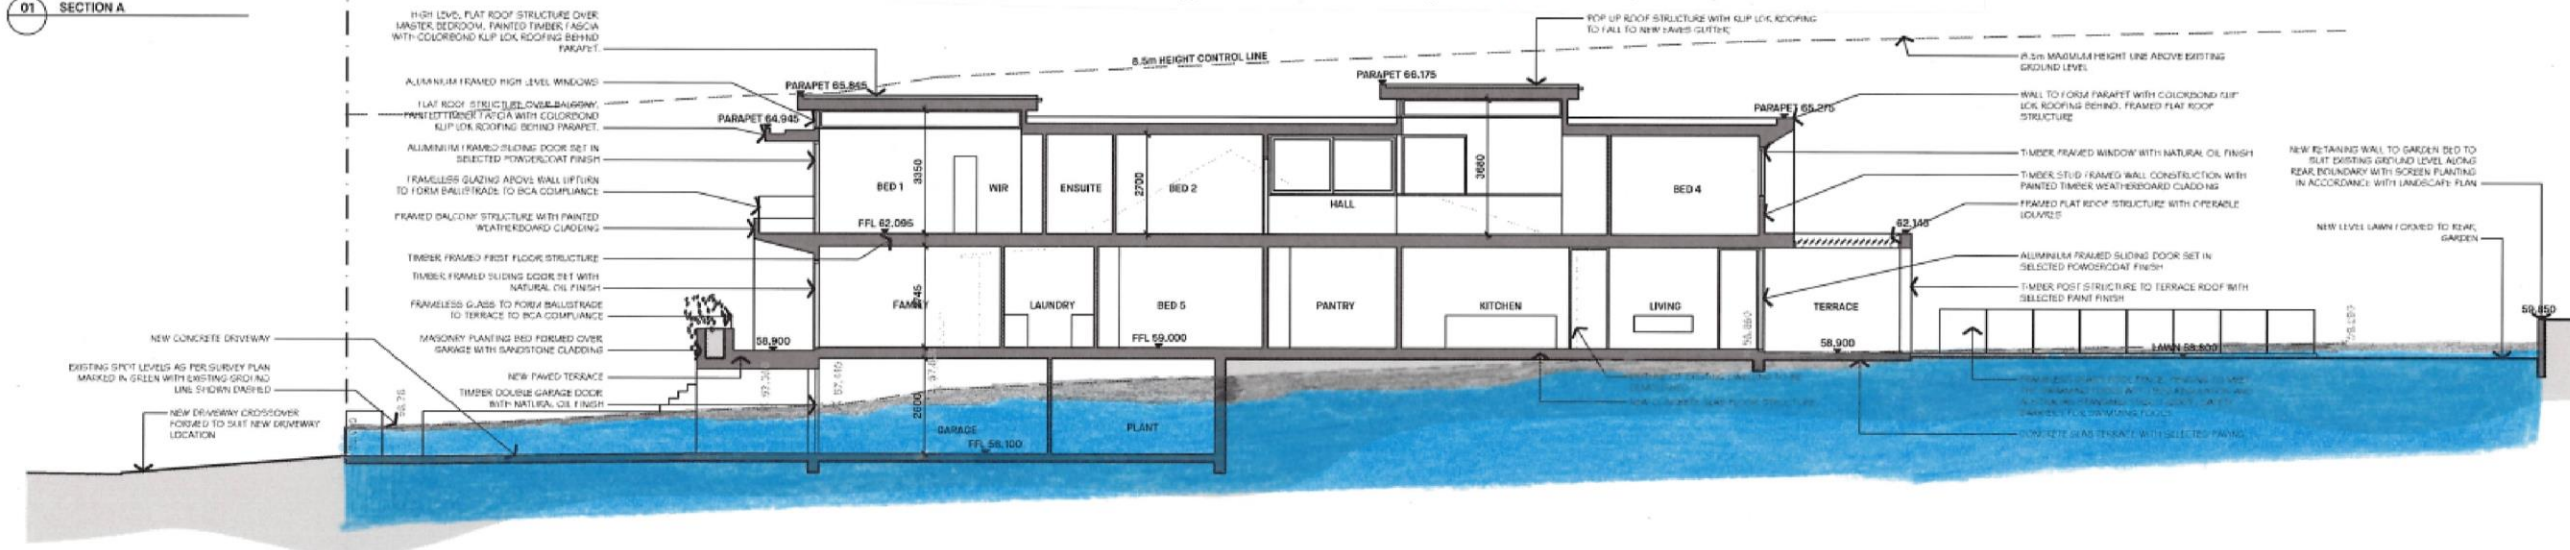
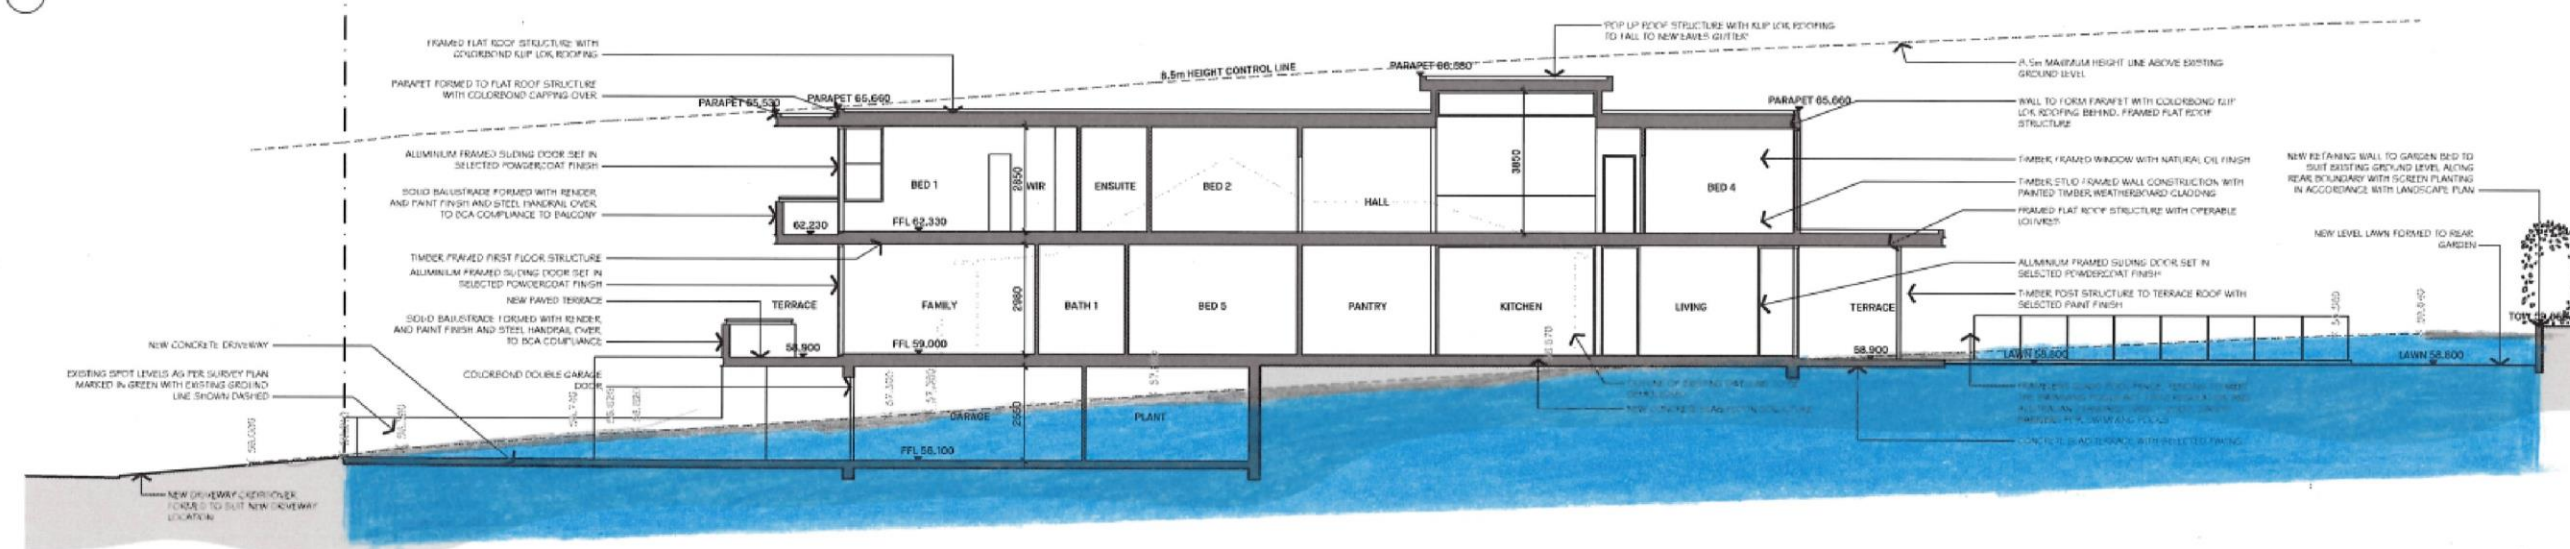
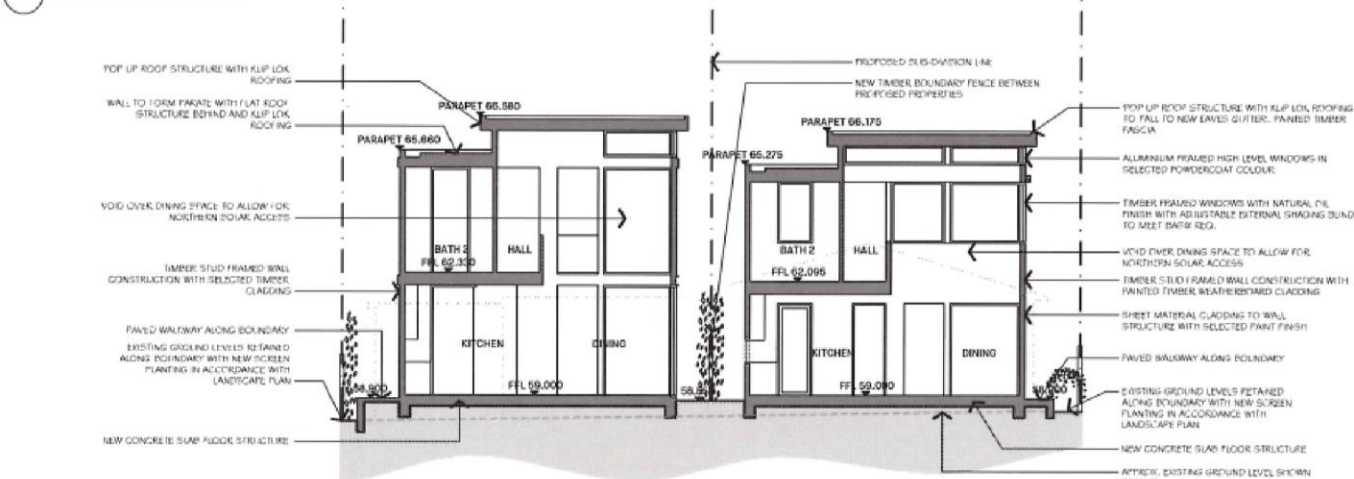
TYPE SECTION – Diagrammatical Interpretation of expected Ground Materials

The surface features of the block are controlled by the outcropping and underlying sandstone bedrock that steps up the property forming sub-horizontal benches between the steps. Where the grade is steeper, the steps are larger, and the benches narrower. Where the slope eases, the opposite is true. The rock is overlain by manmade fill over natural sandy soils over firm to stiff sandy clays that fill the bench-step formation. In the test locations, where it was not exposed, the depth to Medium Strength Sandstone ranged between 0.0 to 0.6m below the current surface, being slightly deeper where filling is present across the downhill side of the property and due to the stepped nature of the underlying rock. See Type Section attached for a diagrammatical representation of the expected ground materials.
