**GEOTECHNICAL RISK MANAGEMENT POLICY FOR PITTWATER
FORM NO. 1 – To be submitted with Development Application**

Address of site 87 Alexandra Crescent, Bayview

GEOTECHNICAL INVESTIGATION:

Alterations and Additions at **87 Alexandra Crescent, Bayview.**

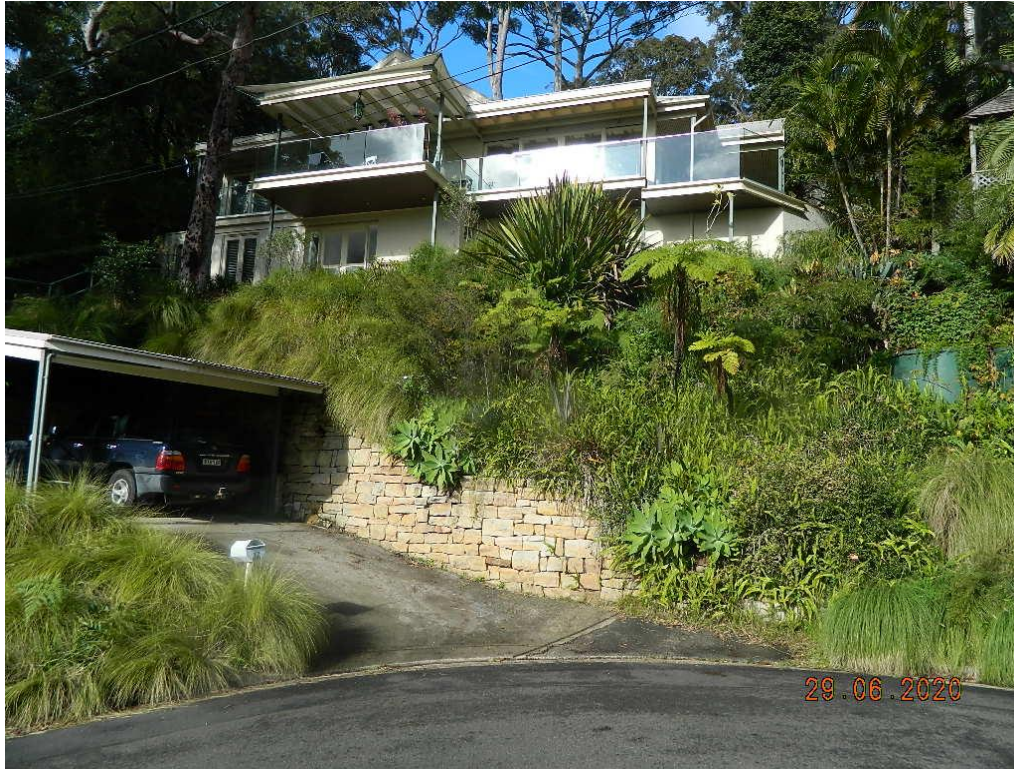
Photo 1

2.3 At the road frontage a concrete driveway runs to a carport cut into the slope (Photo 1). The cut is supported by sandstone block, brick and concrete block retaining walls up to ~3.4m high (Photos 1 to 3). The highest portion of the sandstone block wall is supported by a brick wall in front of the base of the retaining wall (Photo 2). The retaining walls are considered to be stable. Between the carport and the house is a steep and thickly vegetated slope (Photo 1). The part three storey rendered brick and weatherboard clad house is supported by brick walls and brick piers Photos (1 & 4). The supporting walls and piers stand vertical and show no significant signs of movement (Photo 5). Uphill of the house a cut in the slope provides a level platform for the house. The cut is supported by concrete block and sandstone flagging retaining walls up to ~2.7m high. (Photos 6 & 7). The W portion of the concrete block retaining wall is tilting at up to ~4° from vertical. See 'Section 16 Ongoing Maintenance'. A Medium Strength Sandstone bedrock cliff face up to ~7m outcrops above the cut for the house (Photo 8). A portion of the cliff face is undercut by up to ~4.4m (Photo 9). The undercut is considered stable. No geotechnical hazards were observed on the neighbouring properties that could impact on the subject property as seen from the street and subject property.

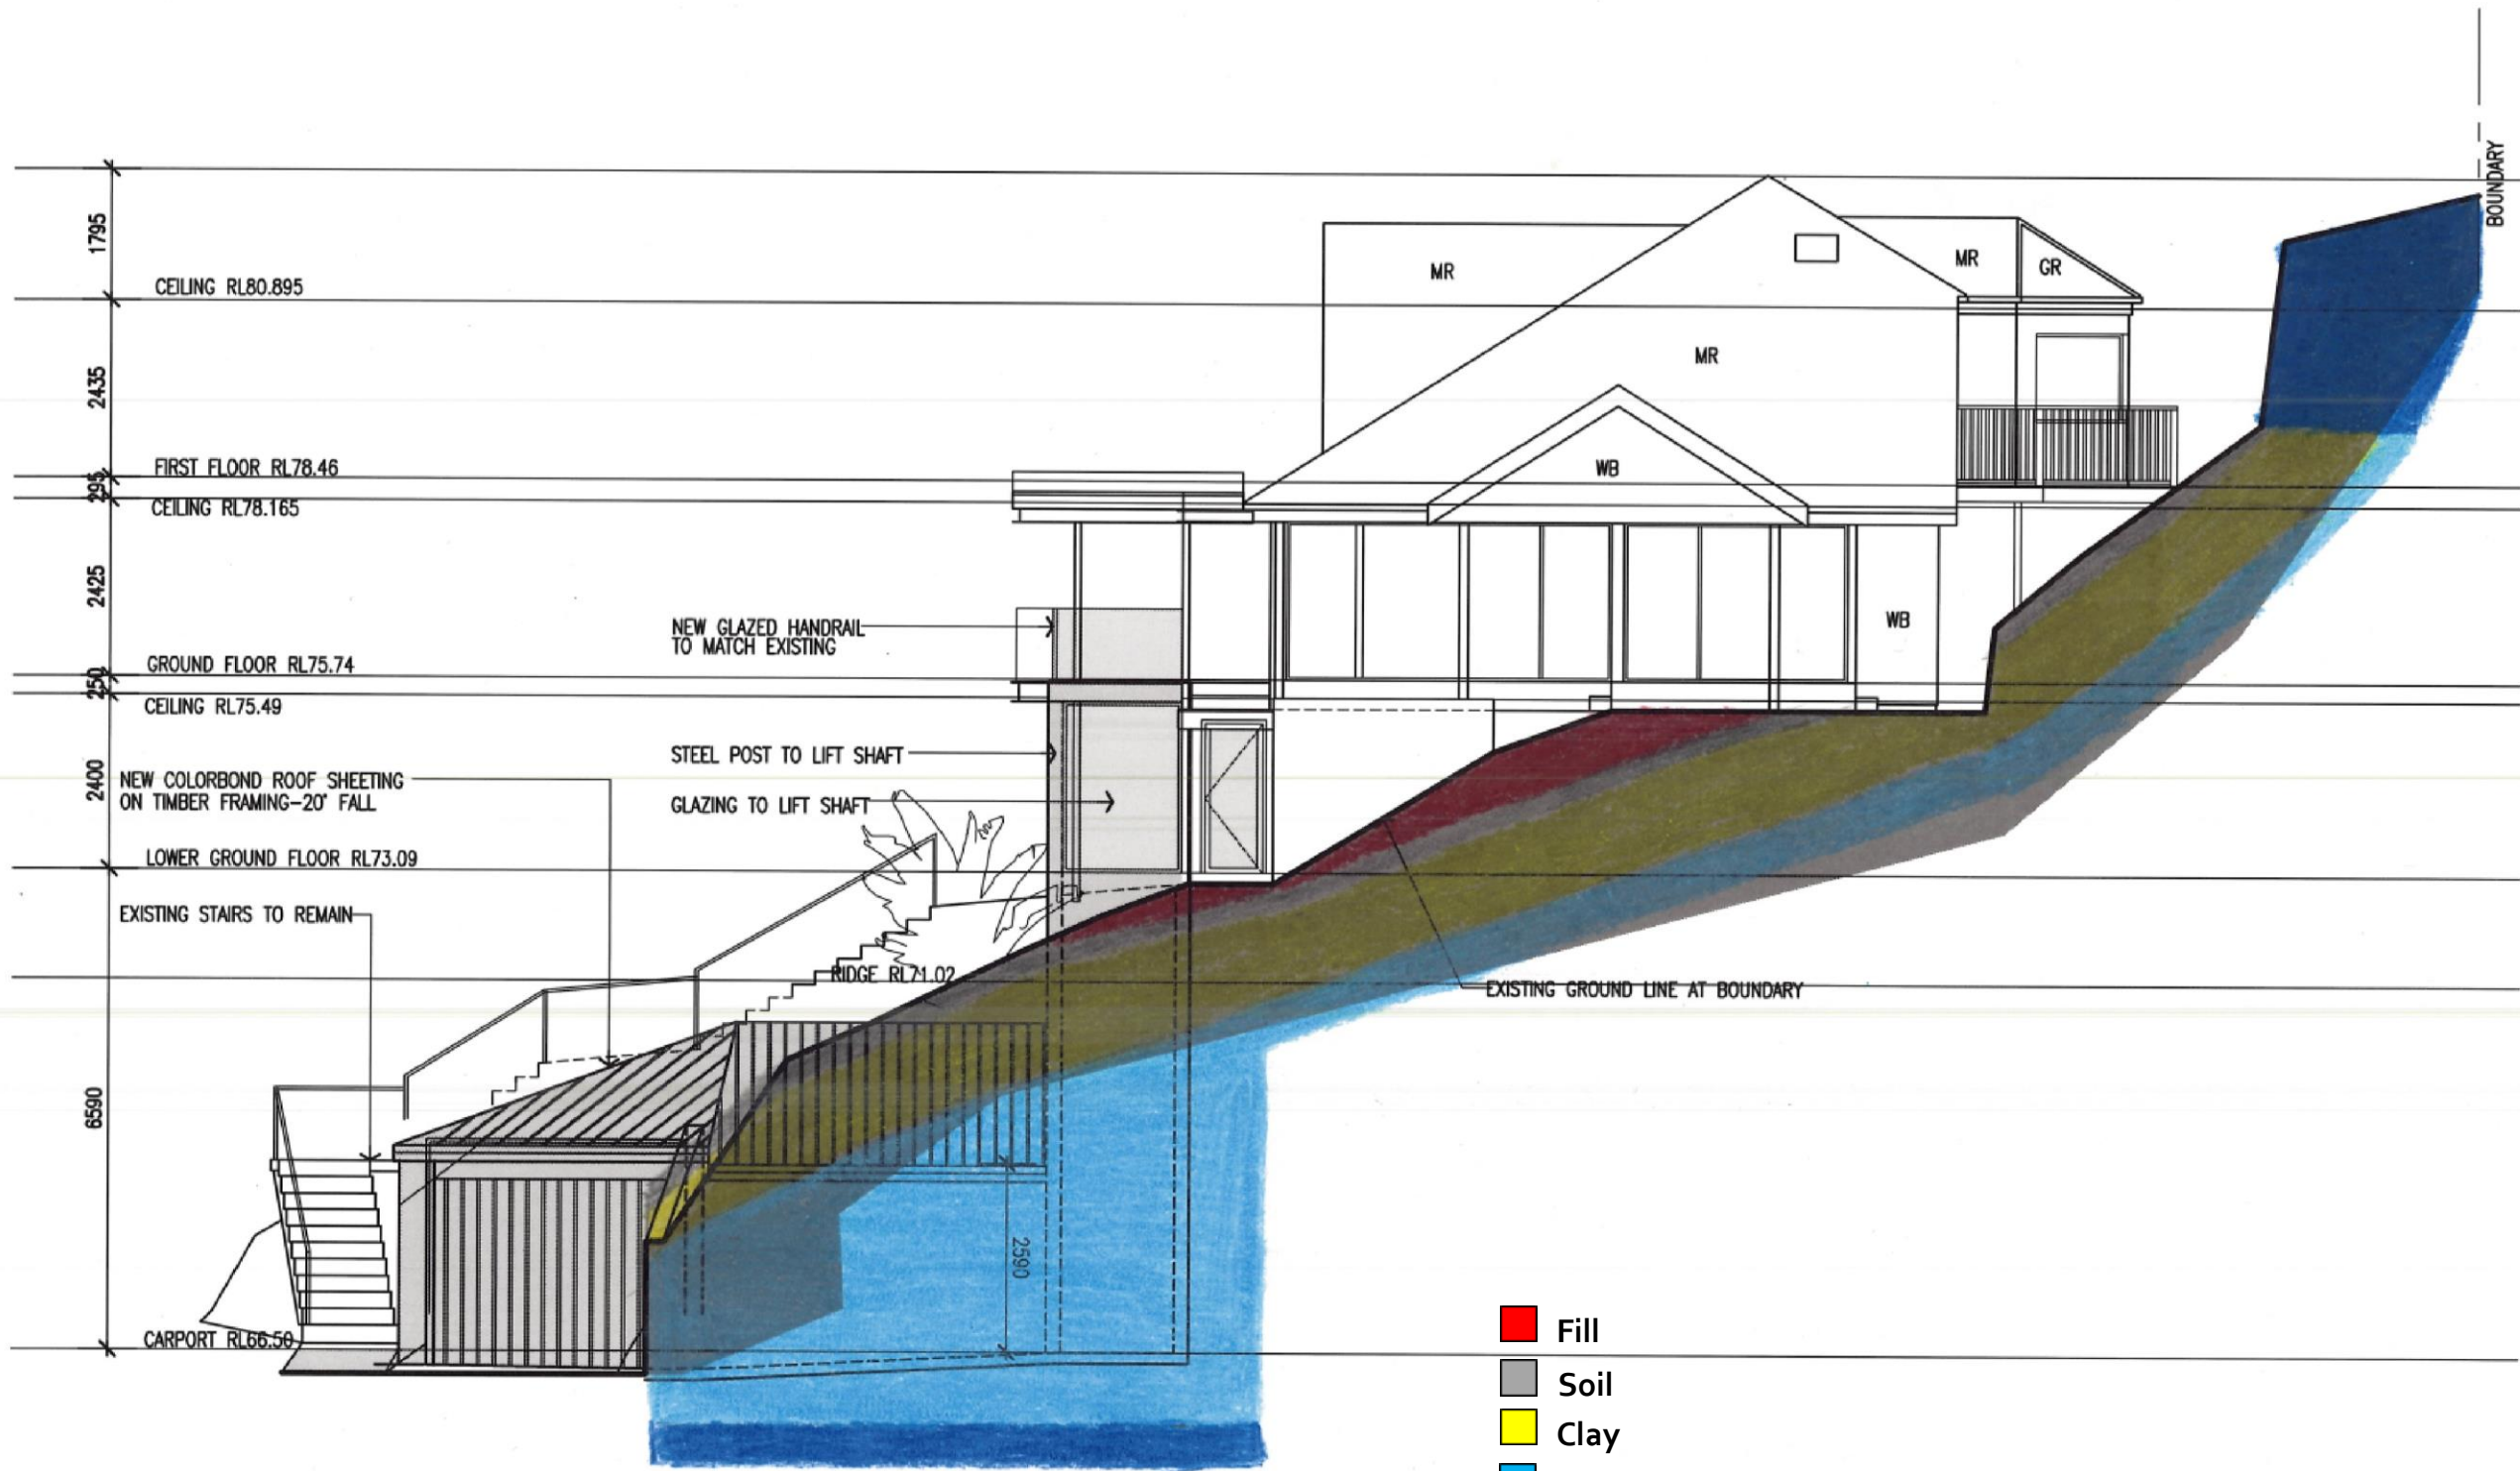
TYPE SECTION – Diagrammatical Interpretation of expected Ground Materials

The slope materials are colluvial at the near surface and residual at depth. In the test locations, the ground materials consist of fill and soil over firm to stiff clays. Fill provides a level platform on the downhill side of the house. Below the filled areas the clays merge into the weathered zone of the underlying rocks at depths of between ~1.0m to ~2.4m below the current surface. In the locations of DCP1 to DCP3 and DCP6 the weathered zone of the underlying rock is interpreted as Extremely Low Strength Shale. It is to be noted that this material is a soft rock and can appear as a mottled stiff clay when it is cut up by excavation equipment. A cored borehole near the location of DCP1 completed by another firm during 2004 shows that Very Low to Low Strength shale extends to a depth of ~7.2m, with Very Low to Low Strength Sandstone encountered below the shale to the extent of the testing at a depth of 9m. In the locations of DCP4 and DCP5 the weathered zone of the underlying rock is interpreted as Low to Medium Strength Rock.
