Preliminary Assessment

Proposed Additions and Alterations

32 Ettalong Street, Wheeler Heights NSW 2097

Project No.: JASC0727-GEO AA
23 March 2022

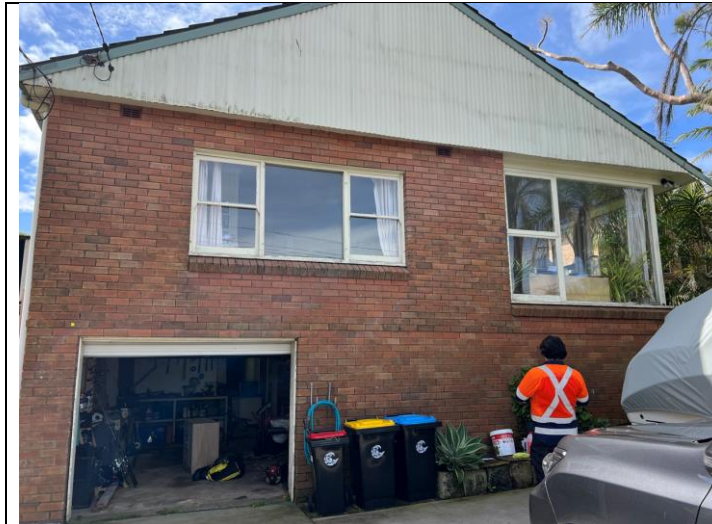
Photo 1: The front of the existing dwelling.

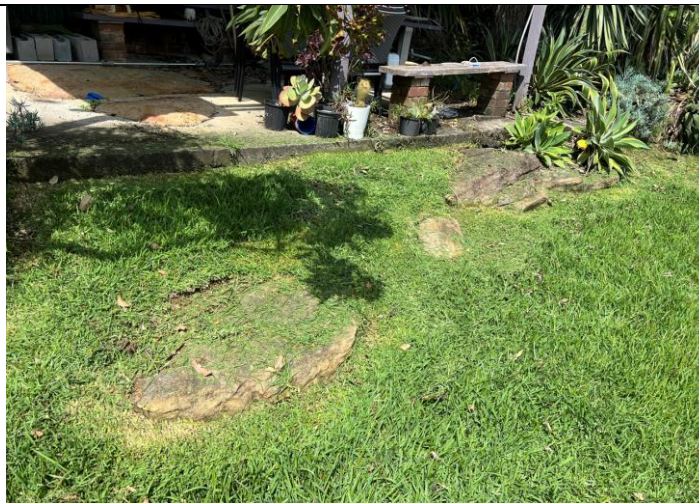
The sandstone bedrock observed was grey to pale brown, with estimated medium to high strength rock (**Photo 2 and 3**).

Photo 2: Photo taken from the rear of residency along the eastern extent showing exposed sandstone bedrock outcrops.

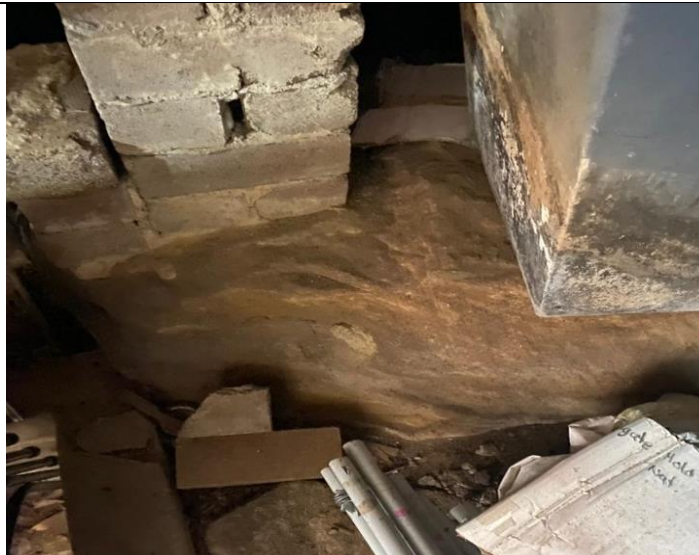
Photo 3: Exposed sandstone bedrock supporting brick pad footing of the existing dwelling.

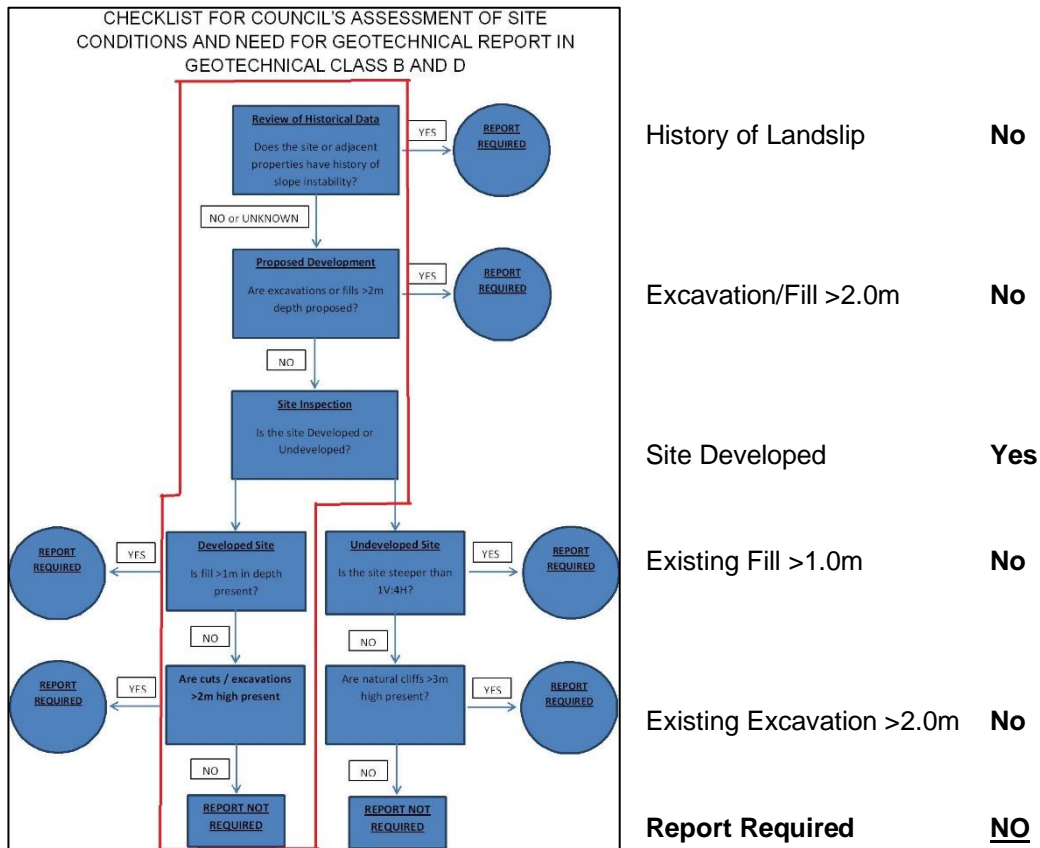
Figure 2 Site Condition Checklist

Based on the outcome of the field assessment, it is considered that a detailed Landslip Risk Assessment is **not** required for this development.

Based on the results of the investigations and the presence of shallow bedrock, the overall risk of slope instability across the proposed development site is **very low** for excavations up to 2.0m. As such, the proposed development site is considered **suitable** for construction. Nevertheless, the proposed development should be carried out in accordance with good hillside practice (refer **Appendix B**).
